**1R - 0463**

**SOIL CLOSURE REPORT**  
**D.S. HUGH**  
PLAINS SRS NO. 2000-10807  
**UL-A, SECTION 26, T21S, R37E**  
**Lea County, New Mexico**  
**NMOCD NO. IR-0463**

Project No. 205071.00

March 2007

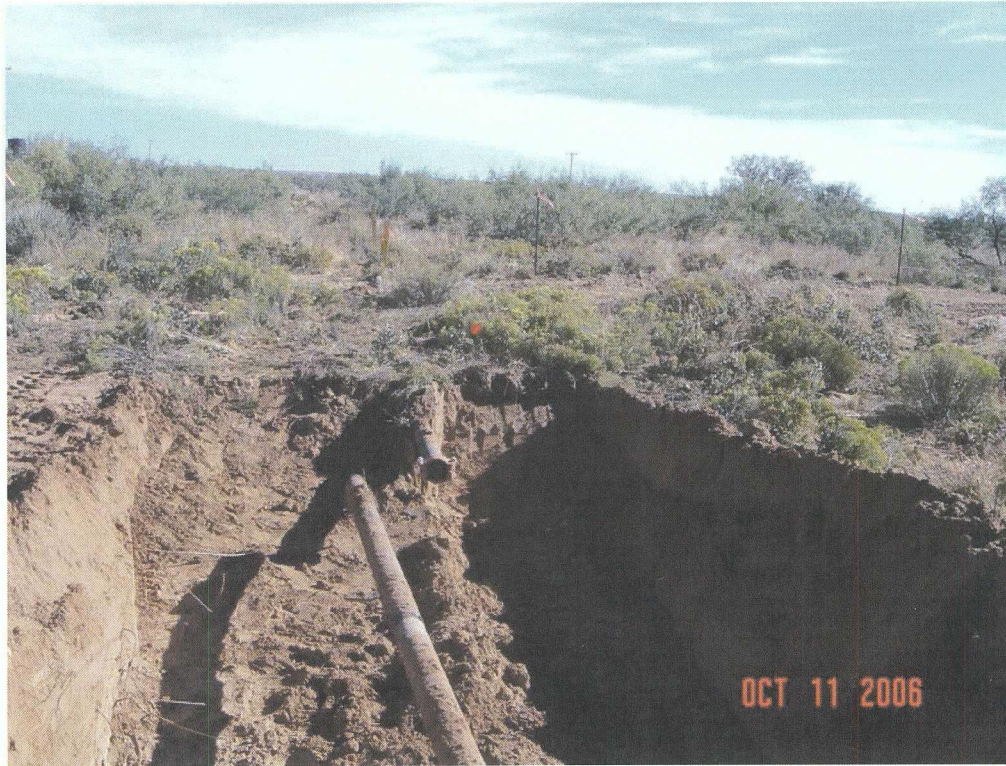
Photograph 1: Buried pipeline excavated, cut and capped with end clamp.

square feet was temporarily fenced on October 10, 2006. On October 11, 2006, the area around the partially buried pipeline was excavated and the pipeline was cut. A roller-grip bull-end clamp was attached approximately 39 feet west from the eastern perimeter of the area temporarily fenced (Photograph 1, Appendix E). A second cut along the pipeline was made close to the western end of the site and capped in the same manner. Approximately 240 feet of pipeline was removed and cut into approximately 40 foot sections and placed on the south west section of the fenced area. Inspection of the removed section of pipeline revealed two clamps and one relatively new 40 foot section of pipeline. The locations of the clamps are shown in Figure 3, Appendix A. The significance of the clamps is discussed in detail in Section 5.3.3.

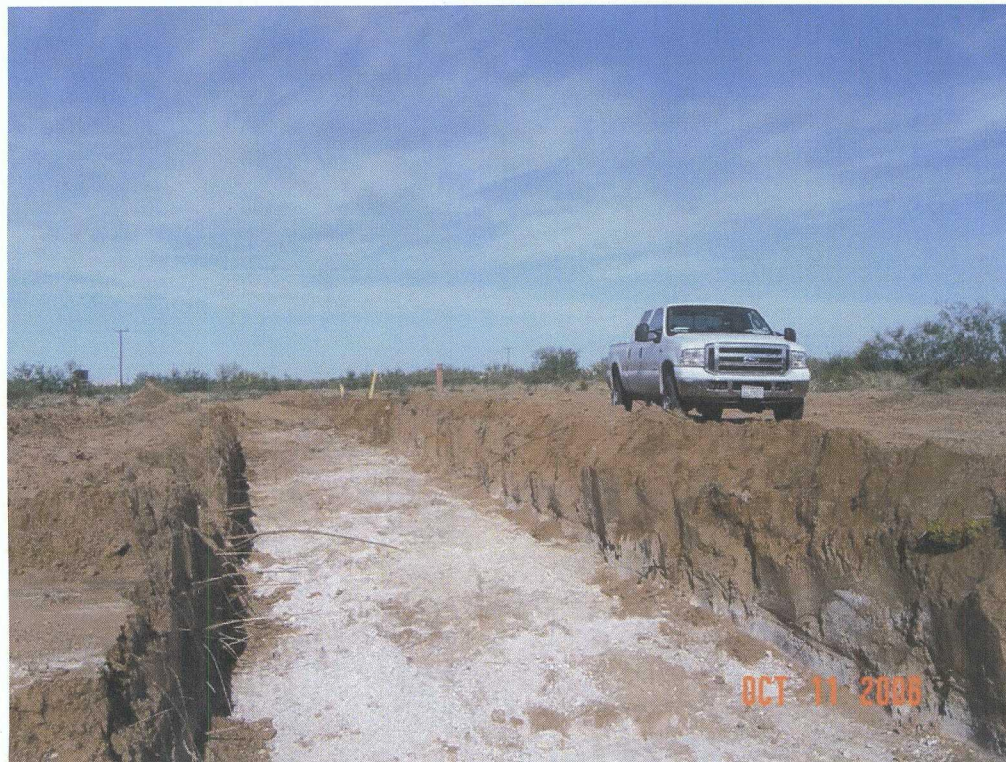
Photograph 2: 230 feet by 12 feet excavation of entire length of release (flow path).

Excavation activities were initiated on October 11, 2006 to remove contaminated soil containing the highest COC concentrations. An excavation along the entire length of the release, approximately 230 feet long and 12 feet wide was completed to an average depth of 5 feet bgs (Photograph 2, Appendix E). This allowed Premier field personnel to identify areas of crude oil impact in the base and side walls of the excavation requiring further excavation.

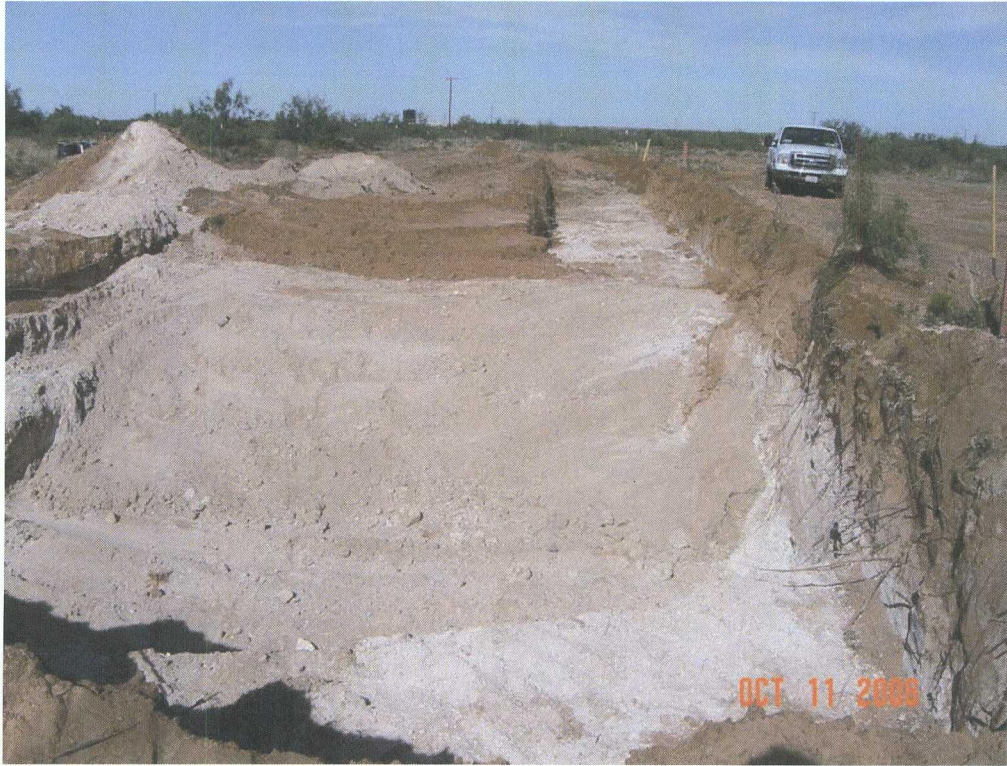
Photograph 3: Excavated area around monitor well MW-2.

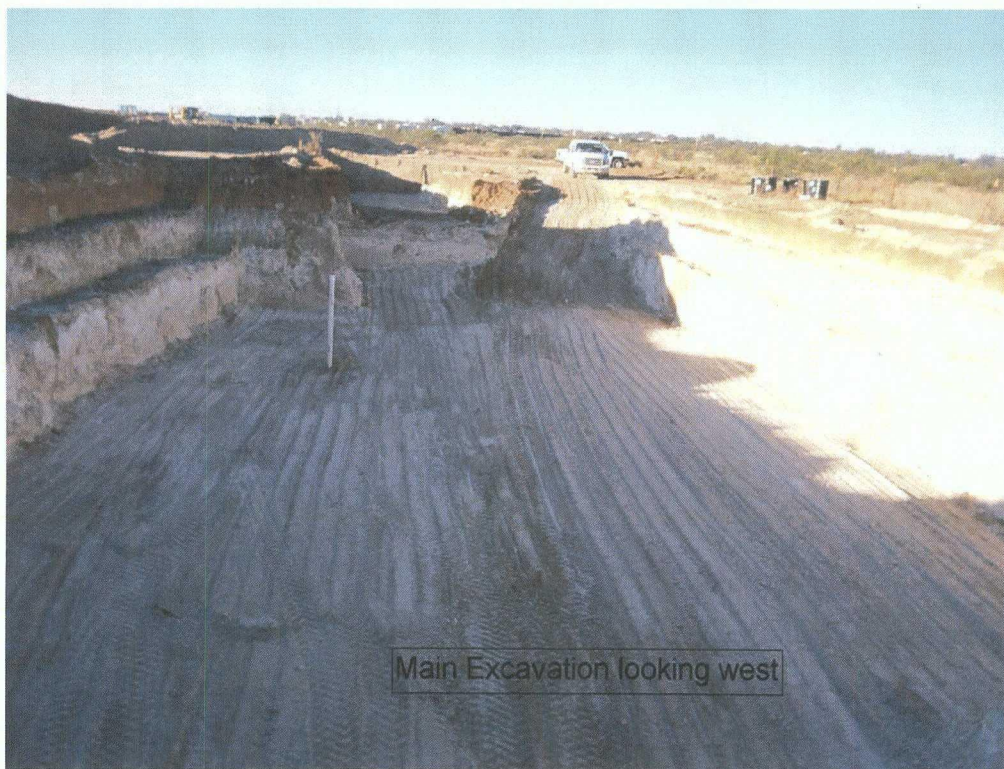
Photograph 4: Excavated area around monitor well MW-1.

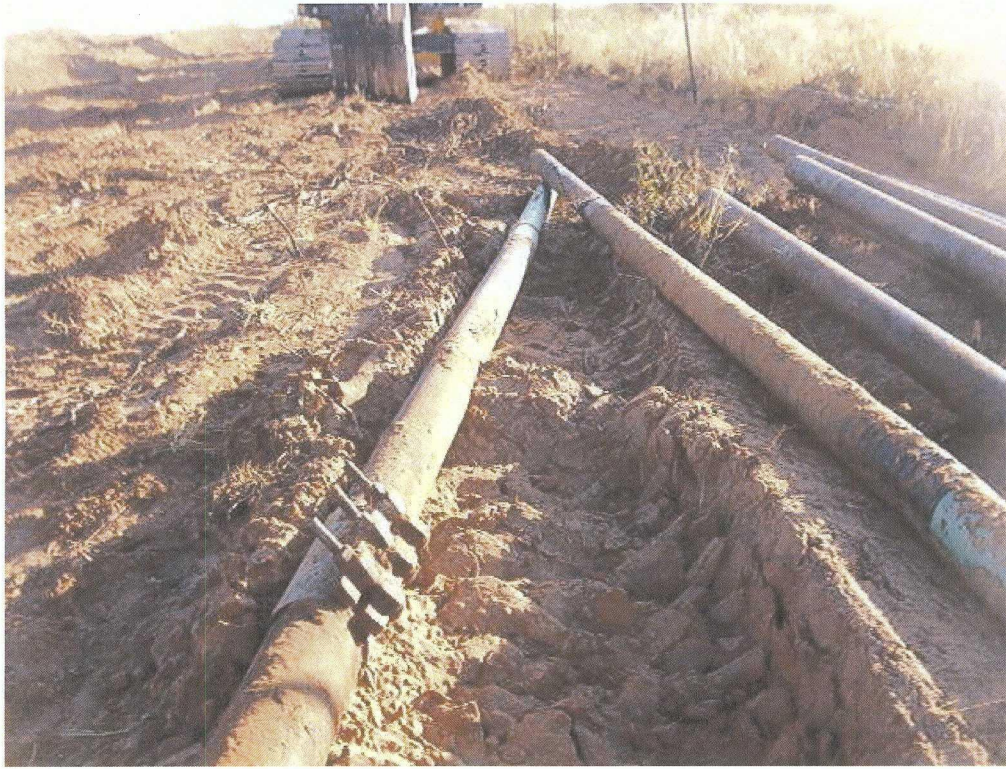
Photograph 5: Clamp on pipeline and relatively new section of green pipe.

During excavation activities, an inspection of the removed section of pipeline revealed two clamps and one relatively new 40-foot section of pipe (Photographs 5 and 6, Appendix E). The locations of the clamps and newer pipe section are shown on Figure 3, Appendix A. The two clamps and the 40-foot section of new pipe indicate that multiple releases have likely taken place at this location in the past. Three soil samples were collected from stained side walls associated with these three points of suspected releases. Sample DS1 was collected in the vicinity of the 40-foot section of new pipe. Sample DS2 was collected in the vicinity of the three pin clamp on the surface pipe associated with the November 10, 2000 release and Sample DS3 was collected from the buried two pin clamp area.

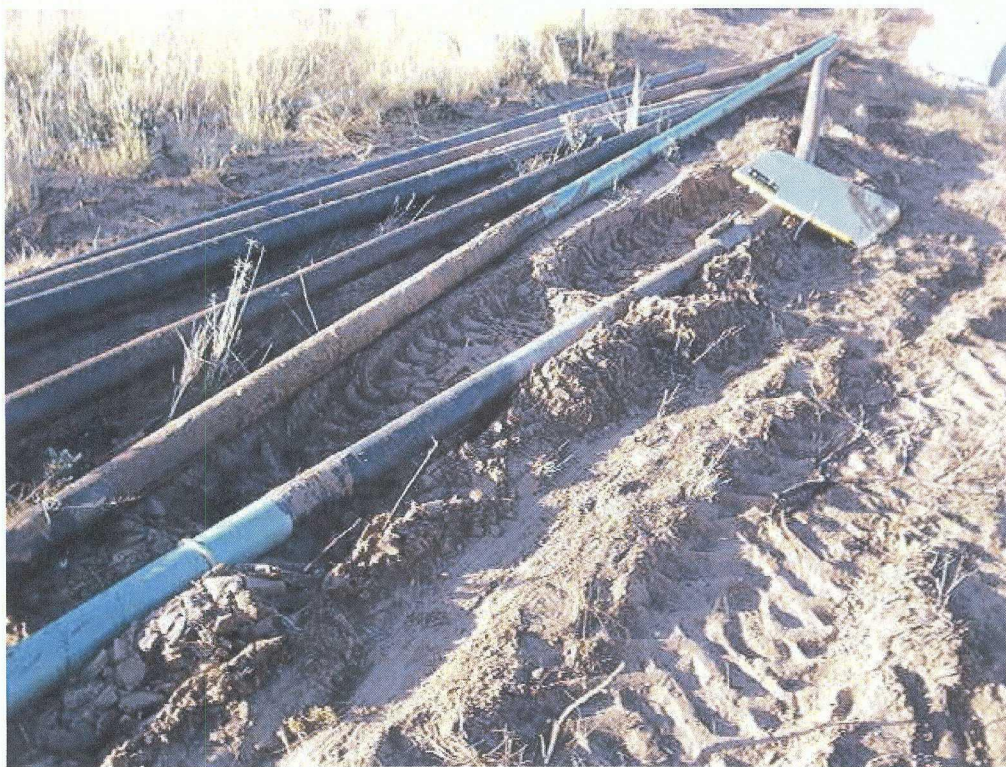
Photograph 6: Clamp on pipeline and relatively new section of green pipe.

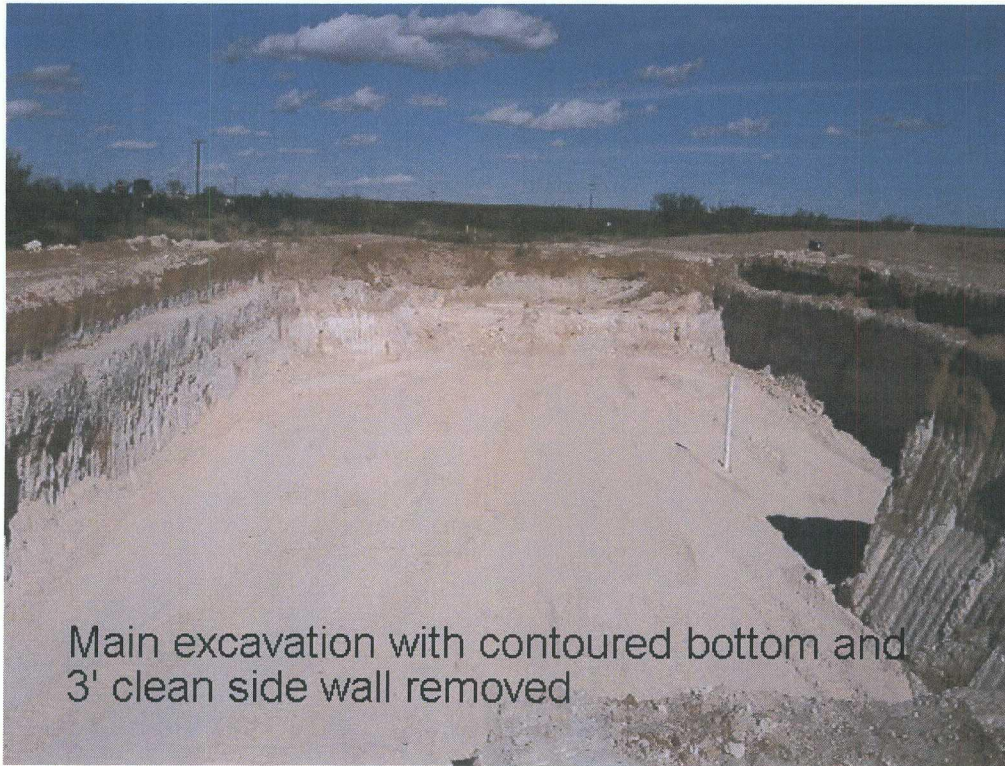
Main excavation with contoured bottom and 3' clean side wall removed

Photograph 7: A buffer zone is created in the main excavation around monitor well MW-1.

groundwater runoff that may infiltrate the liner, and prevent the percolating water from contacting potential hydrocarbon containing (residual) soils below the liner (Photograph 7, Appendix E). The base of the excavation was graded to create a higher central area, creating a drainage gradient away from the center of the excavation. This will shed water that infiltrates from the surface to flow off the liner, away from residual hydrocarbons. A 20-mil, high-density polyurethane reinforced impermeable liner was placed on the base of the excavation (Photographs 8 and 9, Appendix E). The 100 foot by 40 foot sections of liner placed at the base of the excavation were overlapped and interwoven at the ends to seal, forming a single continuous barrier. In the vicinity of MW-1, special precaution was taken to ensure a seal. Bentonite was placed beneath the liner and again above the liner immediately around the monitor well (Photograph 10, Appendix E).

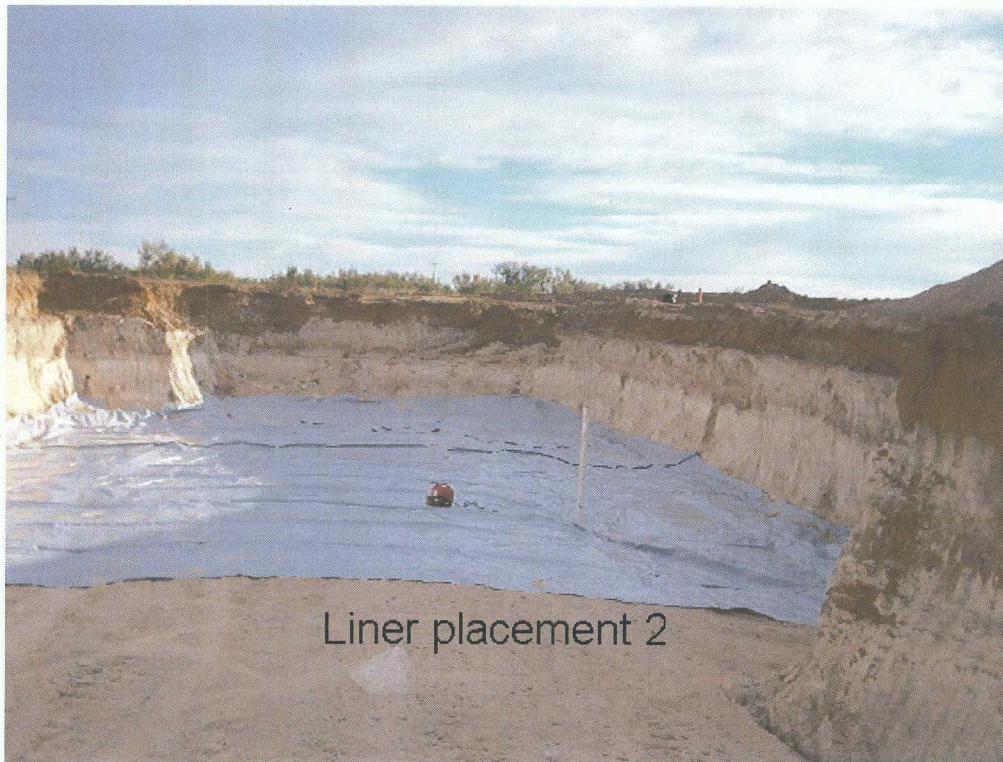
Liner placement 2

Photograph 8: Liner placed on the base of excavation by monitor well #1.

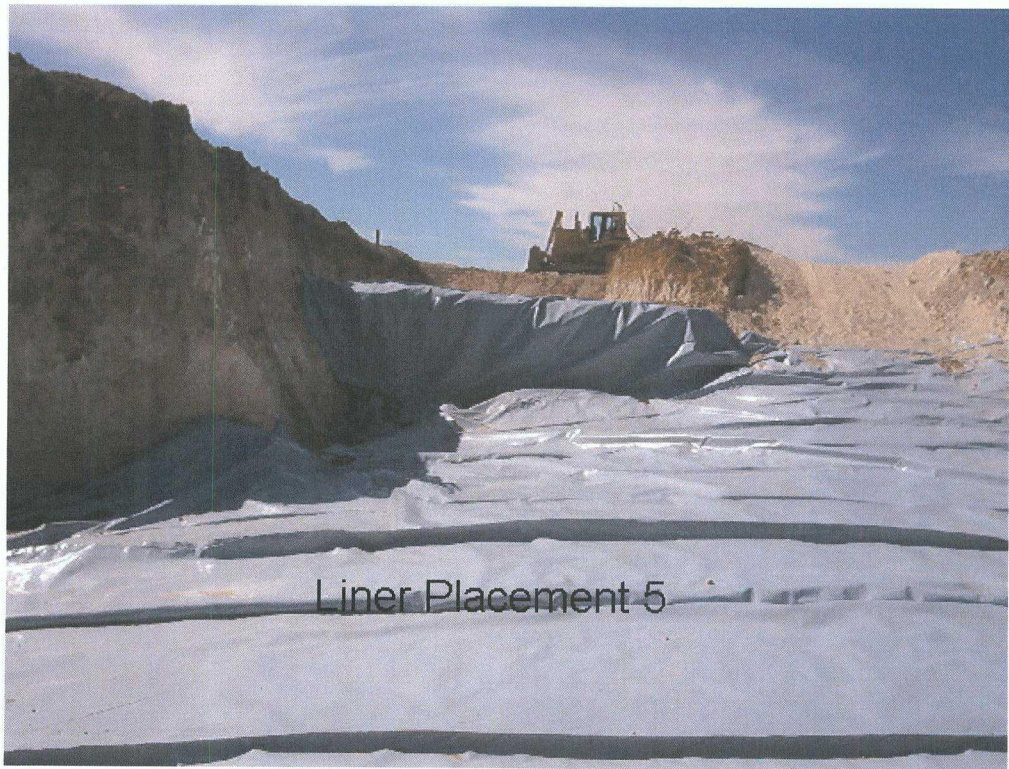
Photograph 9: Liner placed on the base of excavation.

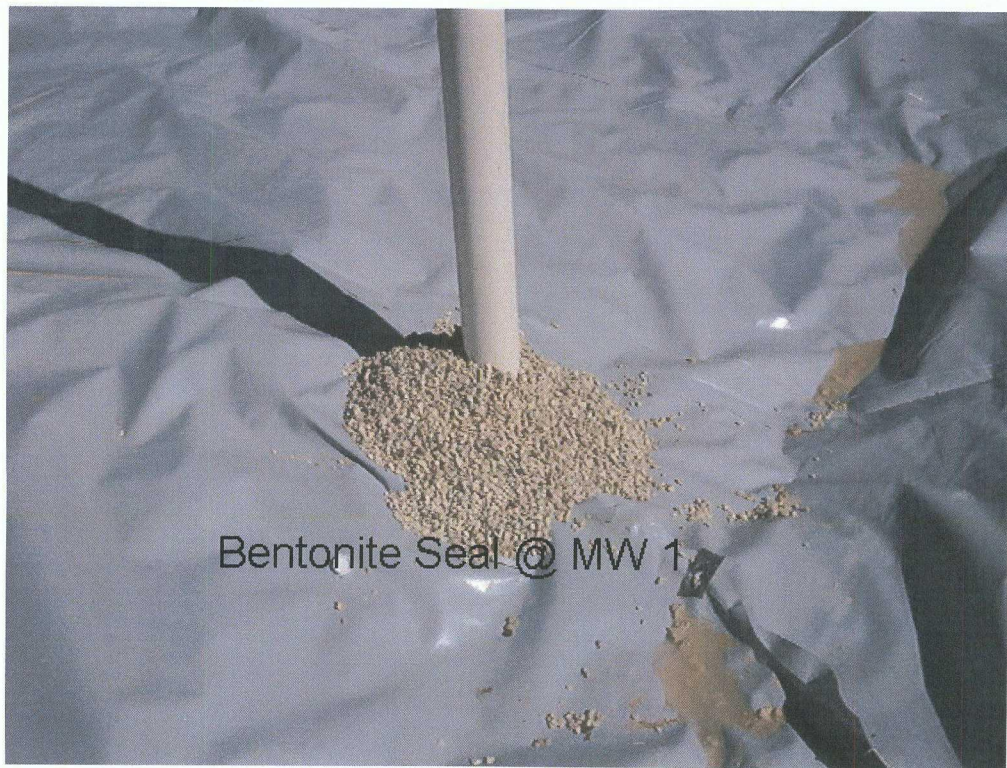
Photograph 10: Bentonite placed around monitor well to seal it in place.

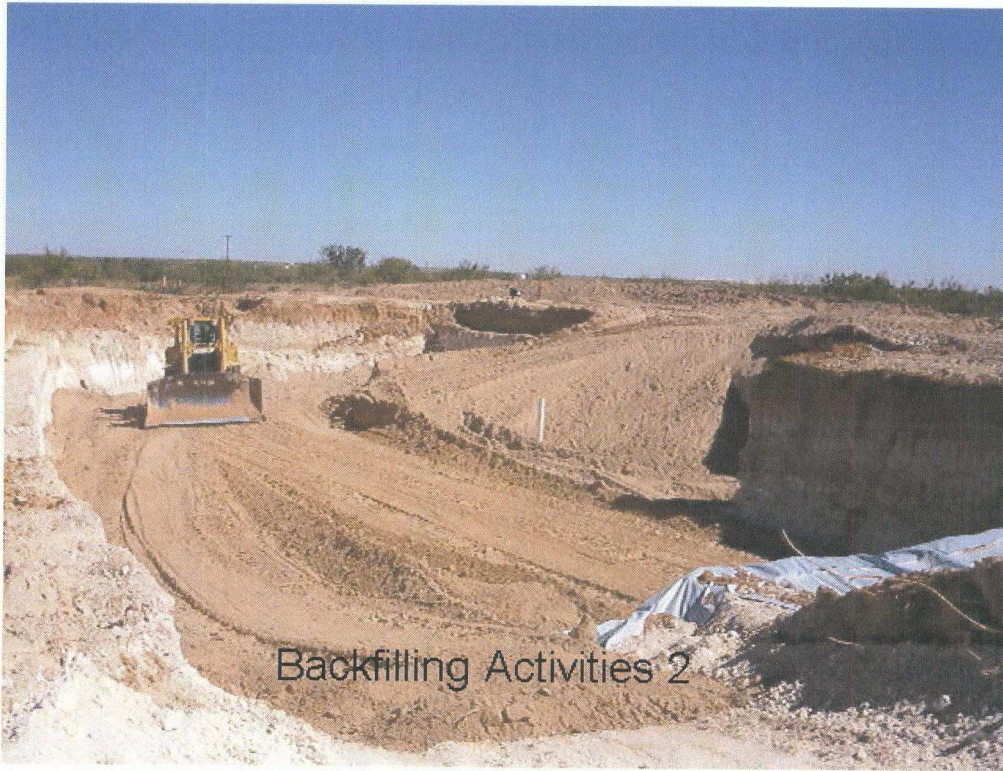
Photograph 11: Treated soil backfilled over liner.

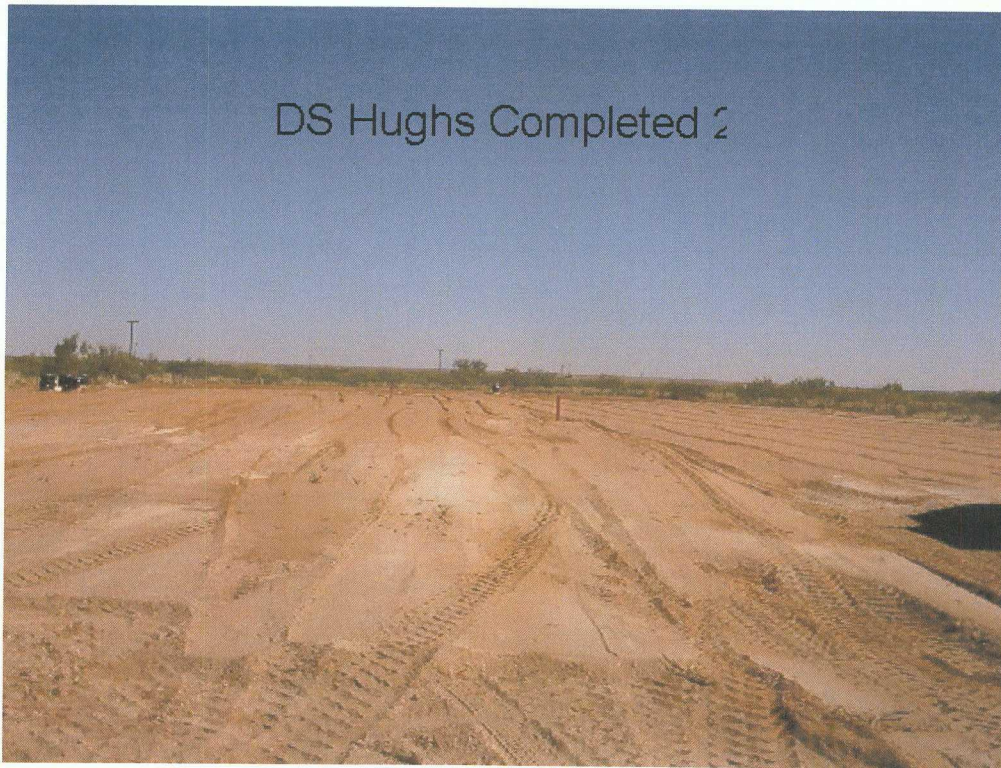
Photograph 12: Site returned to grade.
