# Corrective Action Plan

## Samson Livestock "30" Reserve Pit Samson Investment Company

**R.T. HICKS CONSULTANTS, LTD.**

**Corrective Action Plan**

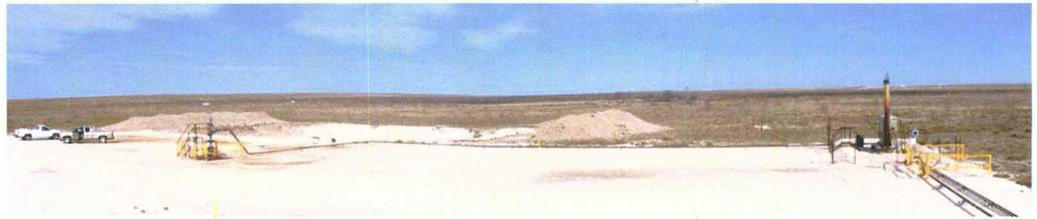
*Figure 1 - Samson Livestock "30" Site (view to northwest)*

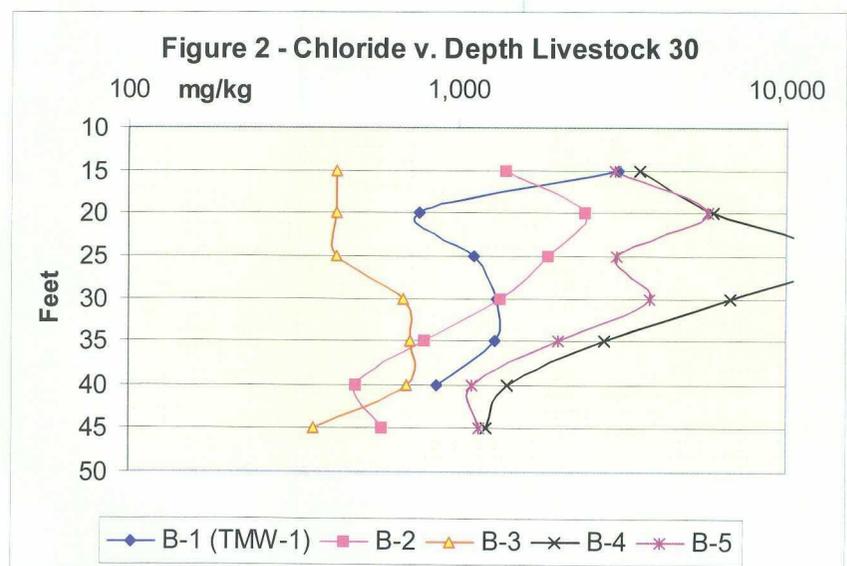
Figure 2 shows the chloride concentrations v. depth for the boreholes within the excavation pit associated with the former reserve pit. The maximum field chloride concentration of 14,080 mg/kg is from B-4 at a depth of 25 feet bgs. The deepest samples above the capillary fringe (about 35 feet bgs) suggest that chloride did not

materially impact the lower vadose zone in the north of the former pit (note that borings 2 and 3 were not drilled within the former reserve pit). In the central and southern portion of the excavation (within the area of the former reserve pit), chloride concentrations above the capillary fringe are 1,298 mg/kg (B-1), 2,799 mg/kg (B-4) and 2,031 mg/kg (B-5).

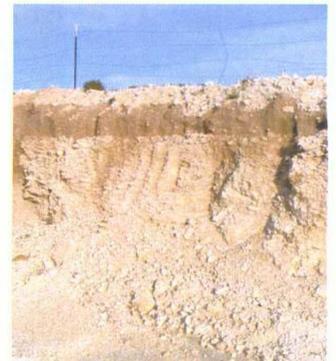
Rocks exposed at the surface along the ridges are alluvial deposits and petrocalcic soils of the Tertiary Ogallala formation (see Plate 5). They are covered by Quaternary age eolian deposits in the valleys, which consist of less than 10 feet of brown to reddish brown silt and very fine grain sand. The contact between the Quaternary and Tertiary formations is shown in Figure 3.

Figure 3. Contact between formations.

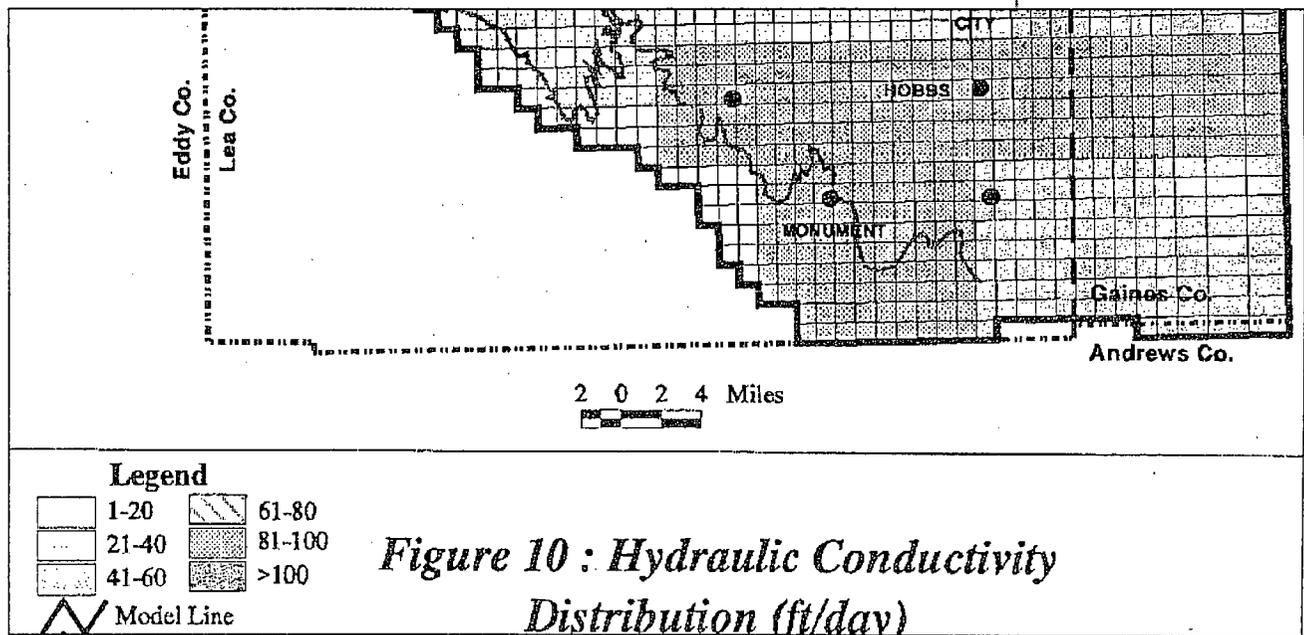
Many reports discuss the hydrogeologic characteristics of the Ogallala Aquifer. Most of these studies and reports do not provide information on the area near the Livestock 30 site. However, Masharrafieh and Chudnoff (Numerical Simulation of Groundwater Flow for Water Rights in the Lea County Underground Water Basin New Mexico, New Mexico Office of the State Engineer Technical Report 99-1, 1999) provides an estimate of the hydraulic conductivity and other parameters near the site (Figure 4). The area of the Livestock 30 well lies about 14 miles southeast of Monument - about 6 miles southeast of the model boundary. In this general area, the 1999 report suggests a hydraulic conductivity for the underlying aquifer of between 81 and 100 feet/day. Based upon our experience, the lithology of the saturated zone is very similar to that encountered south of Monument. In our opinion, the saturated hydraulic conductivity near the Livestock site is within the range of 50-100 ft/day.

Figure 4. Map showing estimated hydraulic conductivity near the site.

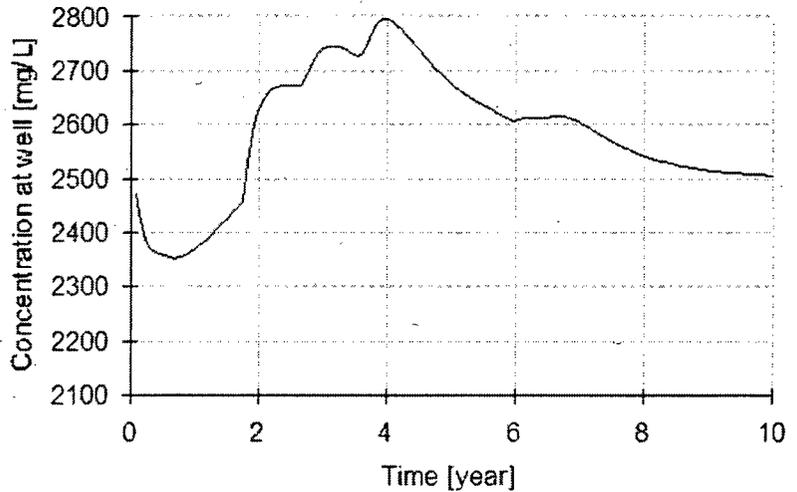
In the absence of any action on the part of Samson and with re-vegetation at the site occurring over several years, a HYDRUS-1D simulation shows residual vadose zone chloride will enter the ground water zone but cause only slight exacerbation of the existing ground water impairment. Figure 5 shows the predicted impact on ground water, given a "background" concentration of 2,500 mg/L chloride.

Note that the initial decline in chloride concentration (between  $t = 0$  and  $t = 2$  years) is a result of the model simplification. In the simplified model, the pore water in the 8 feet between the 2-foot thick chloride-rich zone and ground water contains zero ppm chloride - which results in "dilution" of the ground water as this "pure" water enters the saturated zone. After four years of transport, the entire 2-foot thick chloride mass has entered the aquifer and concentrations begin to decline.

Max Concentration 2796.144 [mg/L] at time 3.932 Year

Figure 5. Predicted impact on ground water given a "background" concentration of 2,500 mg/L.

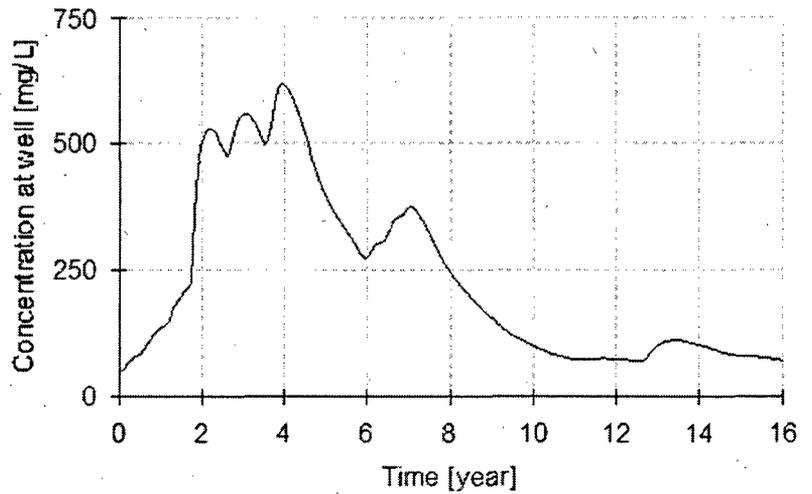
If we assume that the mass of chloride that entered ground water during the pit operation and drying phase is quite small and will be diluted relatively quickly to the background chloride concentration of about 50 mg/L, then Figure 6 provides the prediction of potential ground water impairment due to migration of the 2-foot thick chloride-rich pore water. This simulation predicts that ground water chloride concentrations will increase by about 500 mg/L before beginning to decline (at year 3.9) as the mass moves from the vadose zone into ground water.

Max Concentration 619.633 [mg/L] at time 3.932 Year

Figure 6. Simplified simulation of vadose zone transport with a background chloride concentration of 50 mg/L.

Figures 9a and 9b show the results of this simulation experiment. The chloride peak of about 600 mg/L is essentially the same as the simplified modeling experiment (see Figure 6). However, the simplified modeling, which does not attempt to simulate an engineered ET infiltration barrier, suggests that ground water would exceed the WQCC chloride standard for about 8 years. The more accurate HYDRUS-1D simulation of the infiltration barrier slows the migration of the vadose zone chloride mass such that ground water may exceed standards for a period of nearly 25

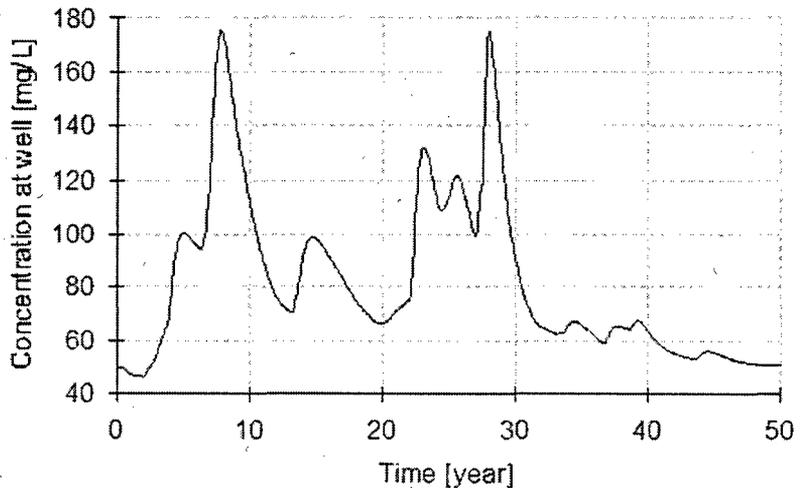
In Figure 7, the simplified model predicts the impact of a 2-foot layer of chloride-rich material (about 2,300 mg/L chloride) placed 18 feet above the water table. This scenario is a reasonable simulation of the impact caused by the migration of chloride-rich pore water residing near the base of the pit (about 10 feet below ground surface). The simulation predicts an initial "pulse" of chloride from about year 6 to year 9 and a second pulse from year 21 to year 30.

Max Concentration 175.193 [mg/L] at time 7.786 Year

Figure 7. Simplified simulation of a 2-foot thick chloride mass of 2,300 mg/kg placed 18 feet above ground water.

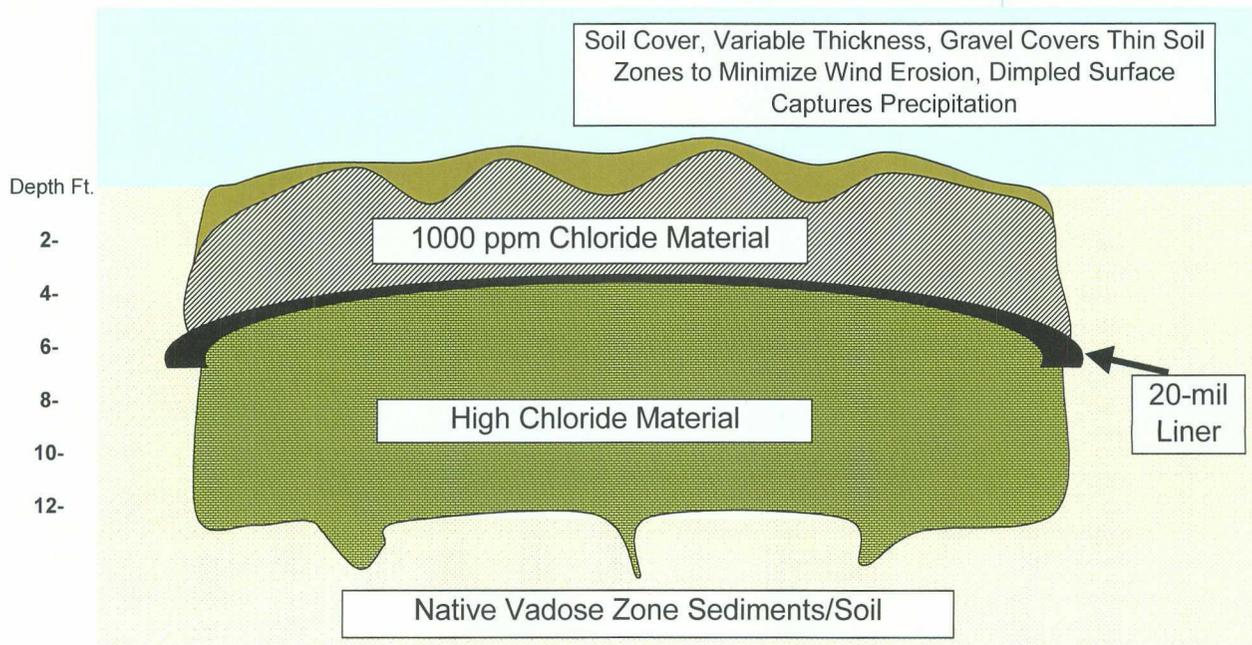
Although we believe the site is well-suited for installation of a Monolithic ET Barrier, we believe we can improve the short-term efficacy of the design through the placement of a 20-mil synthetic liner onto a prepared surface, then covering the liner with at least 4-feet of relatively fine-grained clean fill, then a top dressing of soil. A drawing of the proposed remedy is presented in Figure 8. A more complete description of the proposed remedy is presented in a later section of this plan.

Figure 8. Drawing of proposed remedy.

3. A very thin (about 1-inch) layer of gravel or coarse-grained caliche will be placed between the dimpled/seeded areas where the topsoil dressing is only 4- to 6-inches thick. The gravel will create a cover/mulch that is more resistant to wind or water erosion and will reduce evaporation of infiltrated precipitation. These thin soil areas will not be seeded except as occurs naturally due to surrounding vegetation.

4. Beneath the topsoil cover is 4-feet of clean fill, most of which would be derived from the original excavation and some that may be borrowed from adjacent areas to create the grade required to shed excess precipitation. If possible, we will cause the upper portion of this clean fill to be finer-grained material, the middle portion of the clean fill coarser-grained, and the lower portion of the clean fill that covers the liner will be consistent with the liner manufacturer's specification.

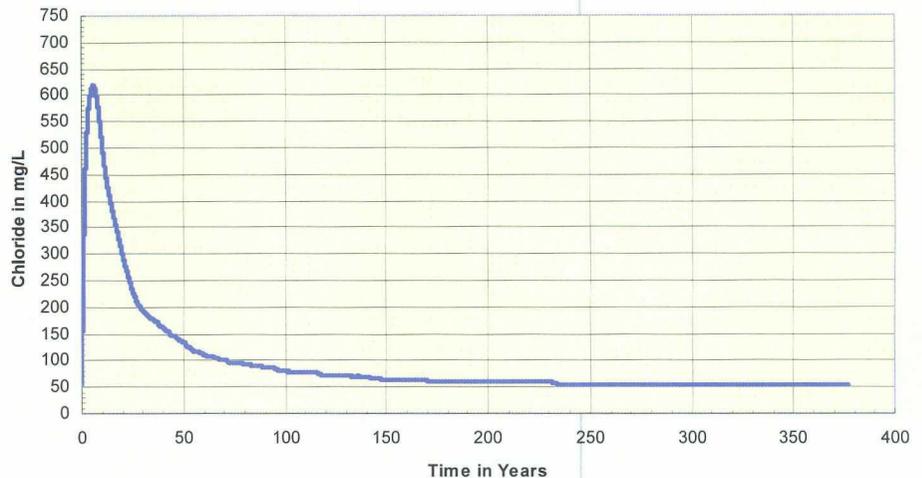
Figure 9a: Chloride Concentration in the Aquifer for the Samson Livestock Site

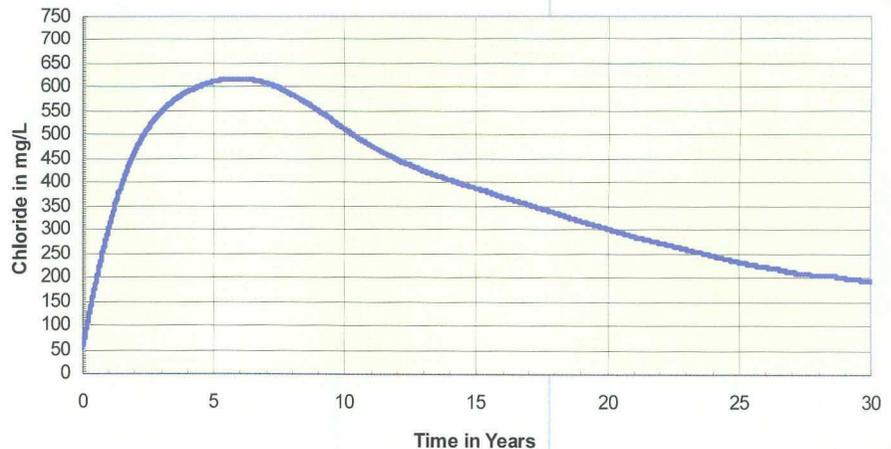
Figure 9b: Early Time Chloride Concentration in the Aquifer for the Samson Livestock Site

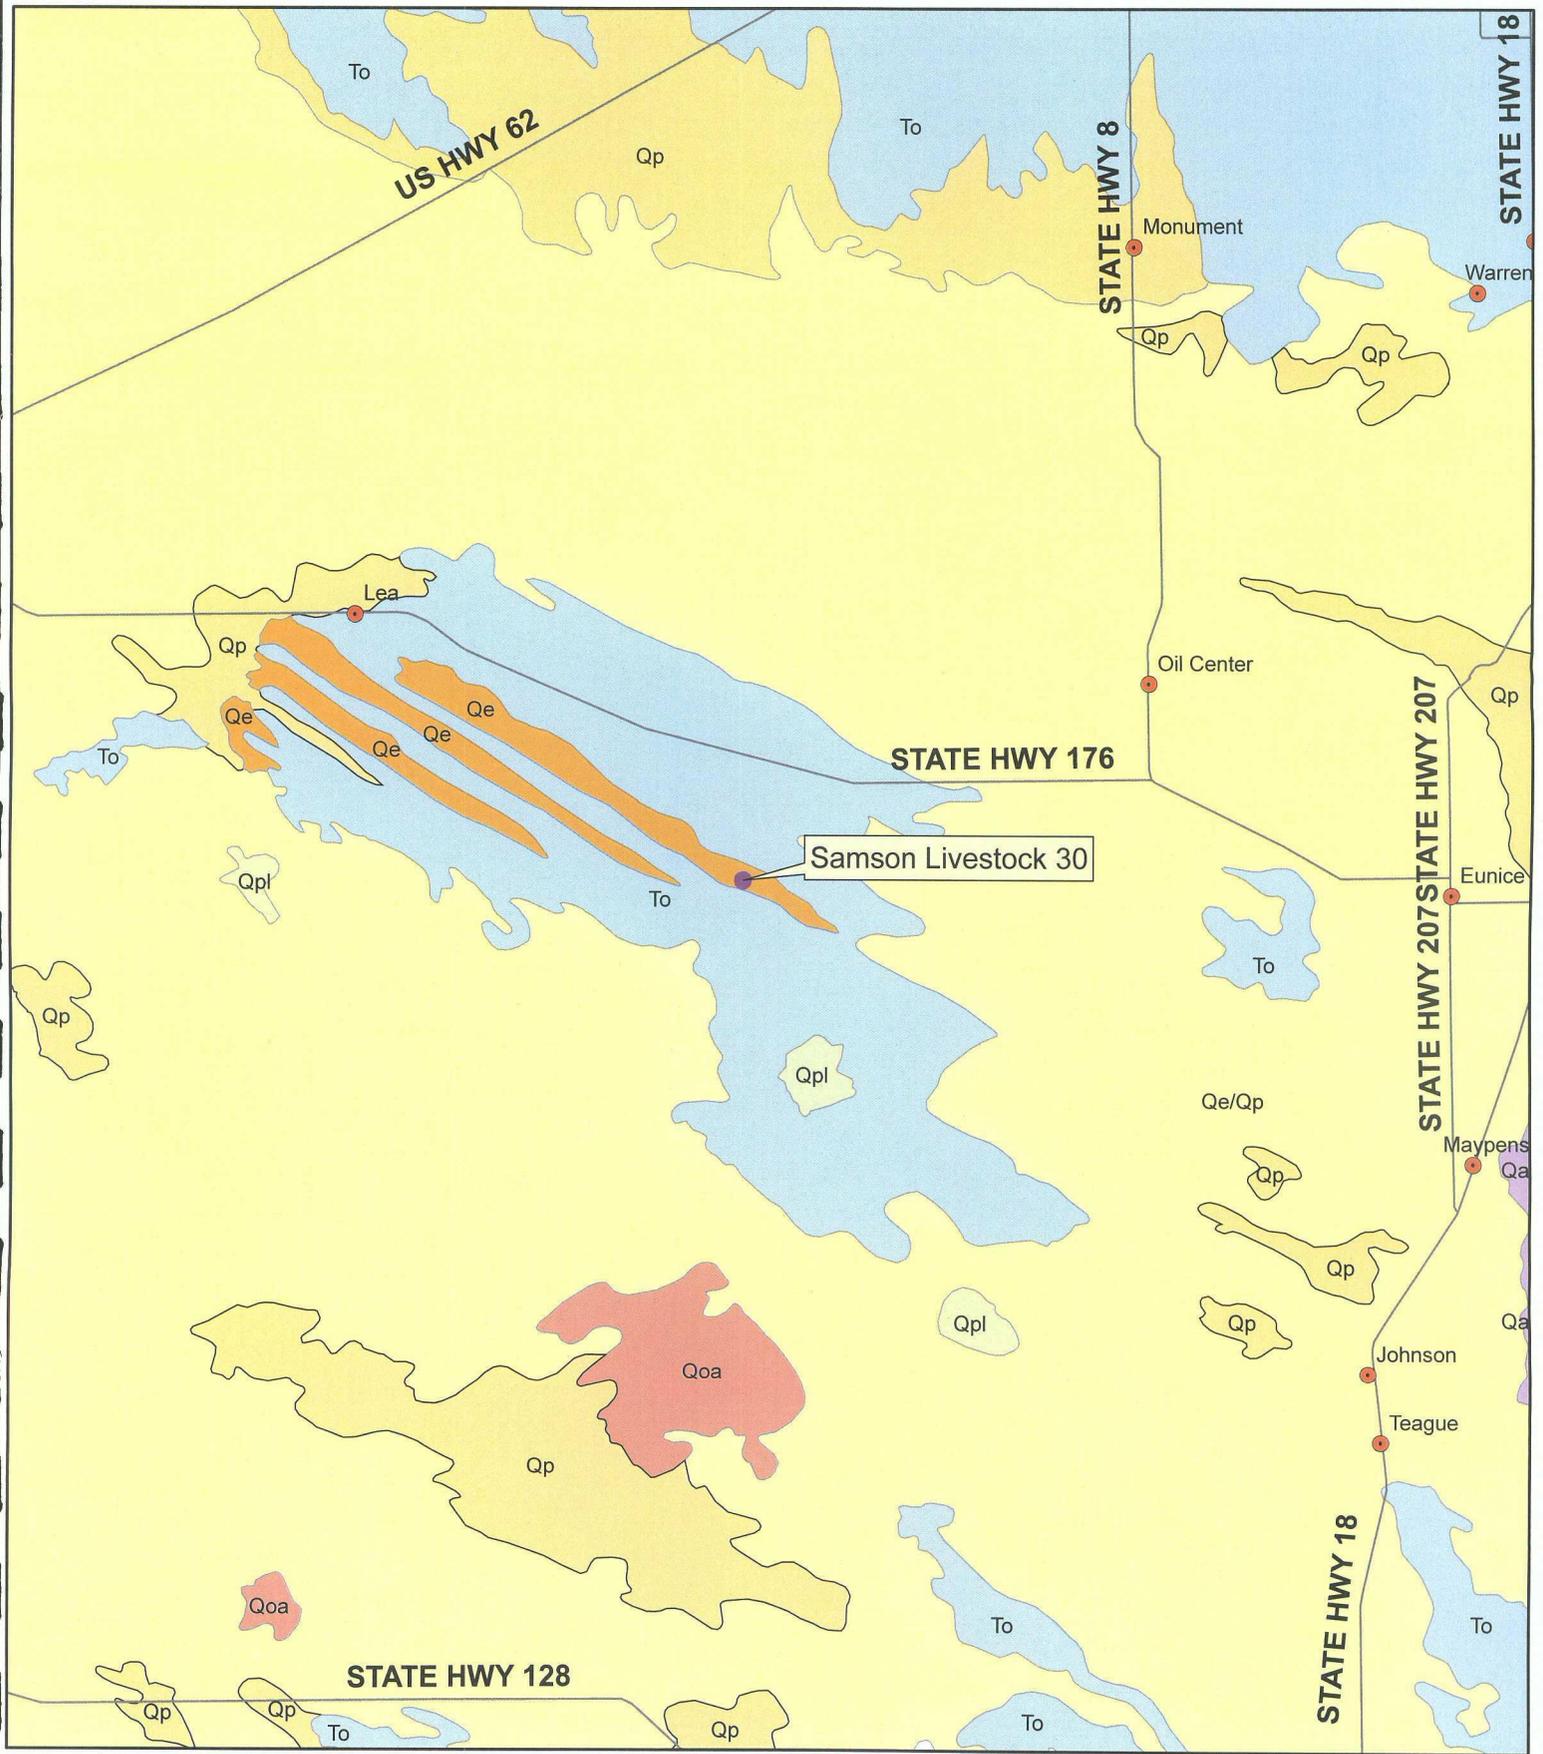
Plate 4

Geologic Map relative to  
 Samson Livestock "30"  
 Samson Livestock "30"  
 Samson Investment Company

To, Tertiary-Ogallala Formation

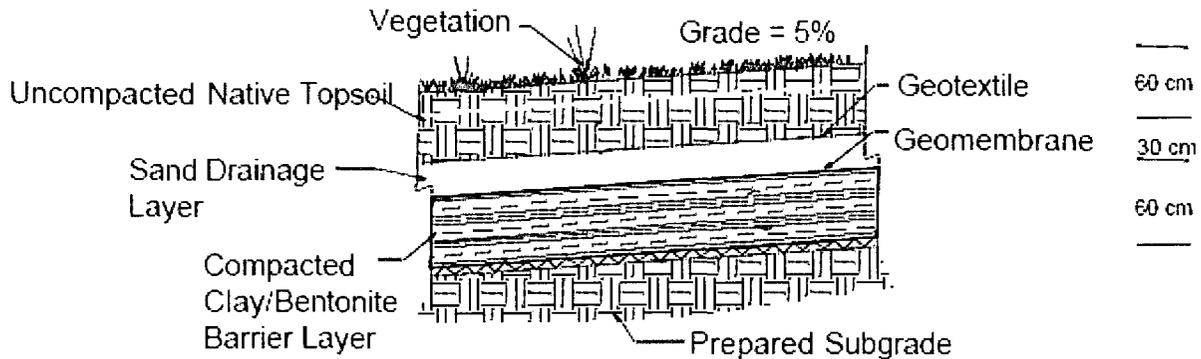
The installed Compacted Clay Cover is 1.5 m thick which basically matches the recommended EPA design described above. The profile for this cover consists of three layers. See figure below.

Profile of Baseline Test Cover 2 (Landfill 3)

The bottom layer is a 60 cm thick compacted soil barrier layer. The native soil required amendment to meet the saturated hydraulic conductivity requirement (maximum of  $1 \times 10^{-7}$  cm/sec) for this barrier layer. Laboratory tests determined that a mixture of 6% by weight of sodium bentonite with the native soil compacted 'wet of optimum' to a minimum of 98% of maximum dry density would be adequate.

A 40 mil linear low density polyethylene (LLDPE) geomembrane was placed directly on the compacted soil barrier layer to create a composite barrier layer. The purpose of this composite barrier layer is to create an impermeable barrier that blocks the infiltration of water. Eight 1-cm<sup>2</sup> defects (puncture holes) were purposely and randomly placed in this geomembrane to be representative of a geomembrane installation with average quality control conditions ([Dwyer et al. 1998](#)).

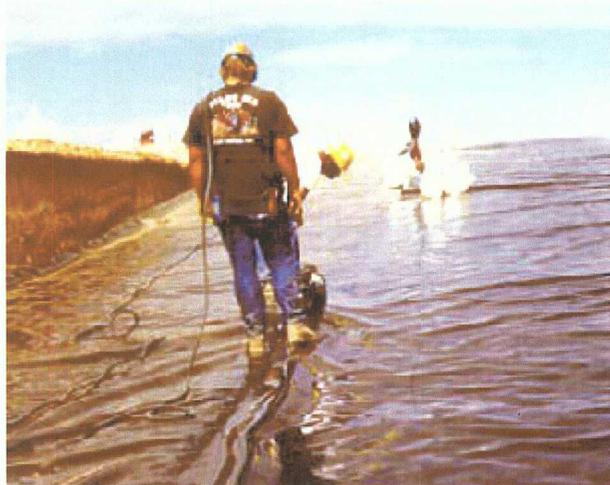
Welding Seams of Geomembrane Panels

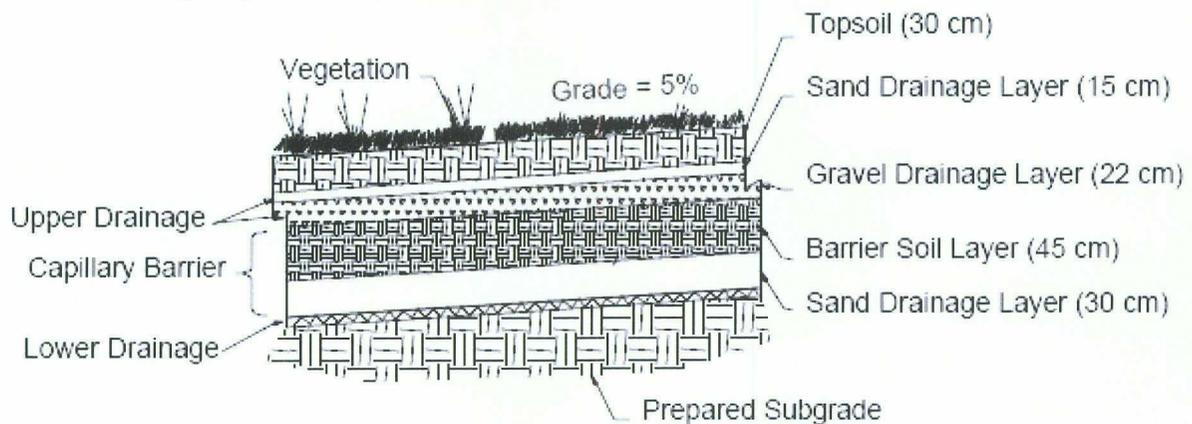
This cover system consists of four primary layers from bottom to top: (1) a lower drainage layer; (2) a barrier soil layer; (3) an upper drainage layer; and (4) a topsoil layer. The barrier soil layer and lower drainage layer comprise the capillary barrier. The lower drainage layer is composed of 30 cm of washed concrete sand. See figure below.

Profile of Alternative Test Cover 3 (Landfill 5)

The 45 cm barrier soil layer was installed directly on the sand. The upper drainage layers were placed over the barrier soil layer. This upper drainage layer consists of two materials containing 22 cm of clean pea gravel and 15 cm of washed concrete sand. Finally, a 30 cm thick layer of topsoil was placed on the sand.

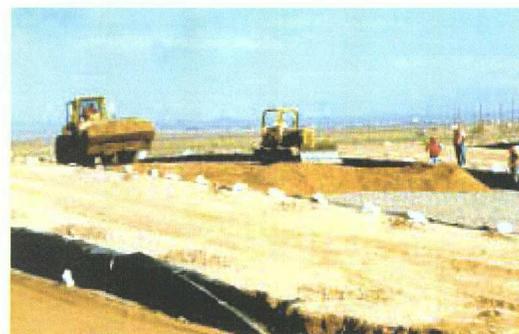
Capillary Barrier Installation

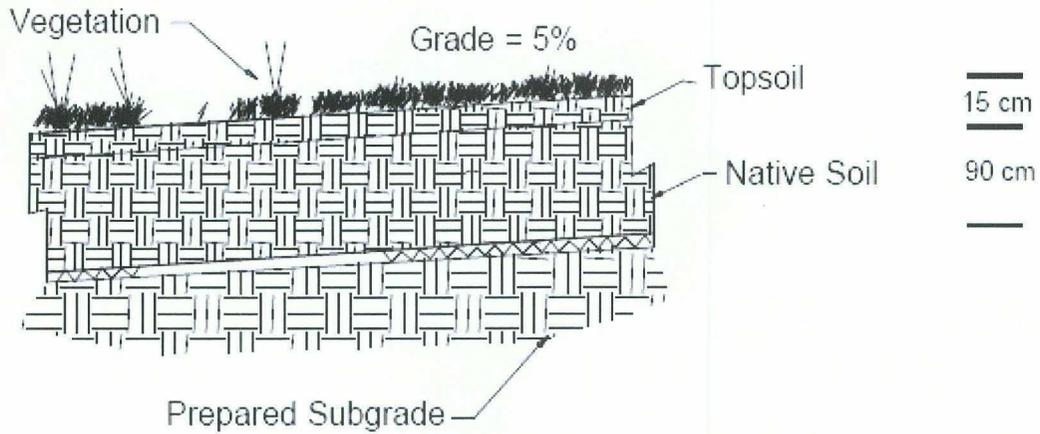
optimum mix of soil texture, soil thickness, and vegetation cover. The installed test cover is a 105 cm thick monolithic soil cover. The bottom 90 cm of native soil was compacted while the top 15 cm of topsoil was loosely placed. The soil allows for water storage, which combined with the vegetation, is designed to optimize evapotranspiration. See figure below.

Profile of Alternative Cover 4 (Landfill 6)

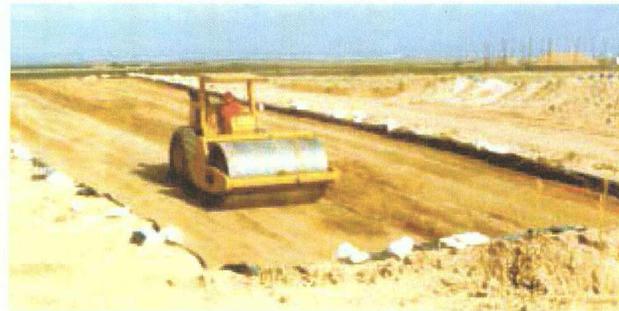
Compacting Soil in ET Cover

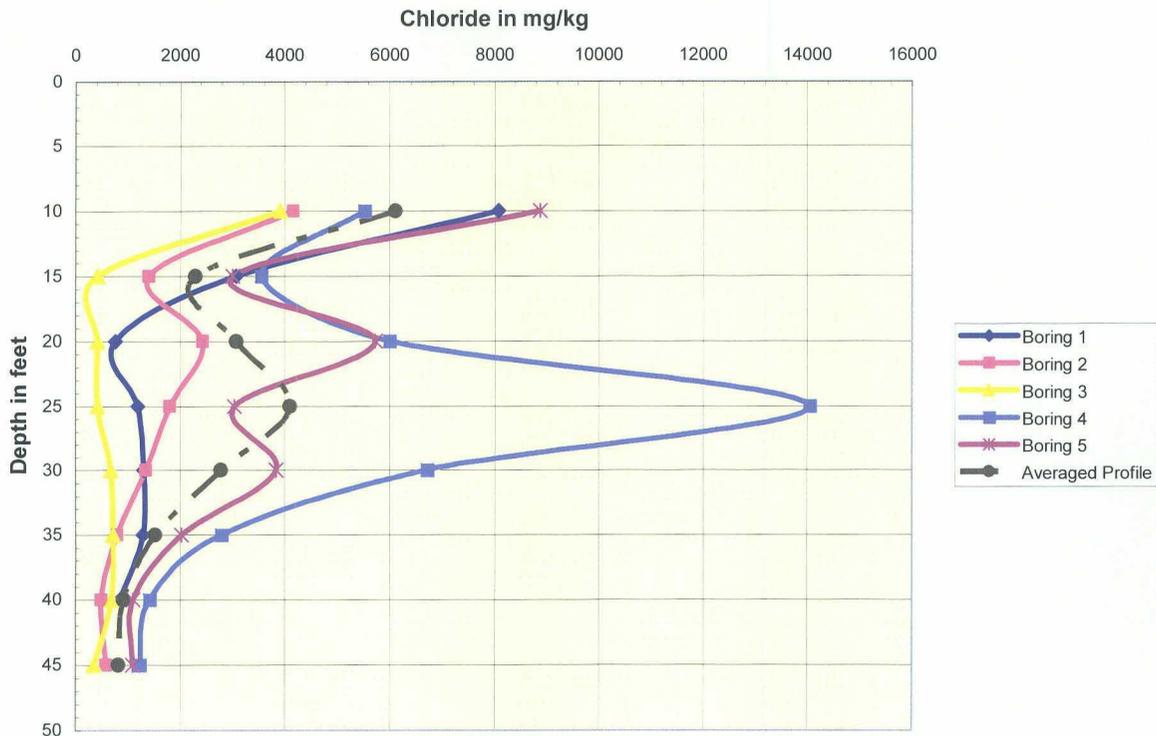
the five borings were averaged with equal area weighting to calculate a representative chloride concentration profile. An integration of the chloride contained within the profile yielded a chloride load of  $41.7 \text{ kg/m}^2$ . The averaged soil concentration values ( $\text{mg/kg}$ ) were linearly interpolated to correspond to the HYDRUS 1-D soil profile nodes. Using the volumetric moisture content from the HYDRUS 1-D initial condition and a default dry bulk soil density of  $1390 \text{ kg/m}^3$ , soil water moisture concentrations ( $\text{mg/L}$ ) were calculated for the HYDRUS 1-D soil profile nodes. These chloride concentrations were installed in the HYDRUS-1D model. An integration of the chloride contained within the soil moisture summed to a chloride load of  $40.4 \text{ kg/m}^2$ .

Figure 1, Chloride Concentration in Soil at the Livestock Site
