NMGSAU BATTERY #94

STAGE 2 ABATEMENT PLAN (AP-19) FINAL REPORT

JANUARY 2007

**HESS CORPORATION
(Formerly Amerada Hess Corp.)
MONUMENT, NM**

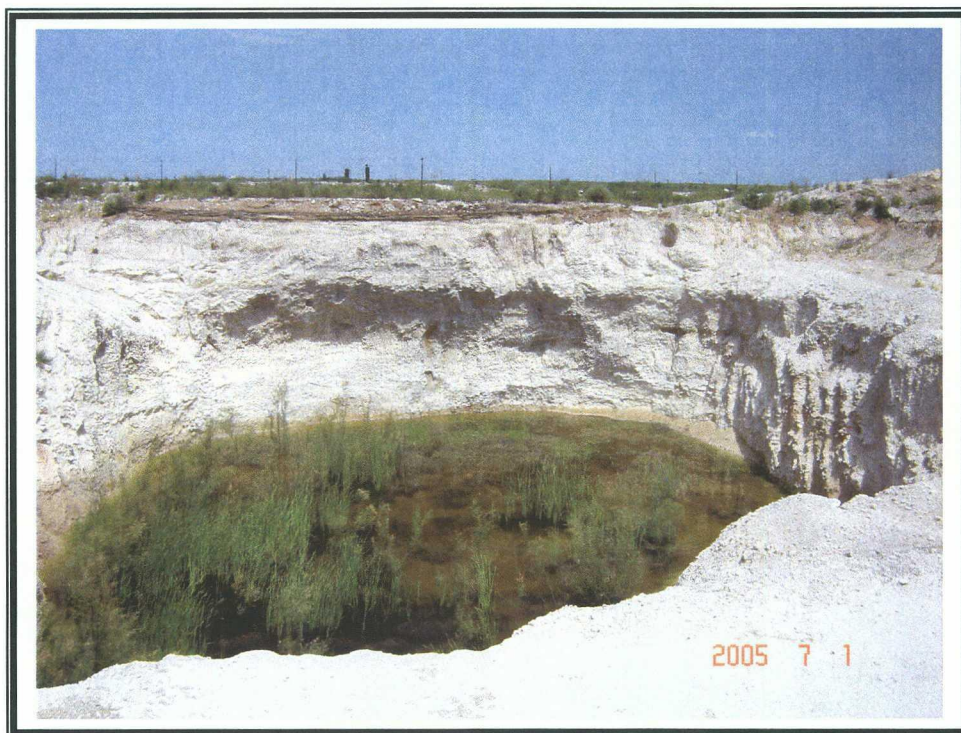
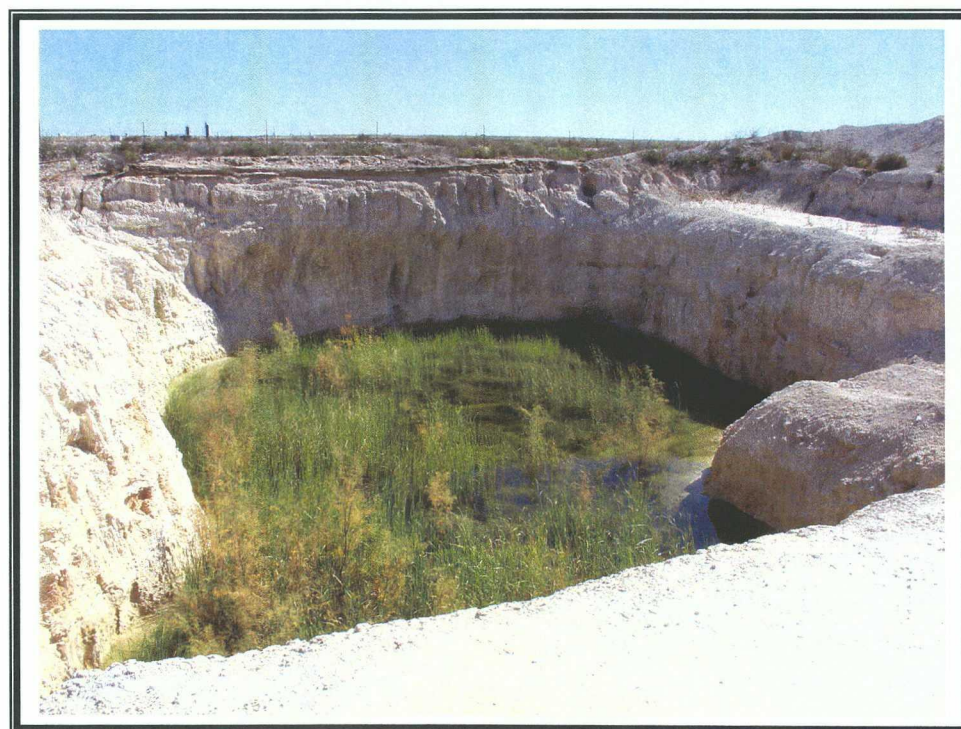
Backfilling and Preparation of Excavation

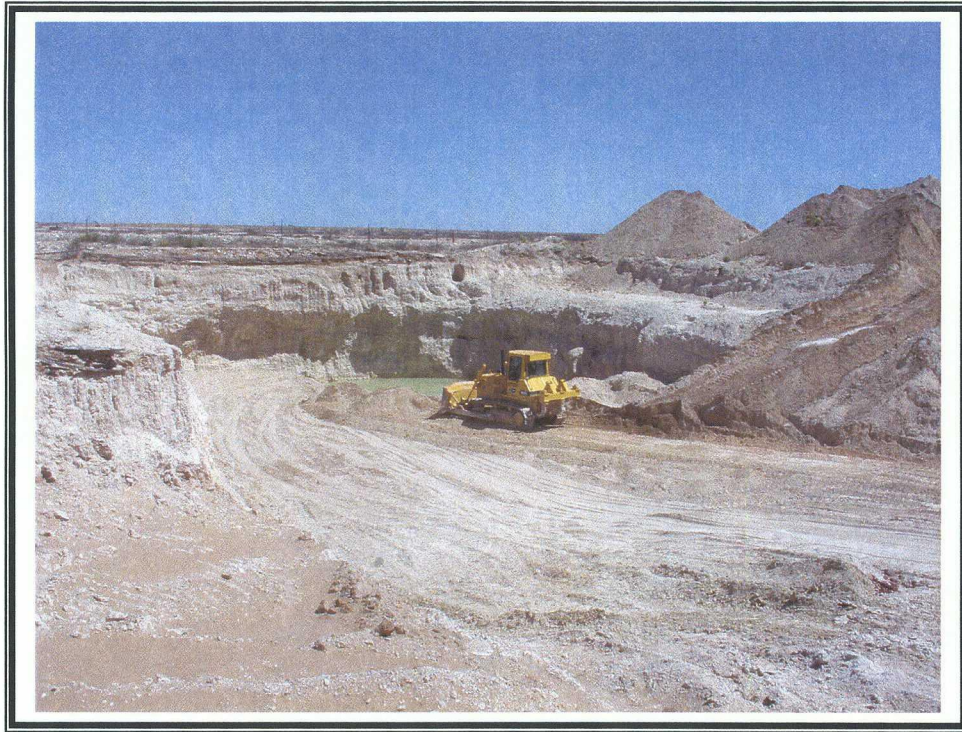
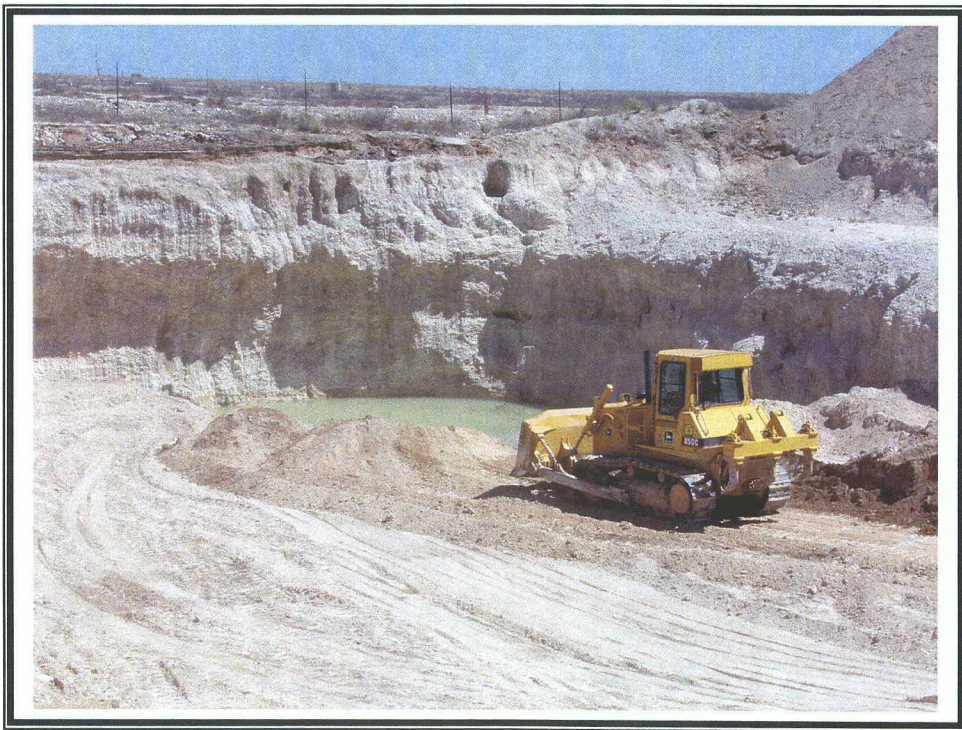
Backfilling and Preparation of Excavation

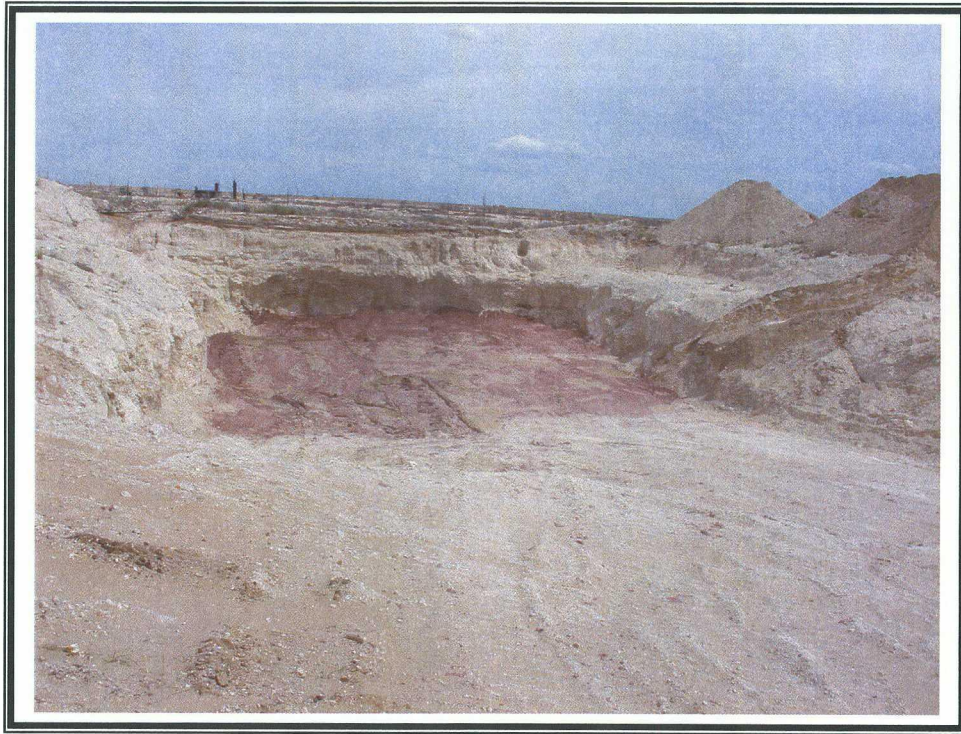
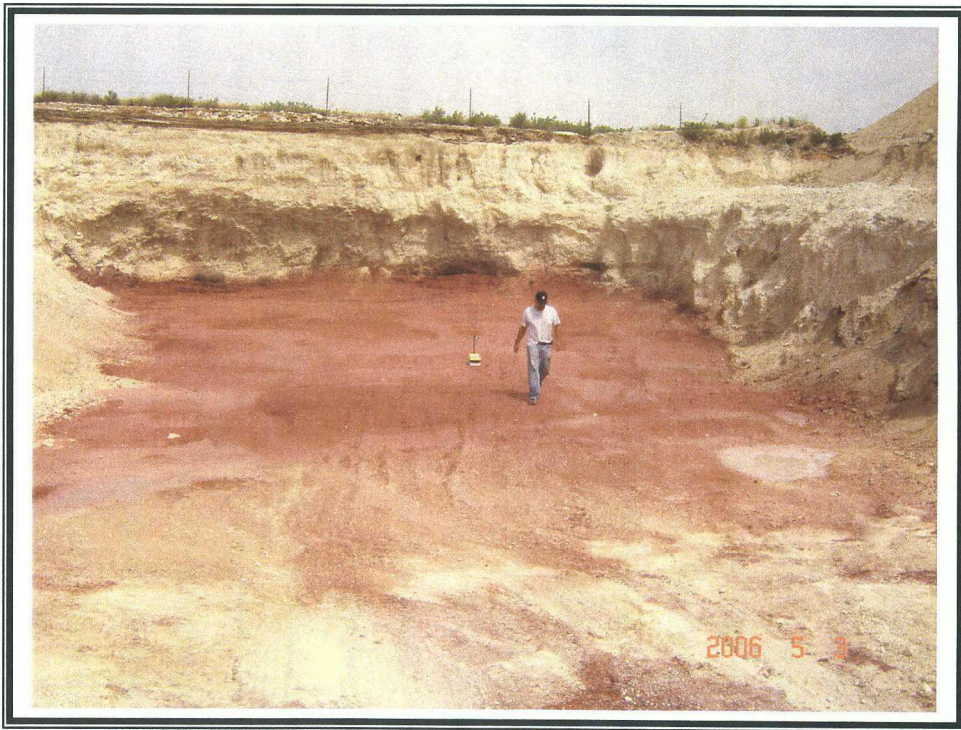
Installation of Clay Liner

On April 11, 2006, a one-foot thick clay liner was installed on the floor of the pit and exceeded the Proctor compaction standard. Proctor compaction test results can be found in **Appendix V**.

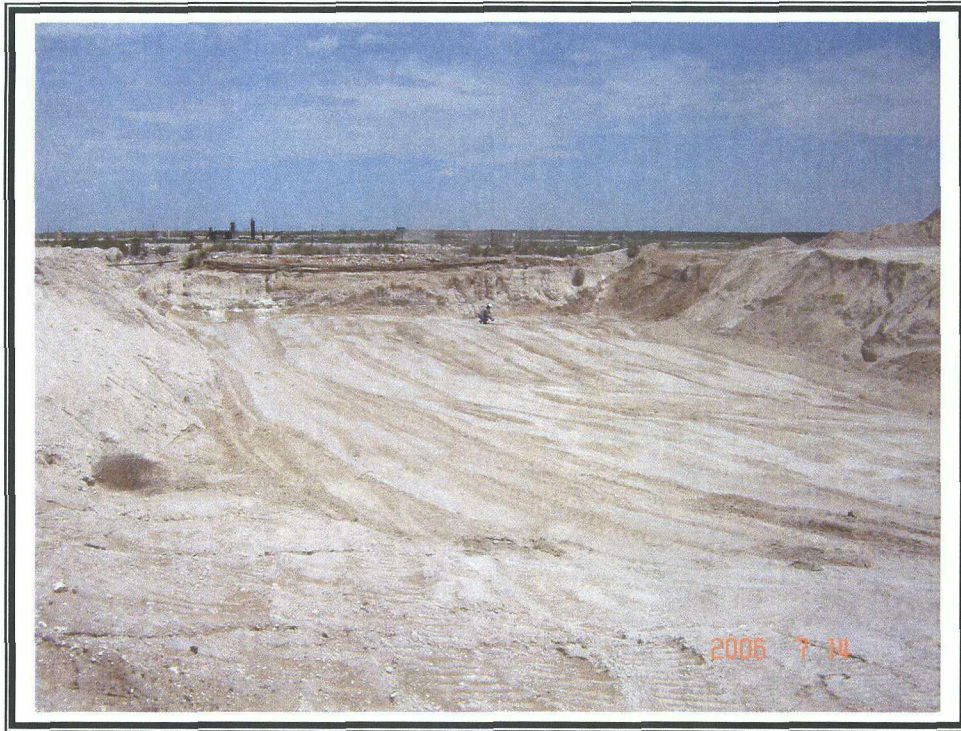
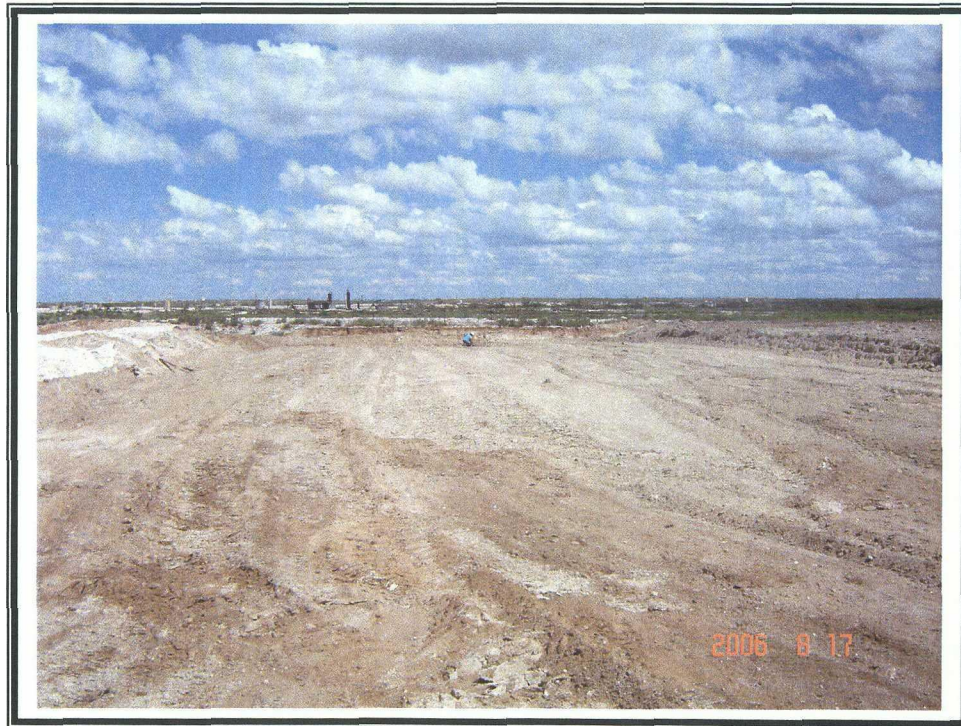
Installation of Blended Soil Lifts

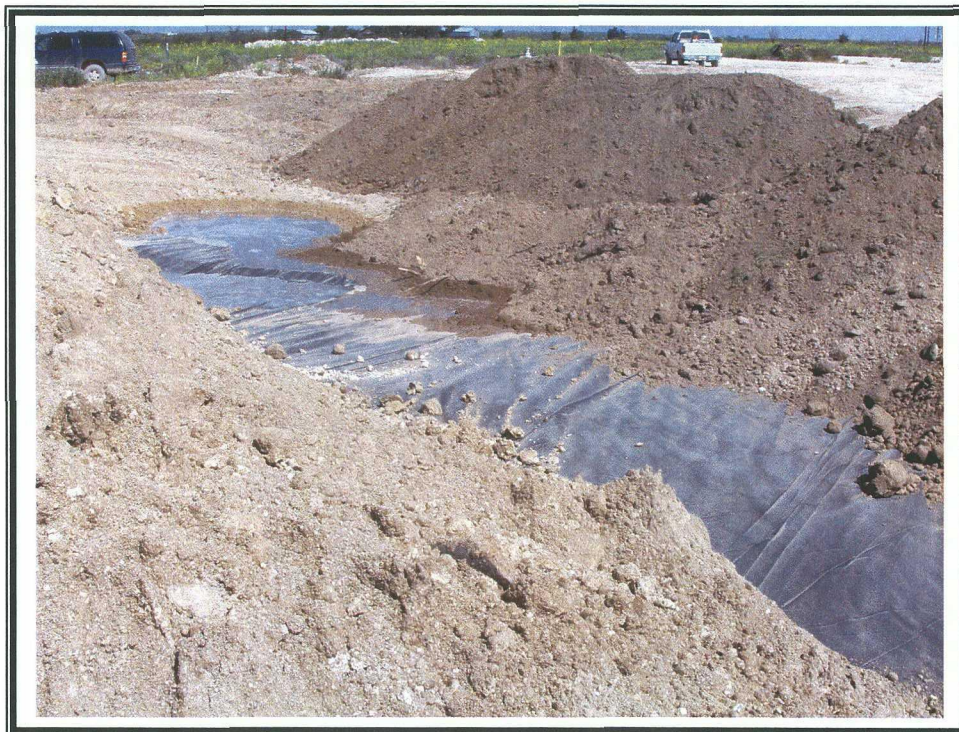
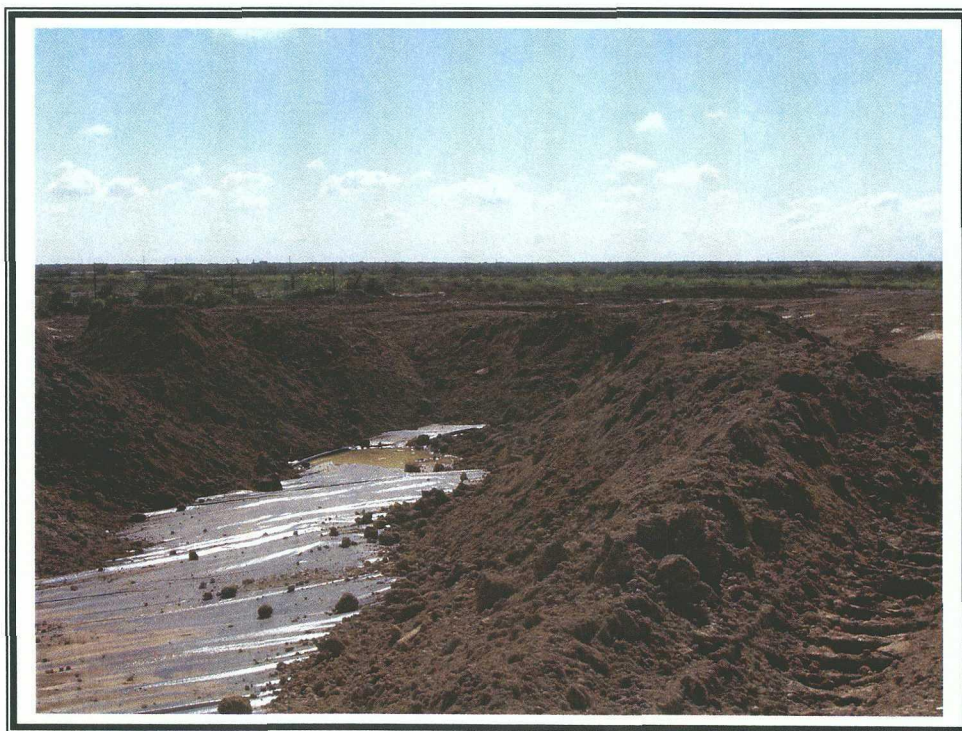
Installation of 20 mil Plastic Liner

After reaching the three (3) foot bgs level, a 20 mil poly liner will be placed into the excavation. The poly liner will cover approximately three (3) feet beyond the edges of the area of impact. This liner will serve as an additional impermeable barrier to protect the existing groundwater. The remaining excavation will then be backfilled with clean soil and leveled to grade.

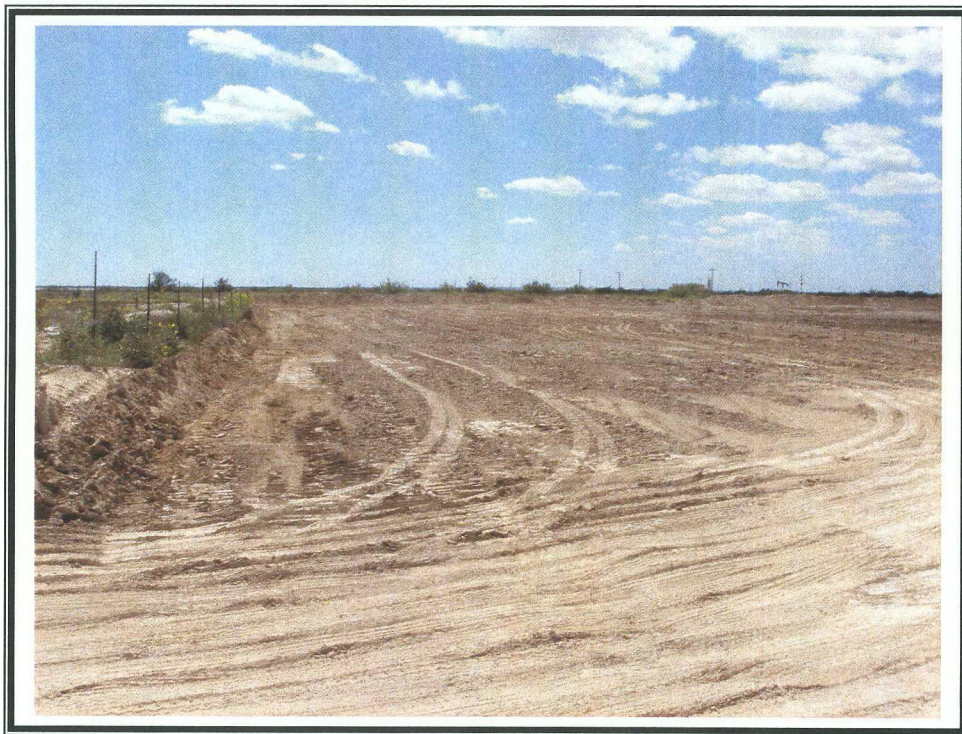
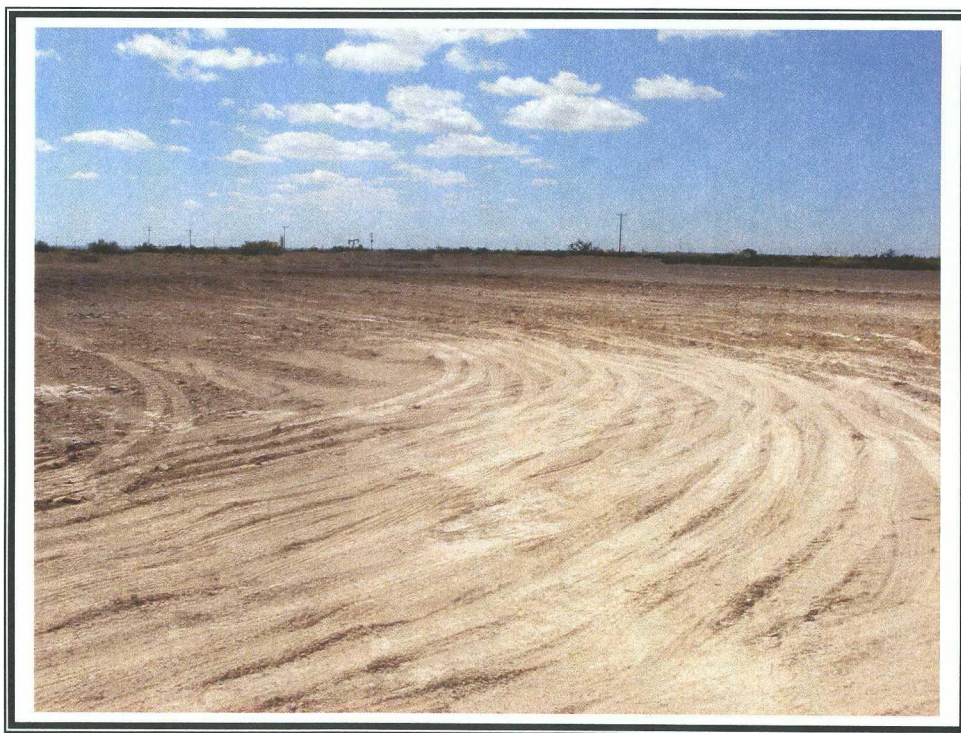
Final Backfilling and Contouring of Site
