Vac Jct J-26-1

RICE OPERATING COMPANY
JUNCTION BOX FINAL REPORT

Vacuum jct. J-26-1

Unit J, Section 26, T17S, R35E

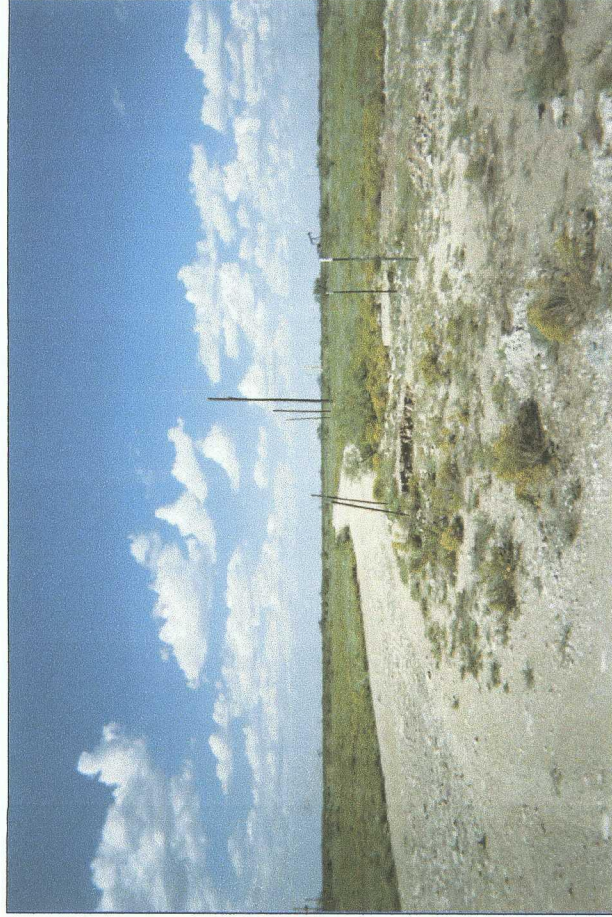
9/13/2005

former junction box site; box removed

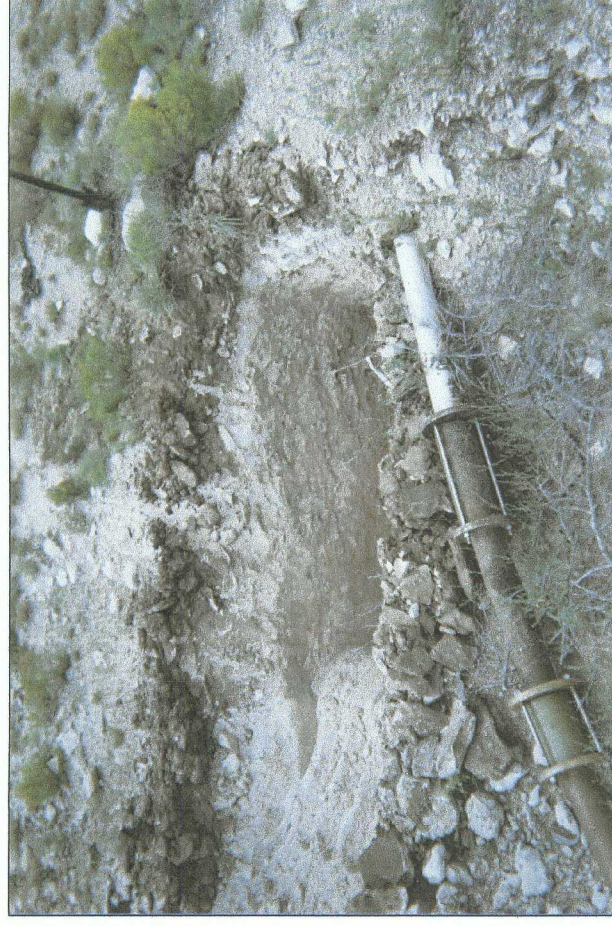
8/17/2007

6-ft-deep delineation trench at former box site

of the Vacuum SWD System abandonment. After the box lumber was removed and the pipelines were capped, a delineation trench was made at the site to collect soil samples. Chloride field tests were conducted on the samples and yielded very low concentrations similar to those of the background sample. Organic vapors were measured and also yielded very low concentrations. The grab samples from the deepest part of the trench (6 ft) was sent to a laboratory for confirmation and TPH analysis. TPH and chloride concentrations were not detected in the sample. The excavated soil was returned to the trench and the remainder of the hole (from removal of the junction box) was backfilled with clean, imported soil which was also spread on the surface to encourage regrowth. The surface was seeded with a blend of native vegetation on 8/23/2007 and is expected to return to productive capacity at a normal rate.

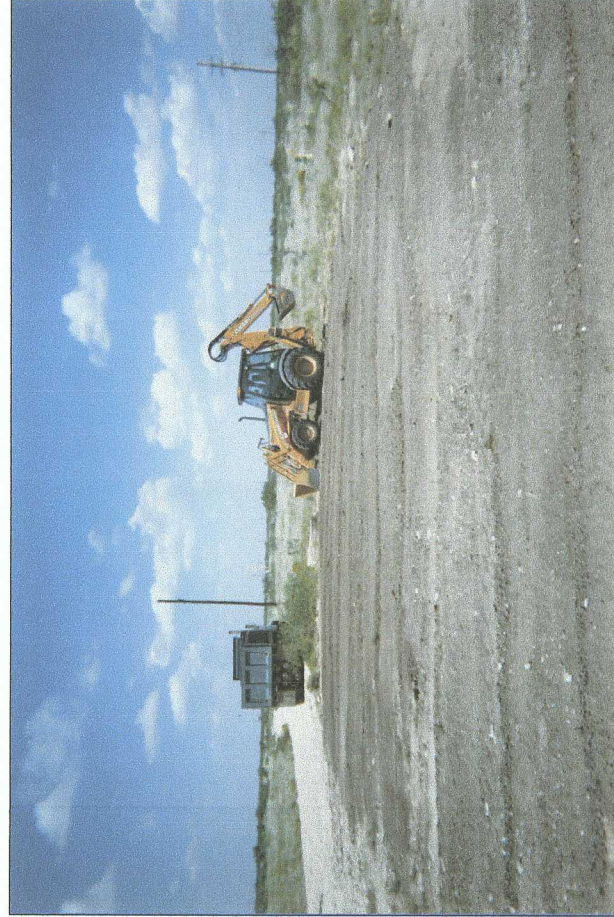
8/22/2007

spreading clean, imported soil on surface

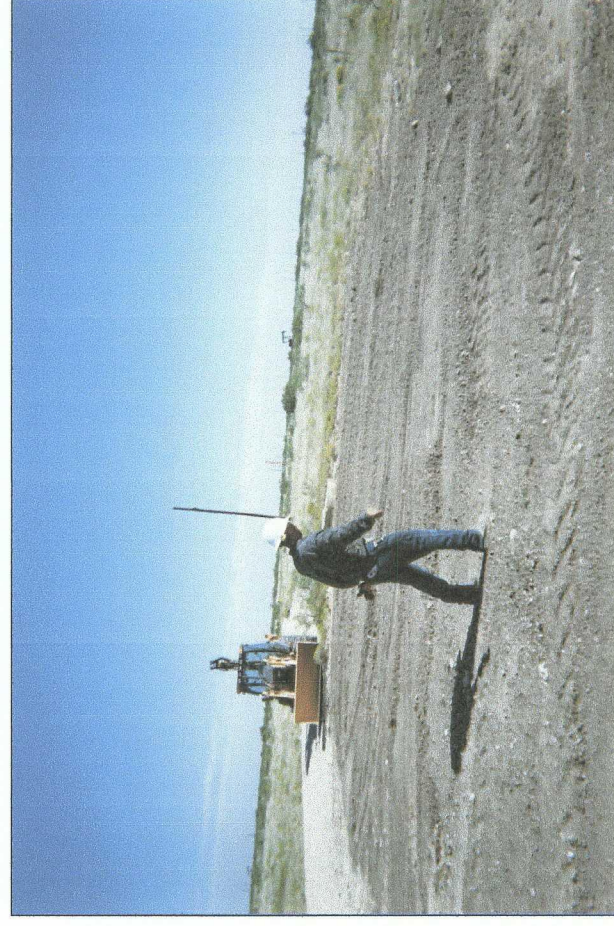
8/23/2007

seeding backfilled surface
