CLOSURE

**RICE OPERATING COMPANY
JUNCTION BOX FINAL REPORT**

Vacuum 'AN' EOL

unit B, section 7, T18S, R35E

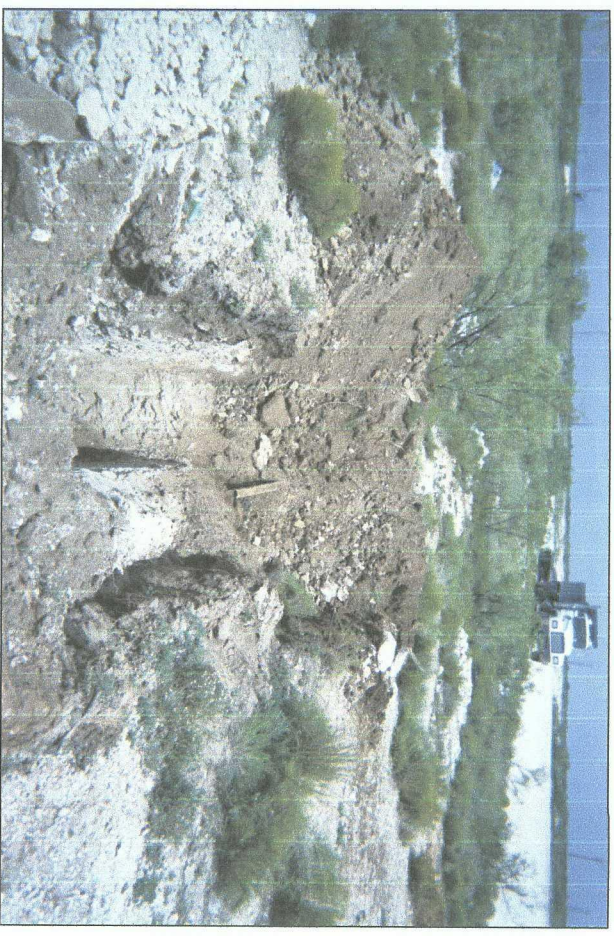
7/19/2007

7-ft-deep delineation trench

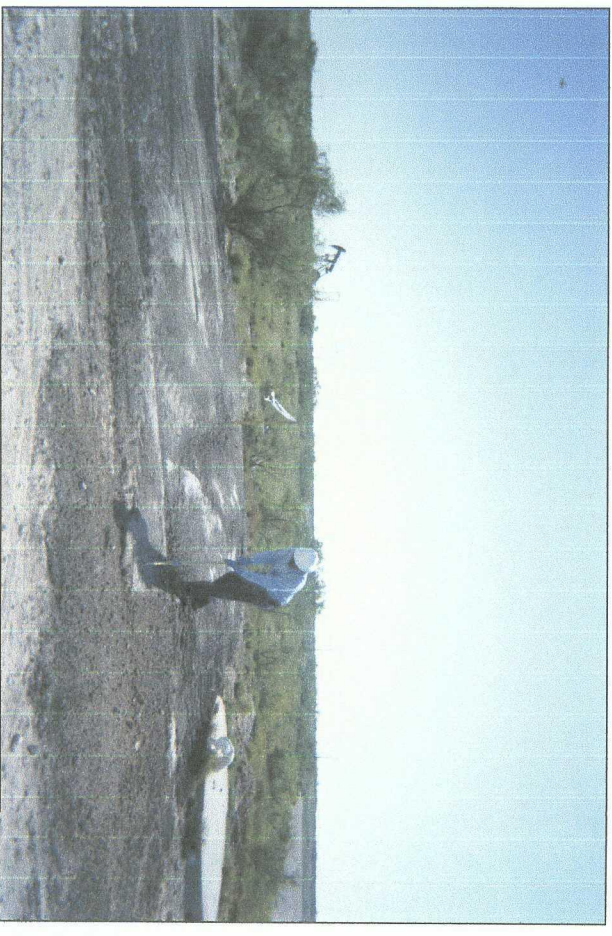
7/25/2007

seeding site with clean, imported soil at the surface
