RICE OPERATING COMPANY  
JUNCTION BOX **DISCLOSURE**\* REPORT

SWD SYSTEM	JUNCTION	UNIT	SECTION	TOWNSHIP	RANGE	COUNTY	NEW BOX DIMENSIONS - FEET		
Vacuum	F-33 boot	F	33	17S	35E	Lea	Length	Width	Depth
							no box; System abandonment

# Vacuum F-33 boot

Unit F, Section 33, T17S, R37E

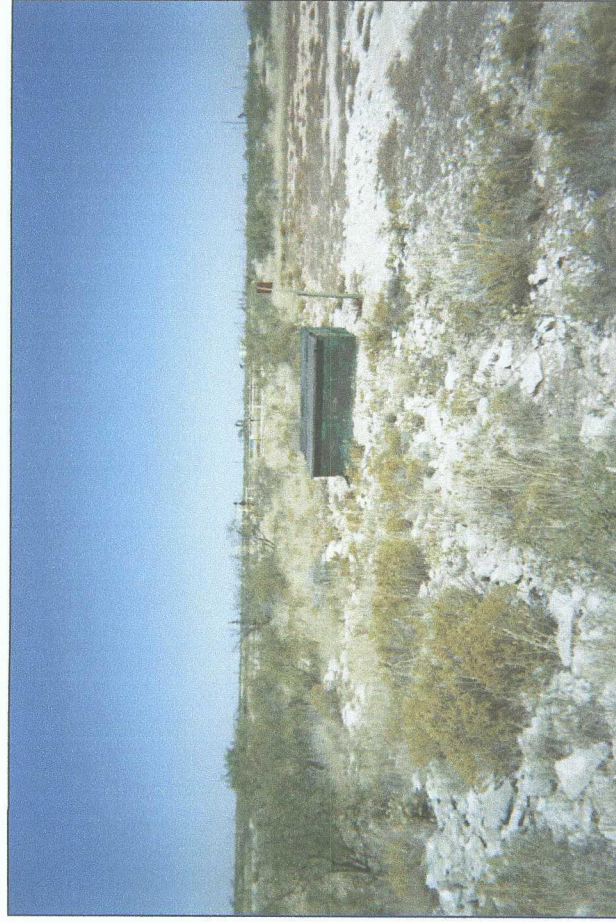
11/7/2005

undisturbed junction box

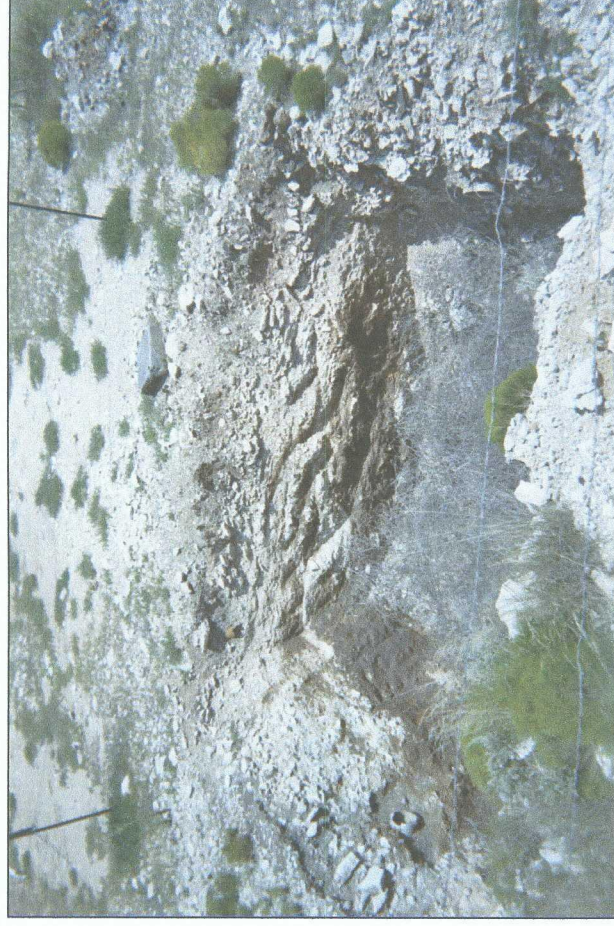
11/16/2005

junction box removed; prior to excavation

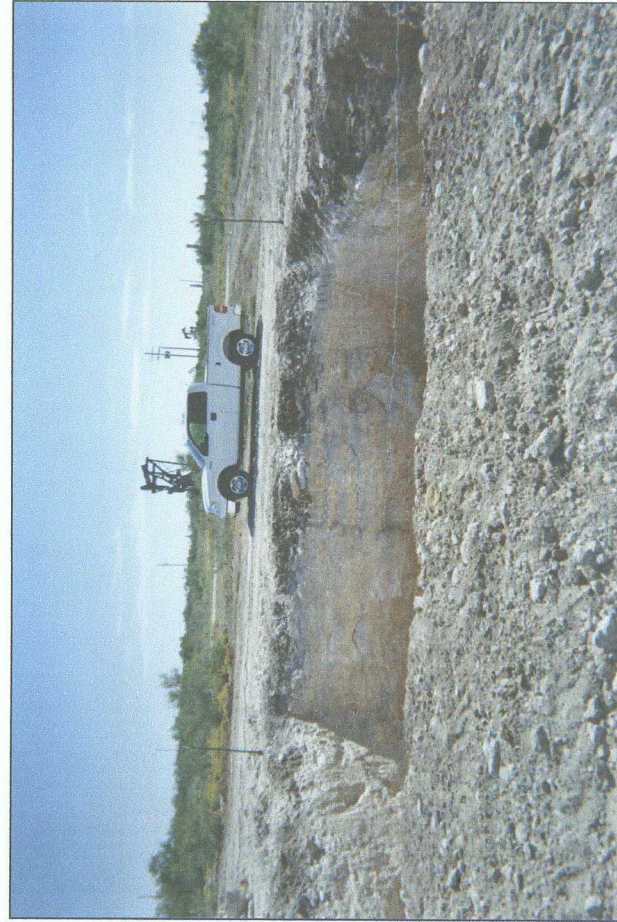
10/2/2007

final 30 x 30 x 12 ft excavation

This junction was addressed as part of  
the Vacuum SWD System abandonment. After the junction box was removed, the site was delineated using a backhoe to collect soil samples at regular intervals producing a 30 x 30 x 12-ft-deep excavation. Organic vapors were measured using a PID which yielded slightly elevated concentrations in soils nearest the junction. Chloride field tests were performed on each sample and yielded elevated concentrations, mostly east and north of the junction. Composite samples were collected from the excavation bottom, walls, and excavated soil for laboratory confirmation. Lab analysis revealed that OCD TPH guidelines were not met. The excavated soil was blended on site and then returned to the excavation and contoured to the surrounding surface. An identification plate was placed on the surface of the backfilled site to mark the location of the former junction. R.T. Hicks Consultants of Albuquerque will be reviewing this site for potential environmental considerations.

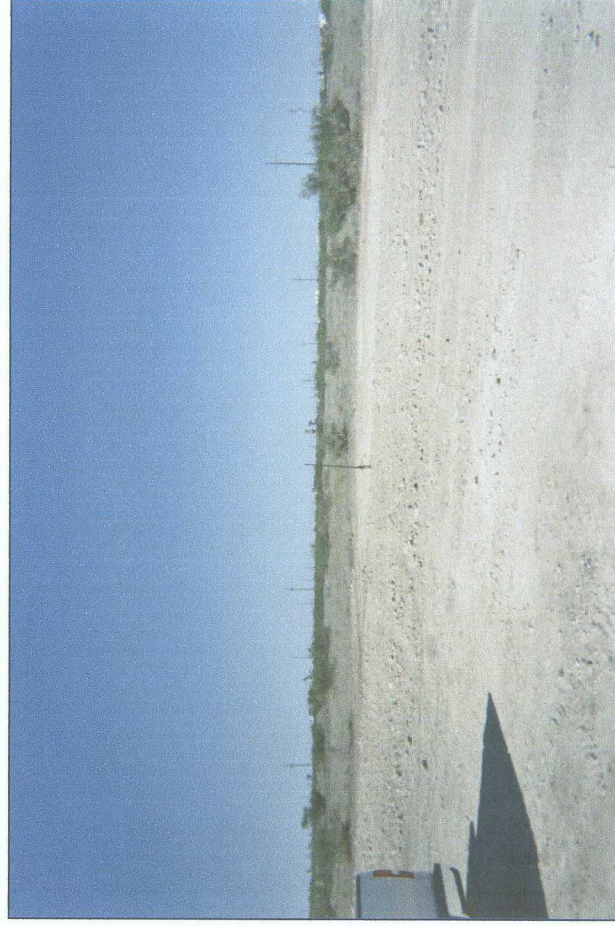
10/15/2007

backfilled; T-post marking former junction site
