BD Pogo Mattern EOL

CLOSURE

RICE OPERATING COMPANY
JUNCTION BOX FINAL REPORT

unit 'L', Section 30, T21S, R37E

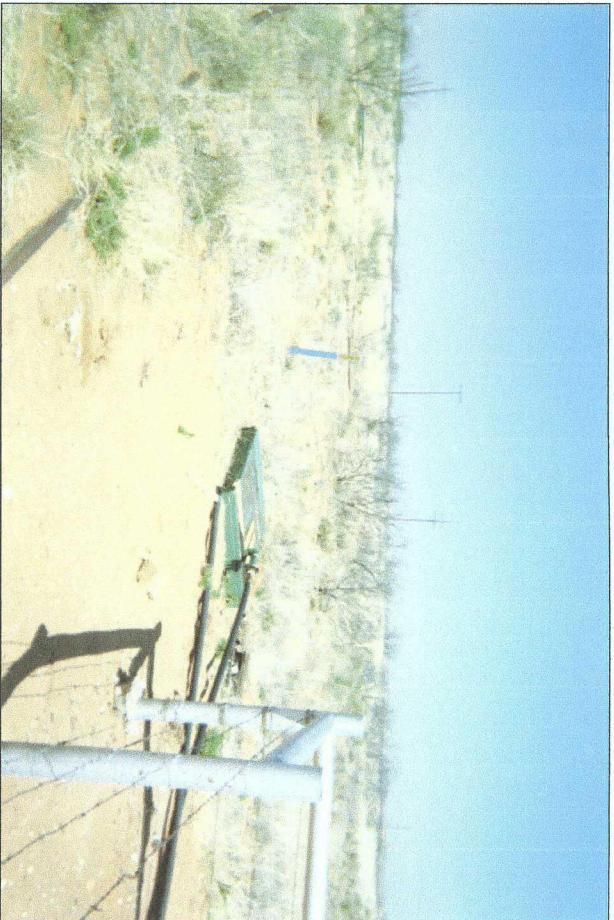
3/24/2006

undisturbed junction box

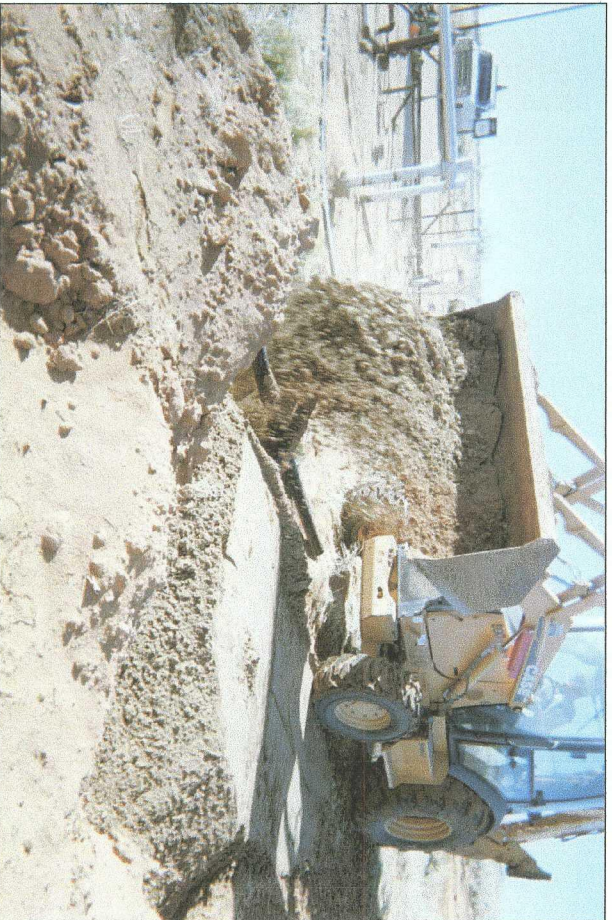
3/14/2007

backfilling with imported soil

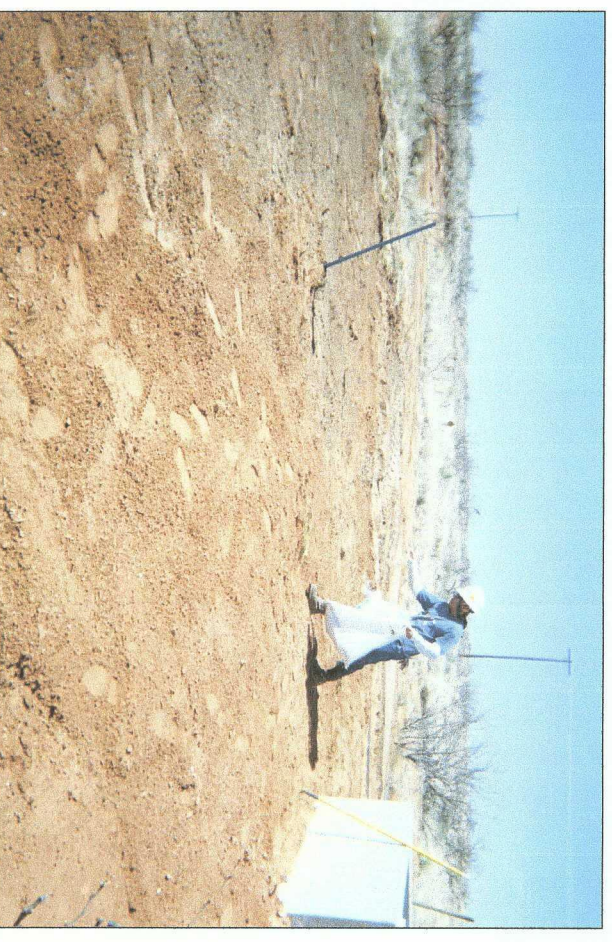
3/14/2007

seeding backfilled site; new box visible on right
