CLOSURE

RICE OPERATING COMPANY
JUNCTION BOX FINAL REPORT

BD E-23 vent

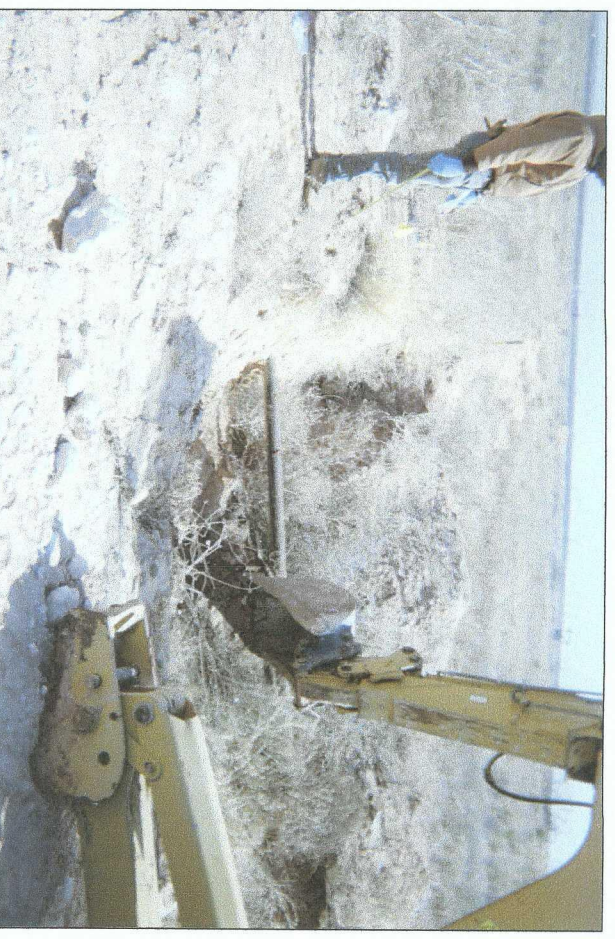
2/9/2007

box removed, beginning excavation & delineation

This junction was eliminated with the pipeline replacement/upgrade program. The area surrounding this box was covered with healthy native vegetation. Once the box lumber was removed, a backhoe was used to collect soil samples at regular intervals producing a 10 x 10 x 12-ft-deep hole. Chloride field tests were performed on each sample and yielded low concentrations. Organic vapors were also measured on all samples and resulted in low concentrations as well. Confirmation samples were analyzed at a certified laboratory. The excavated soil was blended on site with 12 yd³ of clean, imported soil. This blended soil was backfilled into the excavation and contoured to the surrounding terrain. On 3/20/2007, the disturbed surface was seeded with a blend of native vegetation and is expected to return to productive capacity at a normal rate.

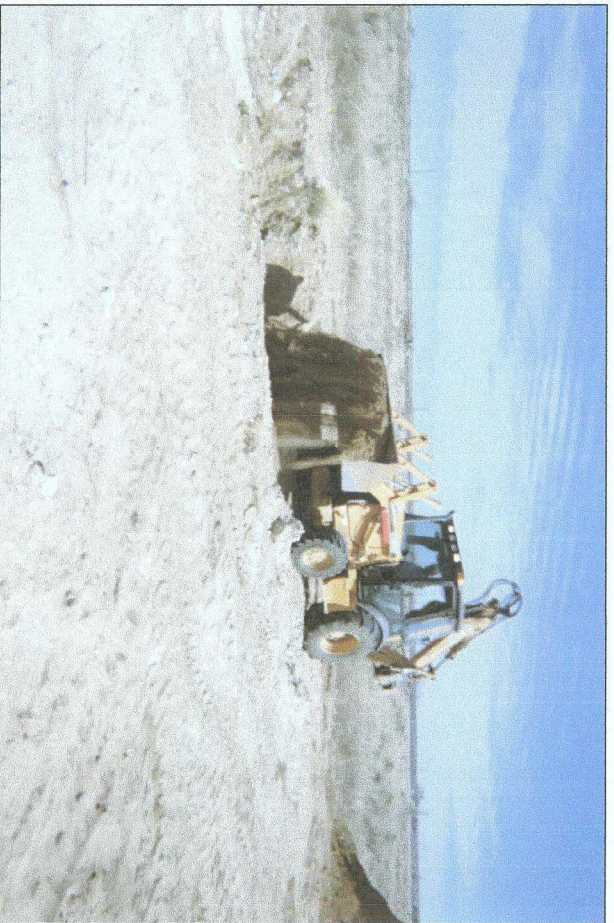
3/2/2007

backfilling 10 x 10 x 12-ft excavation

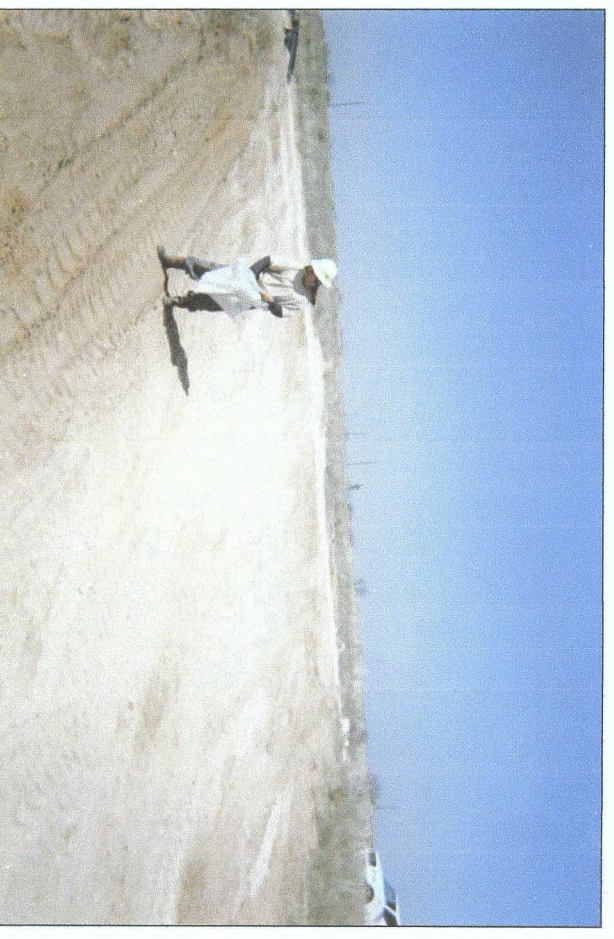
3/20/2007

seeding backfilled surface
