EME J-31 Vent

RICE OPERATING COMPANY

JUNCTION BOX FINAL REPORT

Unit J, Section 31, T20S, R37E

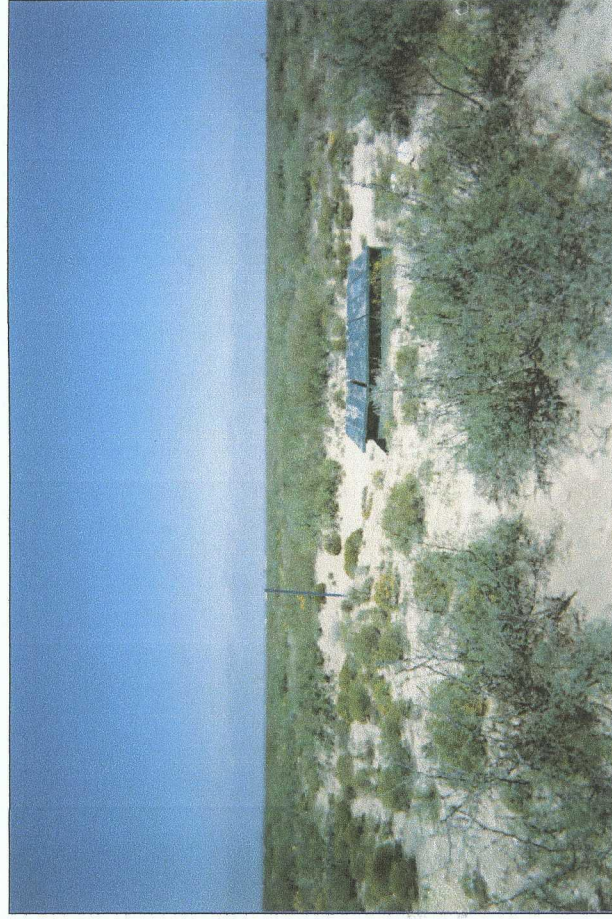
10/13/2004

undisturbed junction box

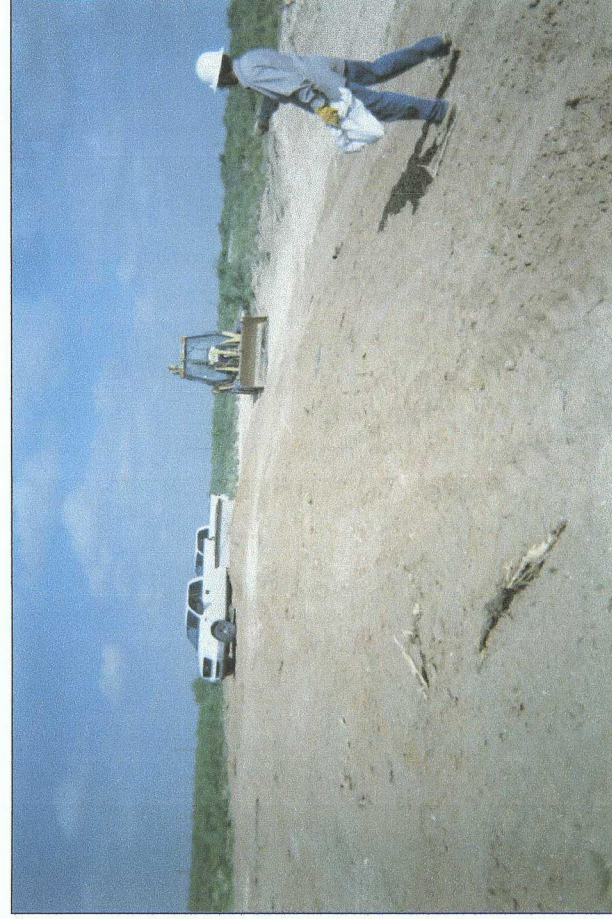
7/11/2007

seeding backfilled site

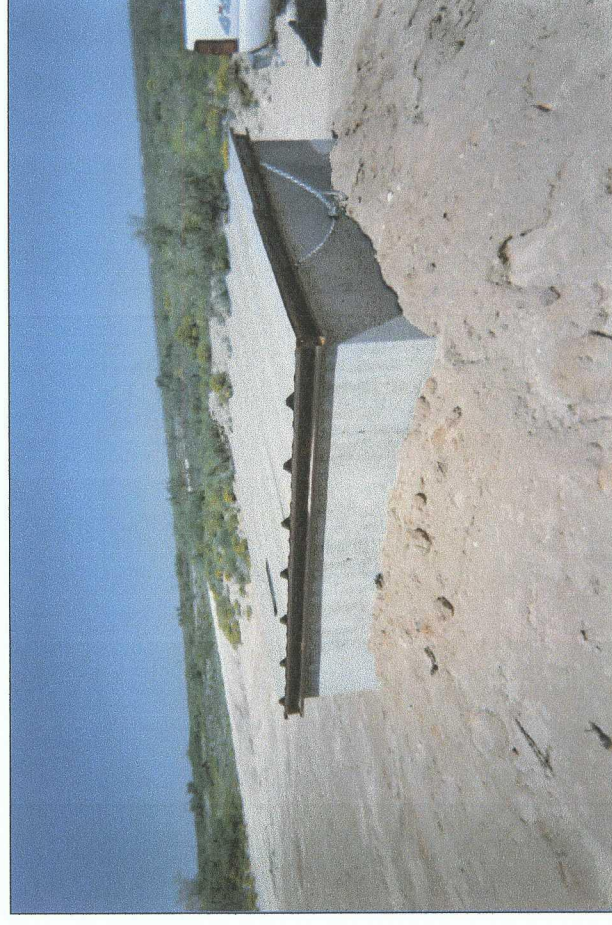
9/28/2007

new junction box 50 ft west of subject site
