EME Jct O-17-2

Aka Skelly 'F' EOL

CLOSURE

RICE OPERATING COMPANY
JUNCTION BOX FINAL REPORT

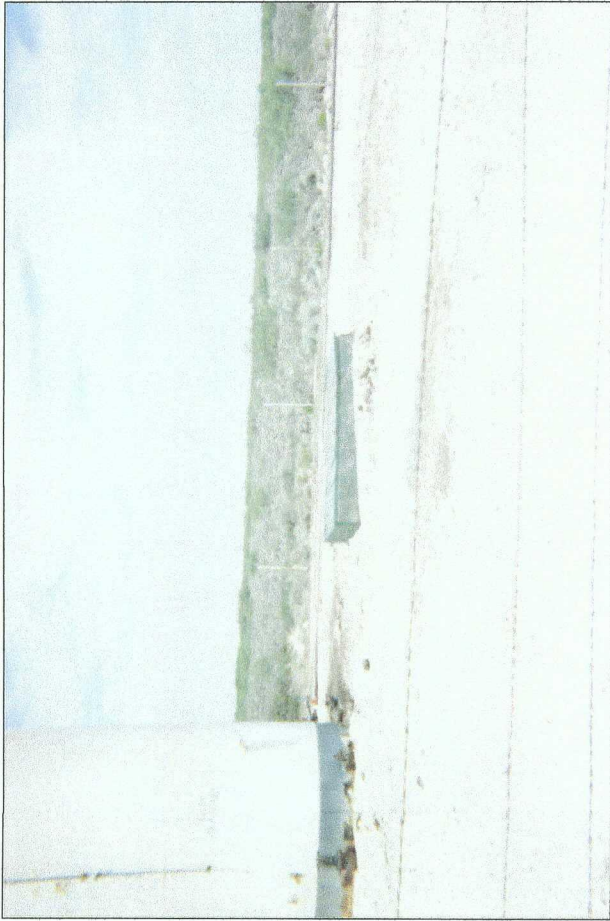
undisturbed junction box inside battery

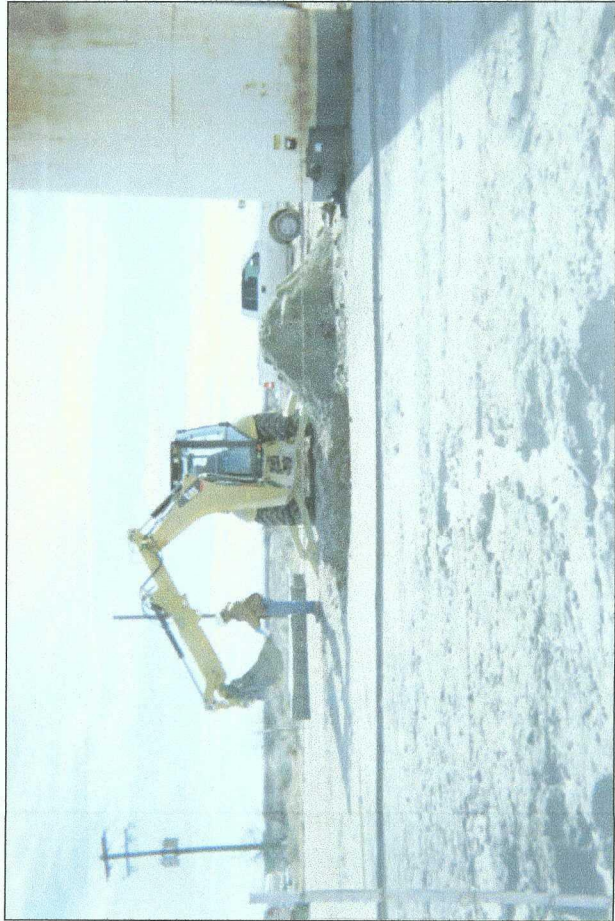
delineation trench at former junction site

This junction box was located inside the fence of an active production facility. The junction site has been eliminated with the pipeline replacement/upgrade program. After the box lumber was removed, a delineation trench was installed at the site to collect soil samples to 12 ft BGS. Chloride field tests were conducted on each sample and yielded very low chloride concentrations throughout that were similar to the background concentration. Organic vapors were also screened in the field using a PID and yielded slightly elevated concentrations. The deepest sample (12 ft grab) was analyzed for confirmation at a commercial laboratory for BTEX, TPH, and chloride. The sample's chloride concentration was not detectable within the laboratory's detection limit. The delineation trench was backfilled with the excavated soil and the disturbed area of the battery's pad was restored. Since chloride is not present at depth, TPH will be addressed by the operator at the abandonment of the production facility.

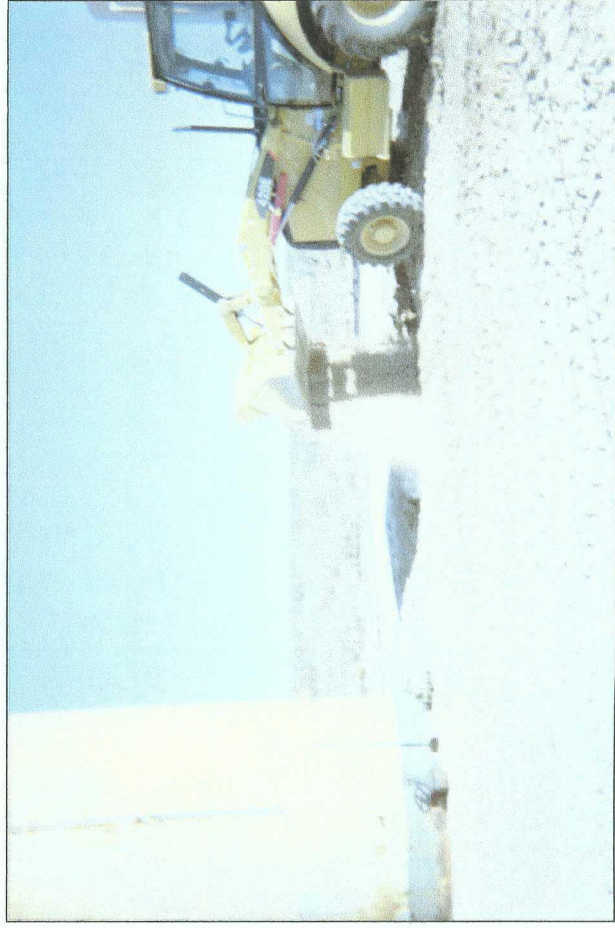
backfilling trench and repairing battery pad
