## AMENDED STAGE 2 ABATEMENT PLAN

### EME P-6 RELEASE SITE (AP-45)

### T20S, R37E, SECTION 6, UNIT LETTER P

### LEA COUNTY, NEW MEXICO

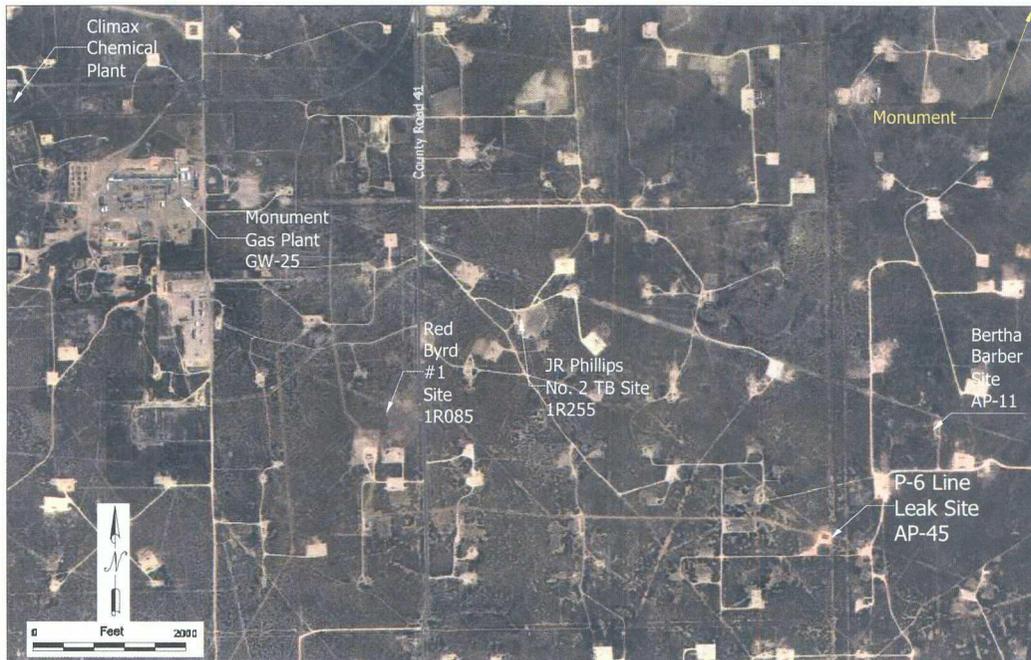
Figure 2: Aerial Photograph (July 2005)

An abundance of oil and gas production facilities are located within and around the EME P-6 Release site as shown in Figure 2 below.

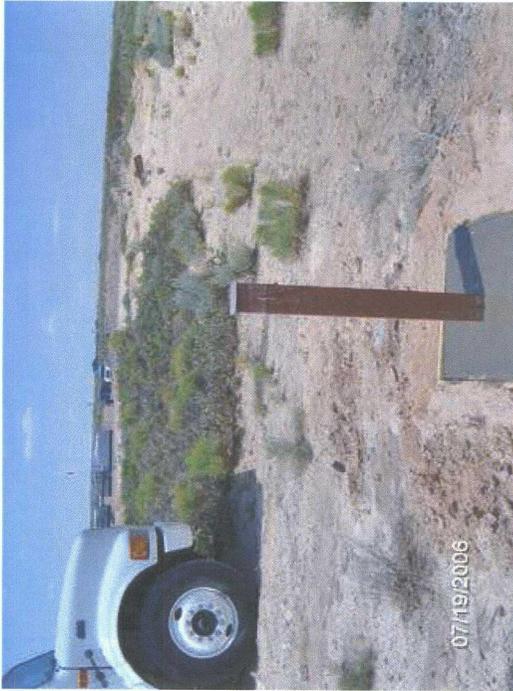
View facing north showing recently completed installation of downgradient monitoring well P6-3.

On July 18 and 19, 2006, two additional monitoring wells (P6-3 and P6-4) were installed in accordance with the Stage 1 and 2 Abatement Plan and NMOCD conditions to the minor amendment. Approval for access was not granted by the landowner to install an offsite, cross-gradient monitoring well (P6-5) located approximately 200 feet east of monitoring well P6-1; however it is not needed since sufficient evidence has been provided to support the conclusion that the elevated chloride and TDS concentrations in the groundwater at the site are the result of regional upgradient sources. A site map showing monitoring wells associated with the P-6 Release site is depicted in Figure 4. The site map also includes an offsite, downgradient well located approximately 500 feet southeast of monitoring well P6-1 at a neighboring site being monitored by ROC (EME M-5 SWD). Various photos of the well installations are included in Appendix B.

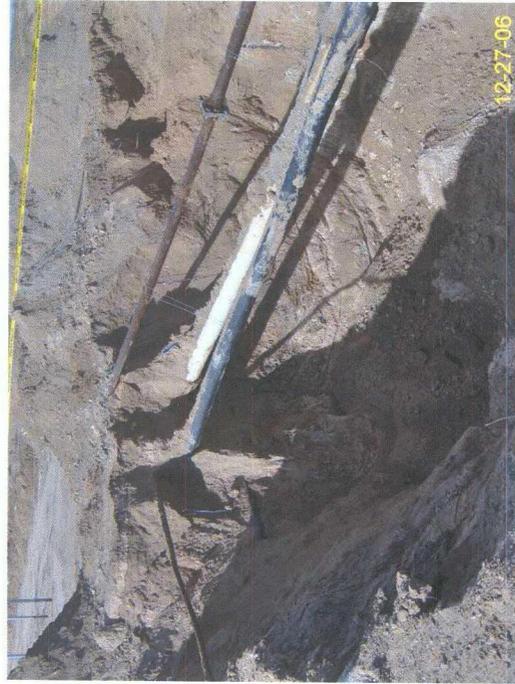
View of west wall of excavation.

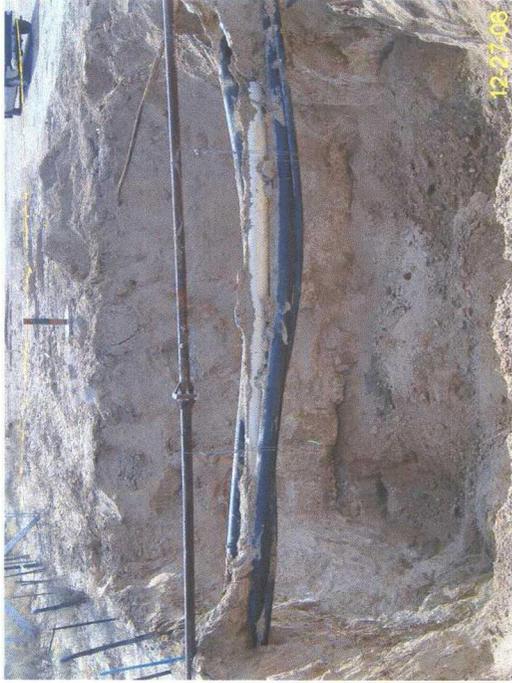
View of south wall of excavation.

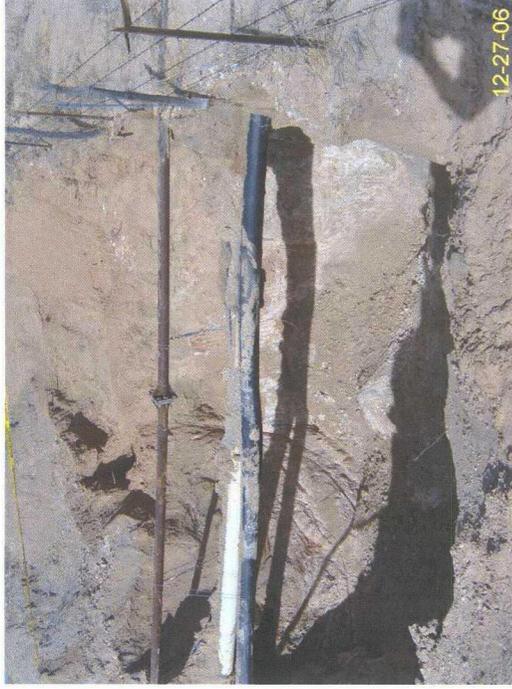
View of north wall of excavation.

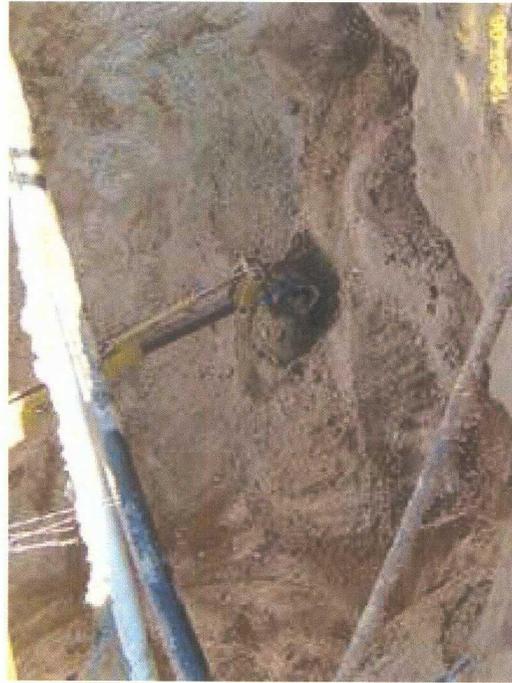
View facing northeast showing floor of excavation (16 feet below ground surface).

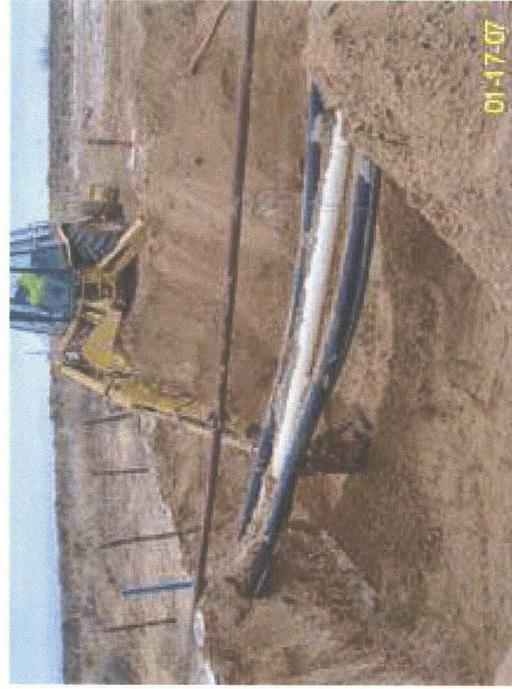
View facing south showing backfilling and tamping of blended soil on south side of excavation.

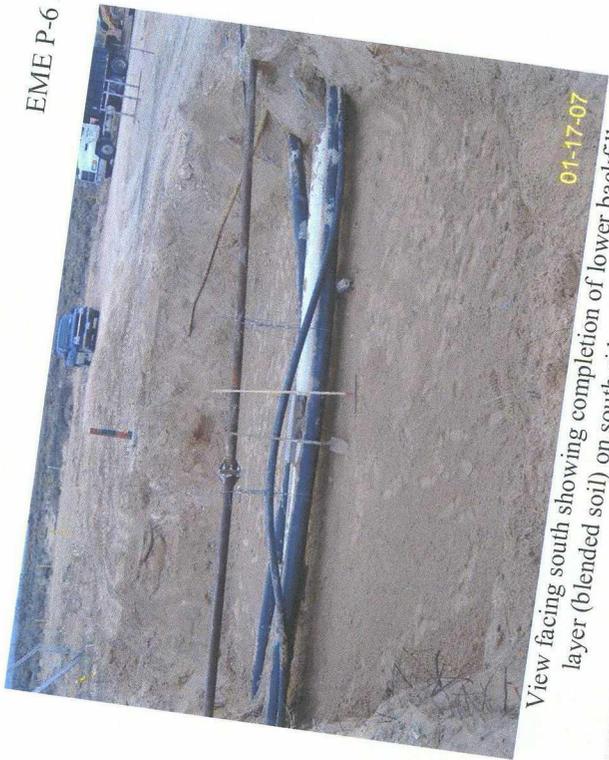
View facing south showing completion of lower backfill layer (blended soil) on south side of excavation.

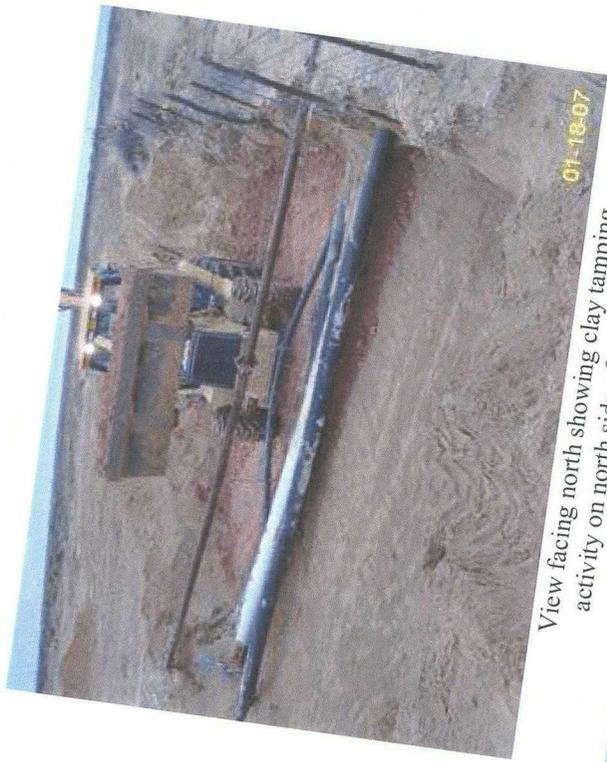
View facing north showing clay tamping activity on north side of excavation.

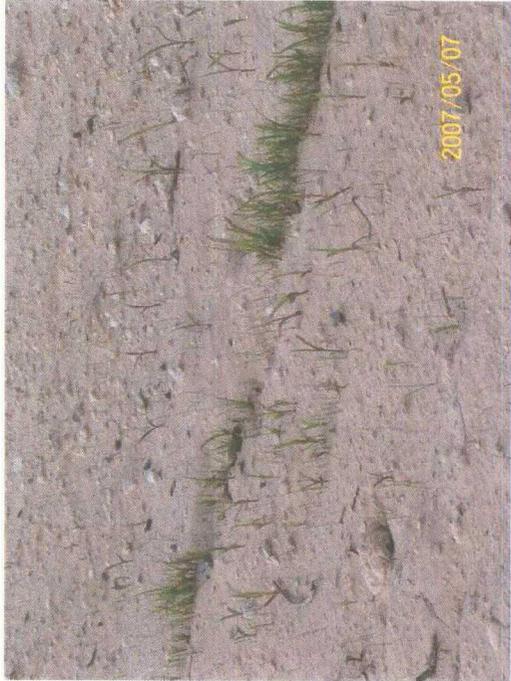
Close-up view showing early healthy growth of grass seed mix.
