ENVIRONMENTAL SITE
ASSESSMENT
Plantation Operating, LLC
C.T. Bates #4
Spill

September 5, 2007

White Buffalo Environmental Services

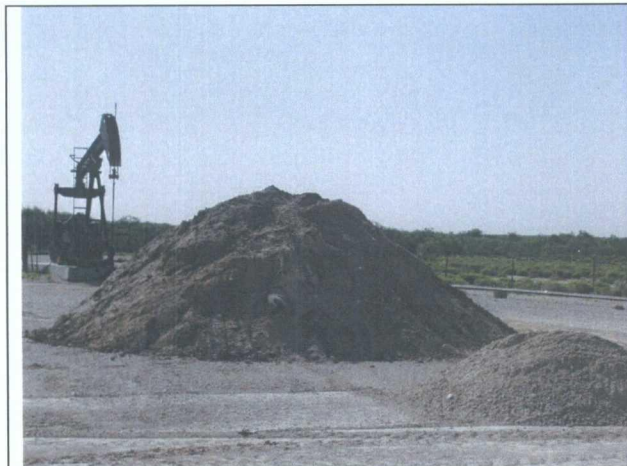
7-13-07 Excavated material when WBES arrived on site

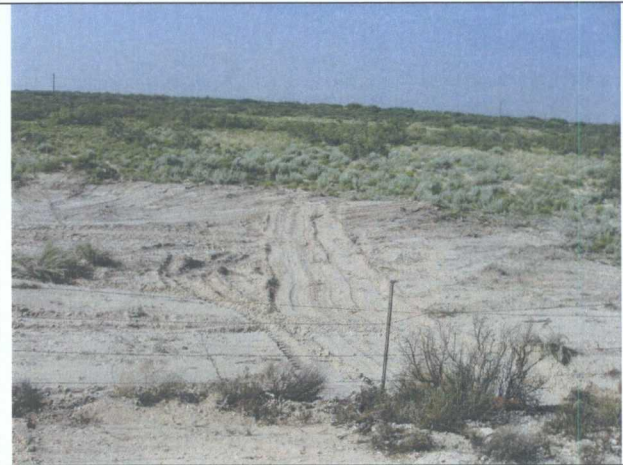
7-13-07 area south of firewall across fence where Plantation excavated prior to WBES arrival

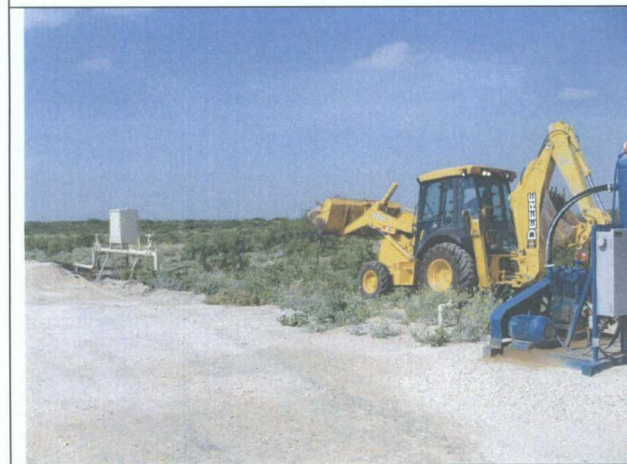
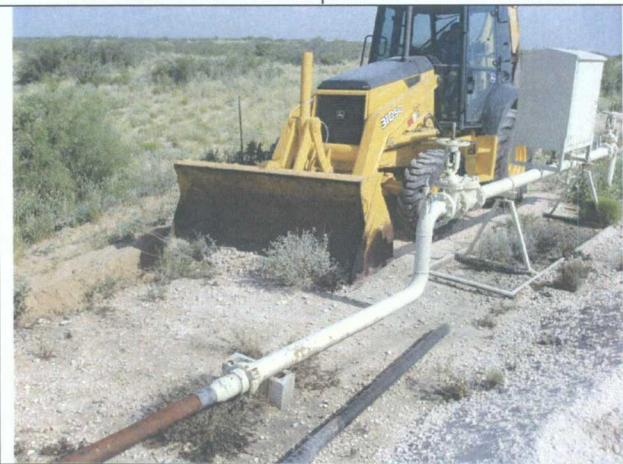
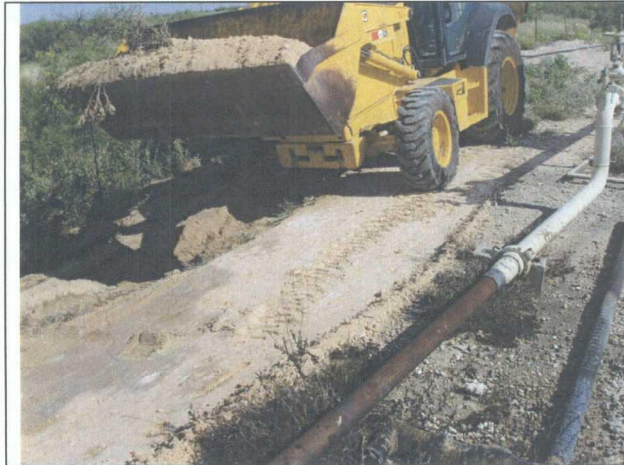
7-13-07 excavating area west of tank battery area

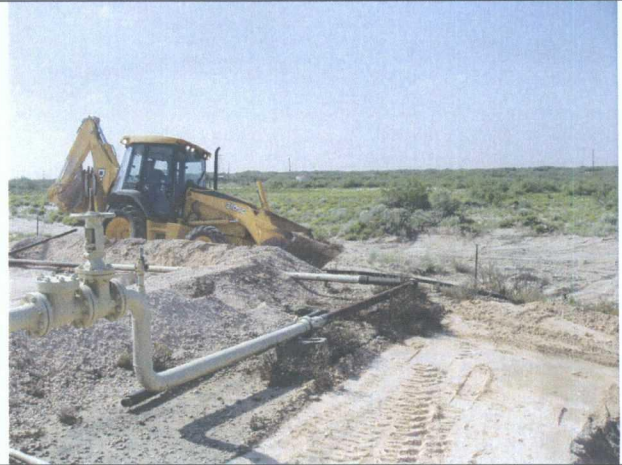
7-13-07 excavating area south of tank battery area

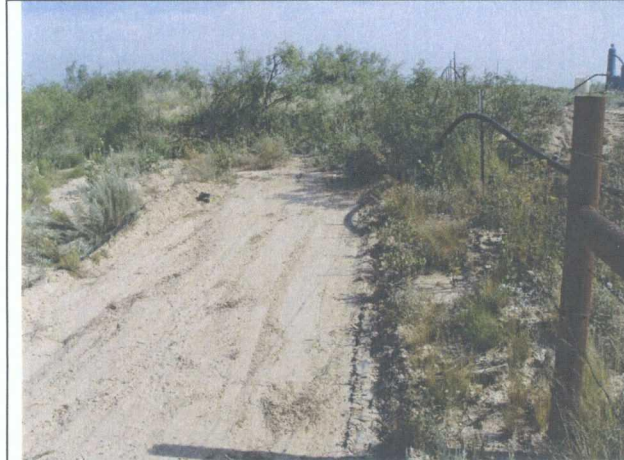
7-13-07 excavating area west of tank battery area
across fence

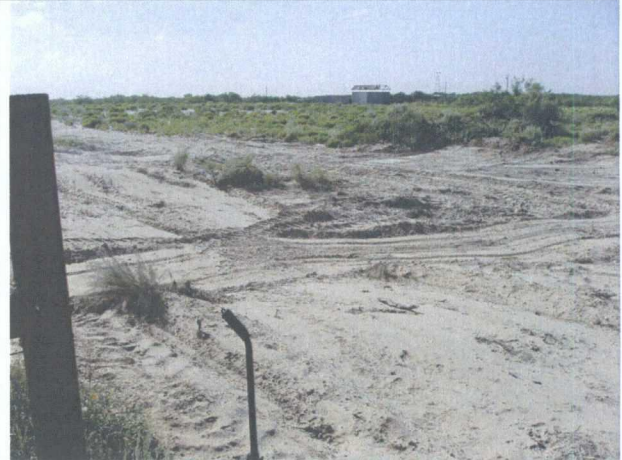
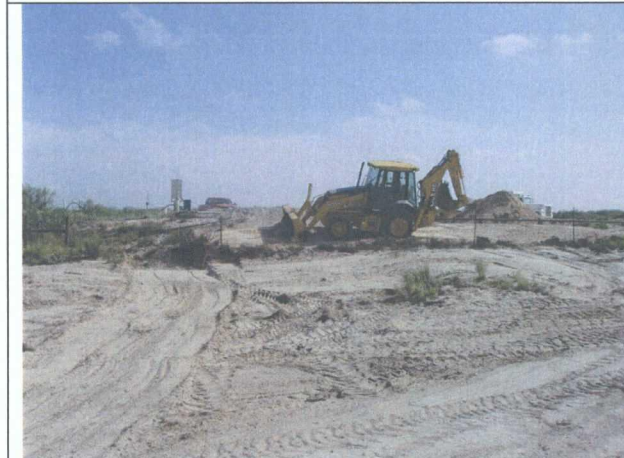
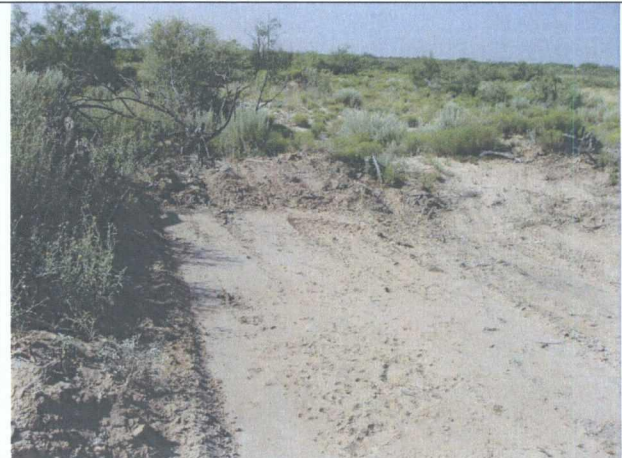
7-13-07 excavating area south of tank battery area
across fence

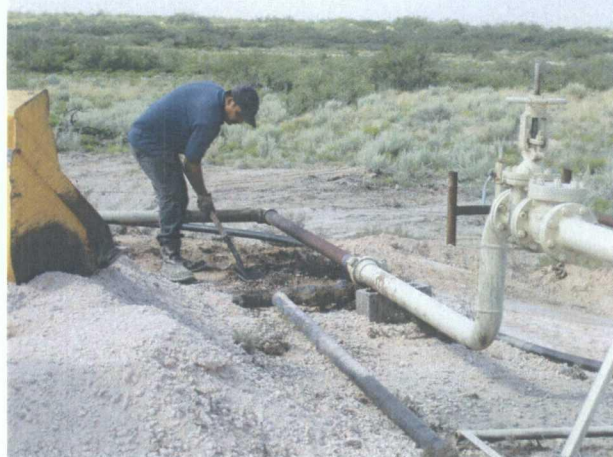
7-13-07 RMA employees removing contaminated soil from around piping

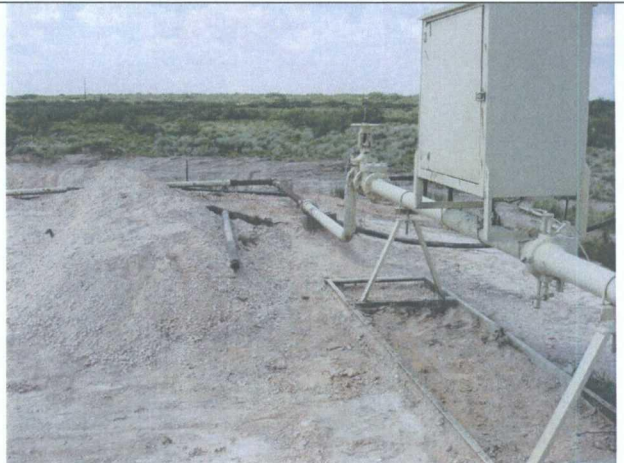
7-13-07 RMA excavated contaminated soil from around piping

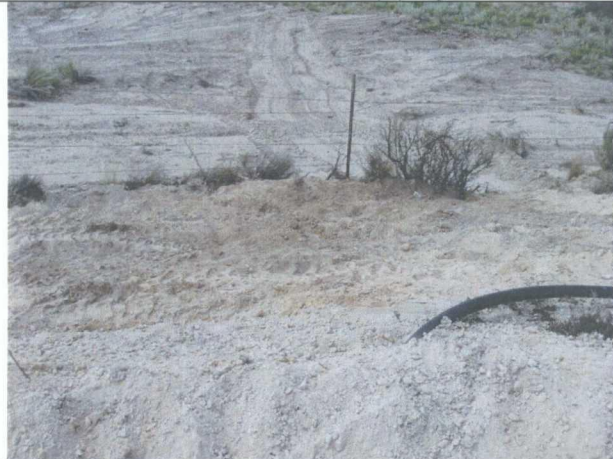
7-13-07 standing on former firewall area facing south after excavation

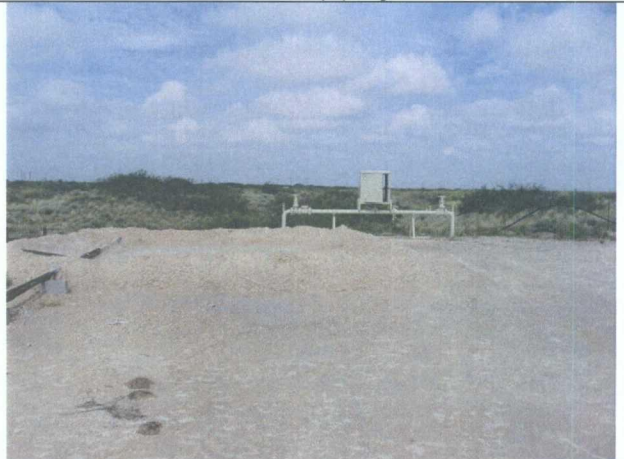
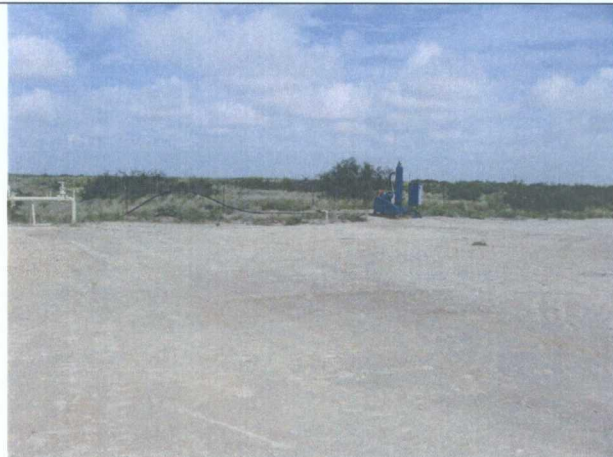
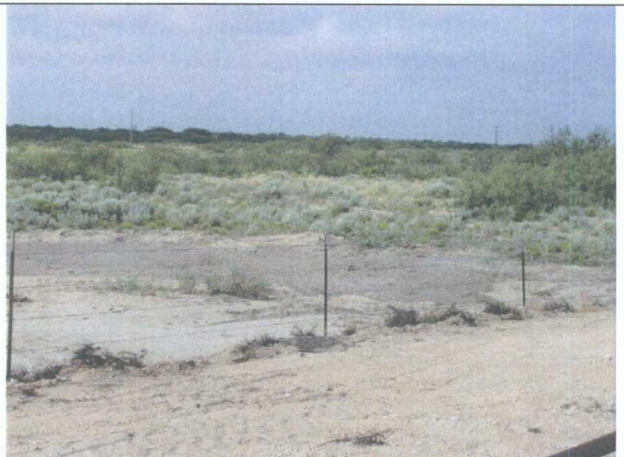
8-1-07 Area prior to second excavation

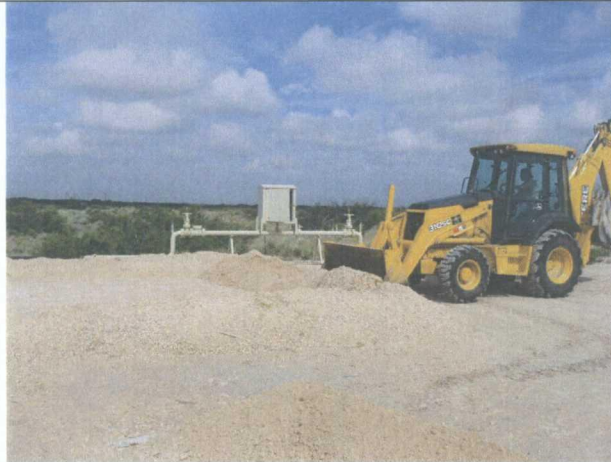
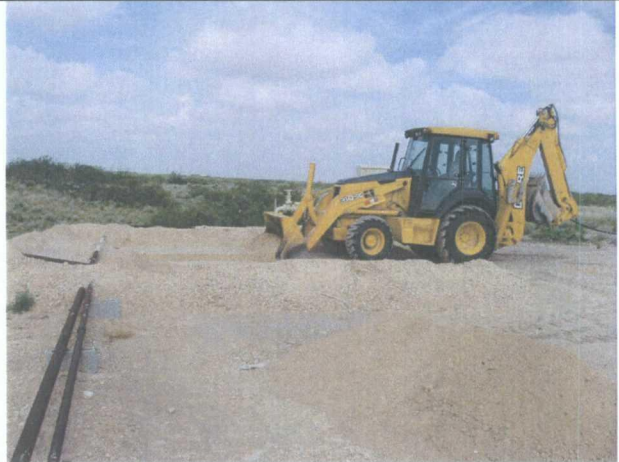
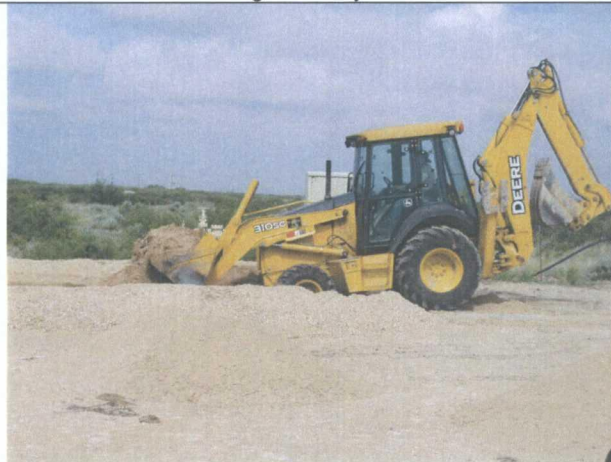
8-1-07 second excavation on elevated areas
according to analytical data

The analytical results from the samples collected on 7-11-07 from the excavated area indicated Soil samples number 1, 4, 5, 6 and the spoils (refer to site Map) were still elevated with Chlorides or above OCD regulations and further excavation was needed in these areas. Contact was made by WBES employees to Plantation Operating LLC. to request further excavation in these areas. Contact was made to RMA Roustabout Service, Inc and on 8-1-07 these area were over excavated and six confirmation samples were collected to verify all contaminated soil has been removed from the site. The samples were transported to ASK Laboratories, Inc. located in Amarillo, TX to be analyzed for Chlorides method 300 Ion Chromatography.

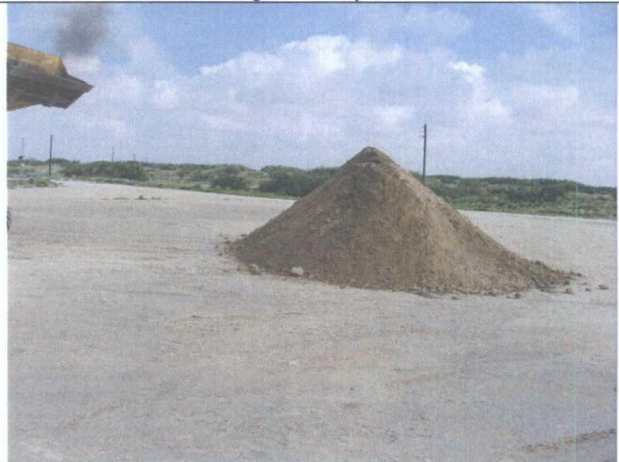
8-1-07 Spoils from second excavation on elevated
areas according to analytical data

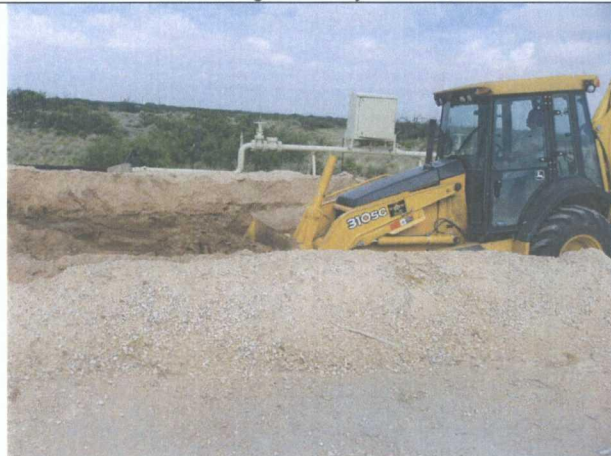
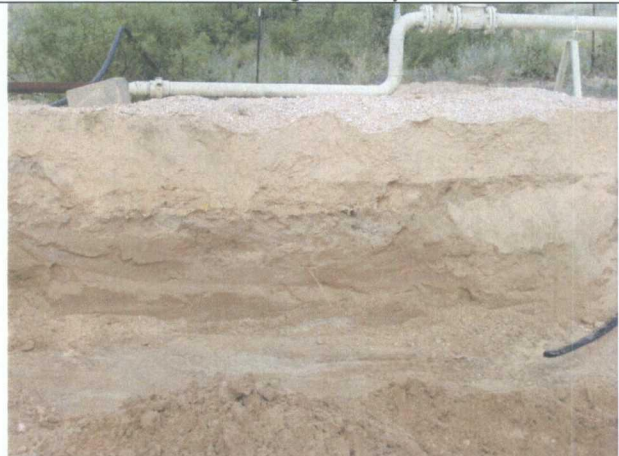
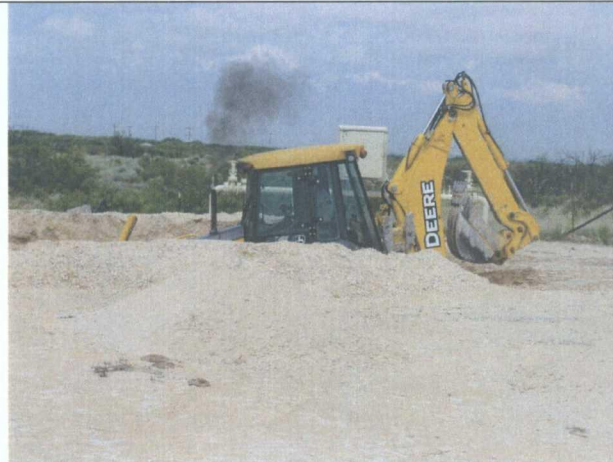
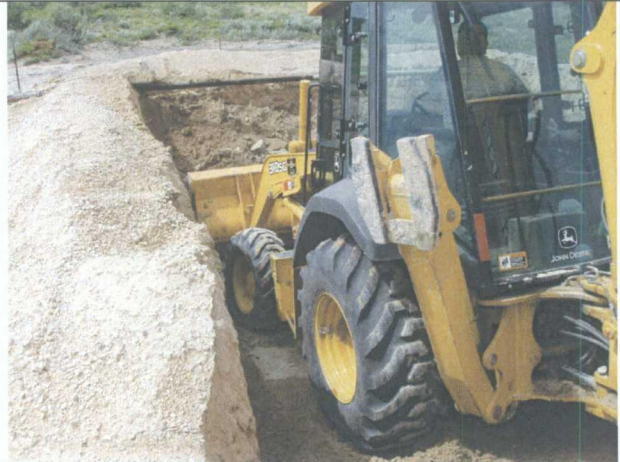
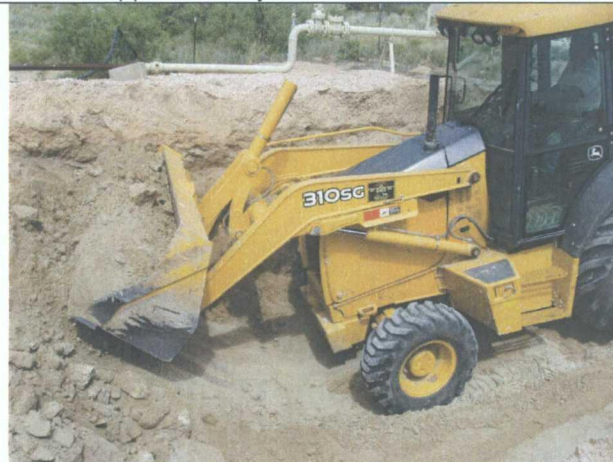
8-1-07 second excavation on elevated areas
according to analytical data. Excavated
approximately 6 feet in firewall area

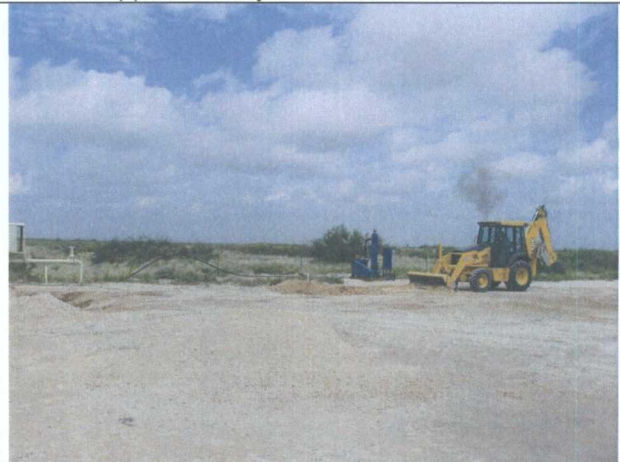
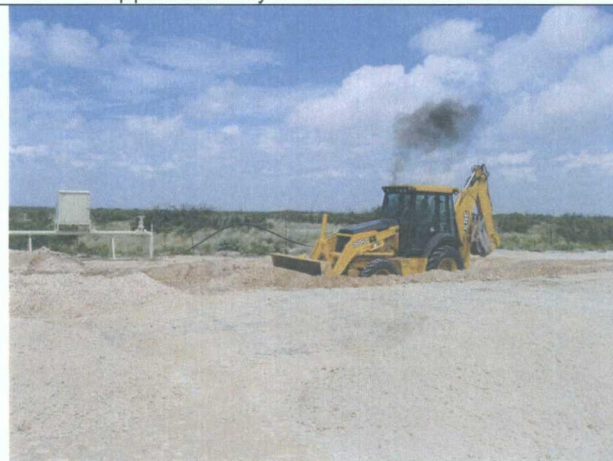
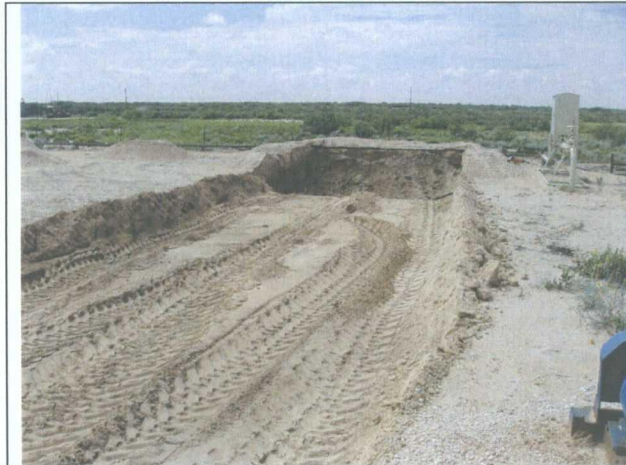
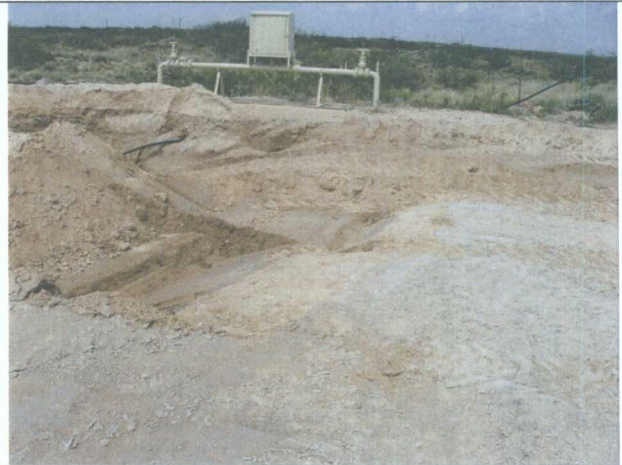
8-1-07 second excavation on elevated areas according to analytical data. Excavated approximately 3 feet in area north of firewall

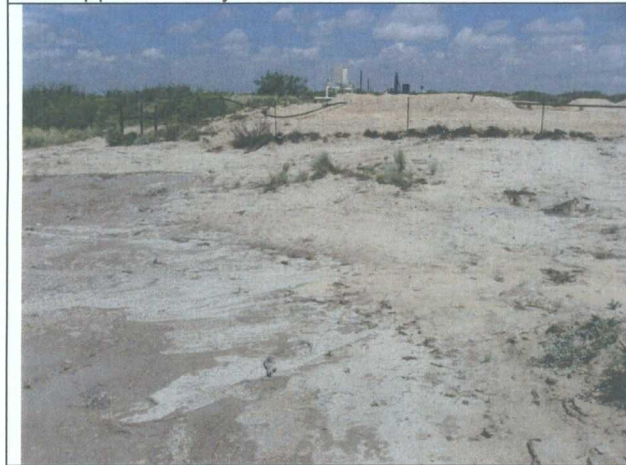
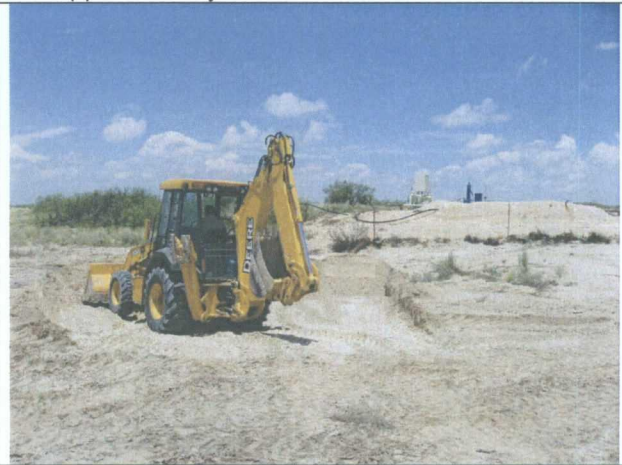
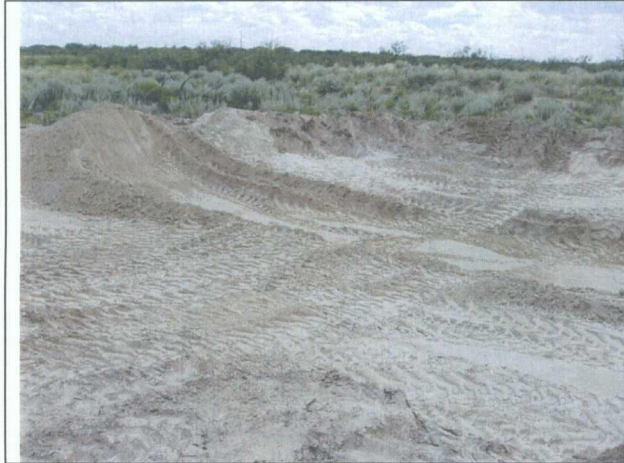
8-1-07 second excavation on elevated areas according to analytical data. Excavated approximately 3 additional feet in area south of firewall across fence

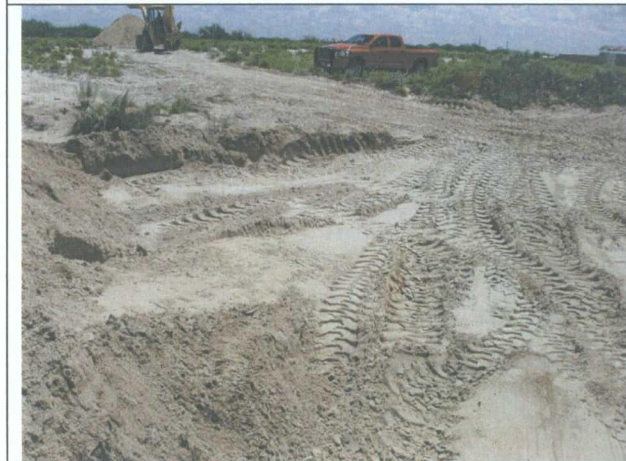
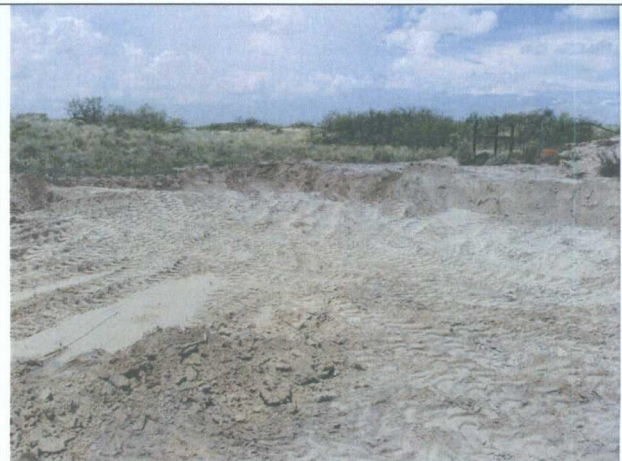
8-1-07 second excavation on elevated areas according to analytical data. Excavated approximately 3 additional feet in area south of firewall across fence	8-1-07 second excavation on elevated areas according to analytical data. Excavated approximately 3 additional feet in area south of firewall across fence

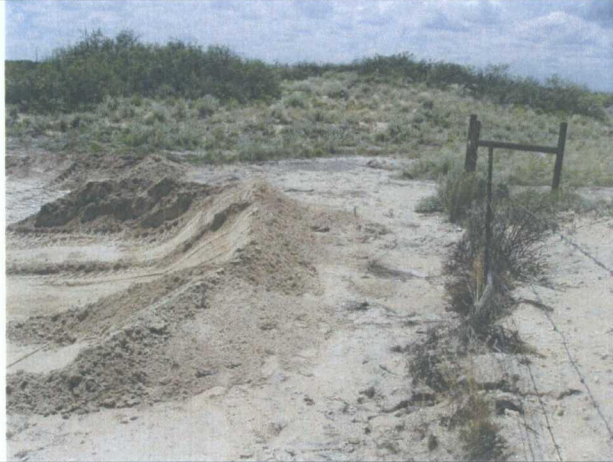
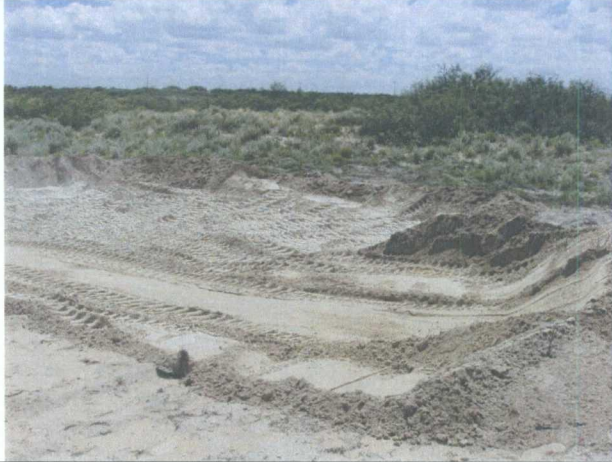
8-1-07 second excavation on elevated areas according to analytical data. Excavated approximately 3 additional feet in area south of firewall across fence	8-1-07 second excavation on elevated areas according to analytical data. Excavated approximately 3 additional feet in area south of firewall across fence

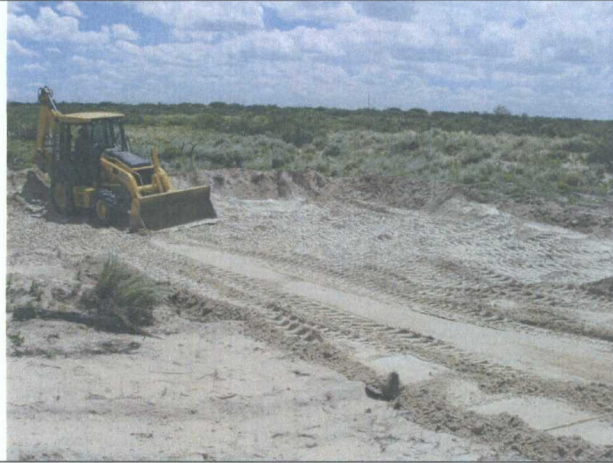
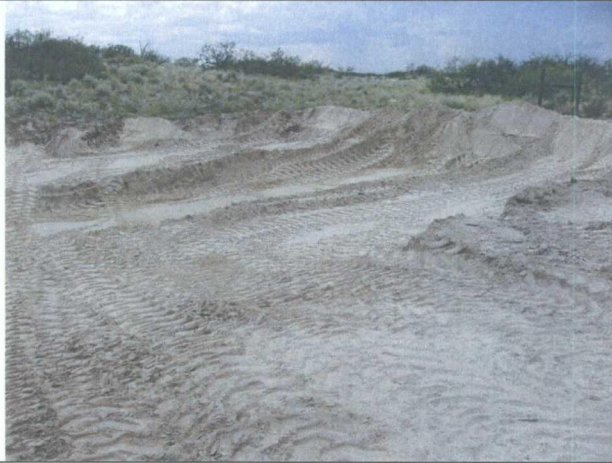
8-1-07 second excavation on elevated areas according to analytical data. Excavated approximately 3 additional feet in area south of firewall across fence	8-1-07 second excavation on elevated areas according to analytical data. Excavated approximately 3 additional feet in area south of firewall across fence

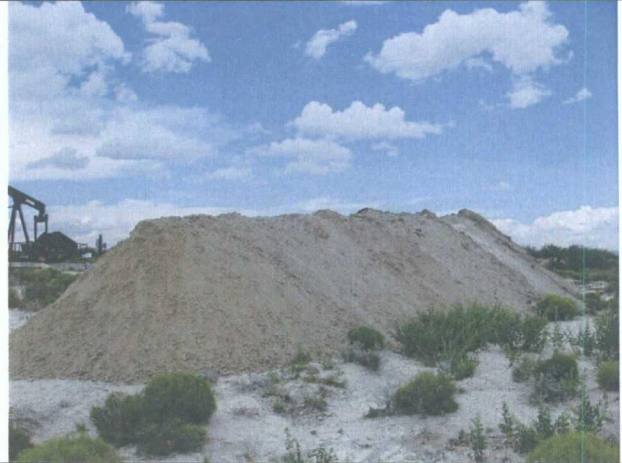
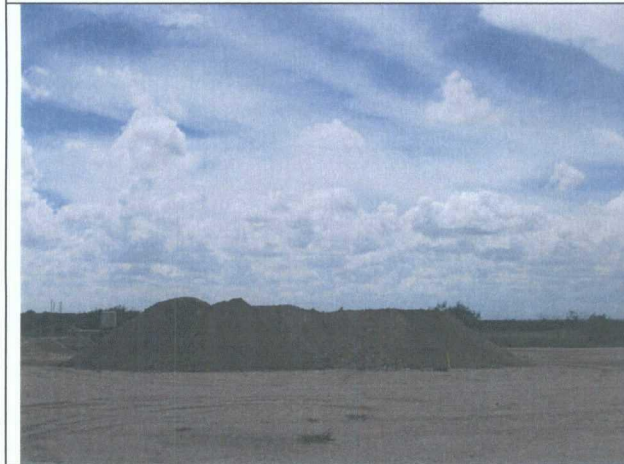
8-1-07 spoils after second excavation

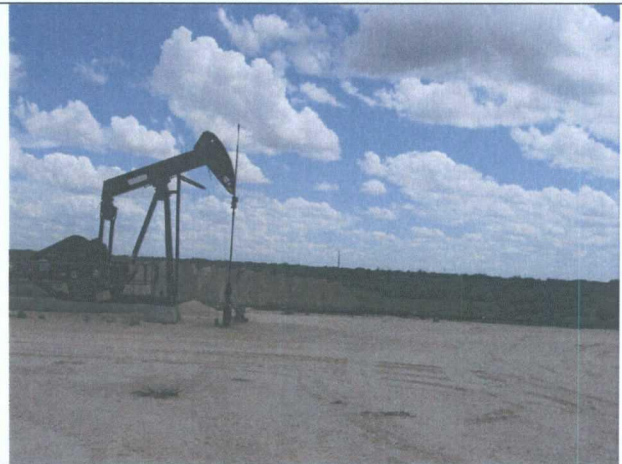
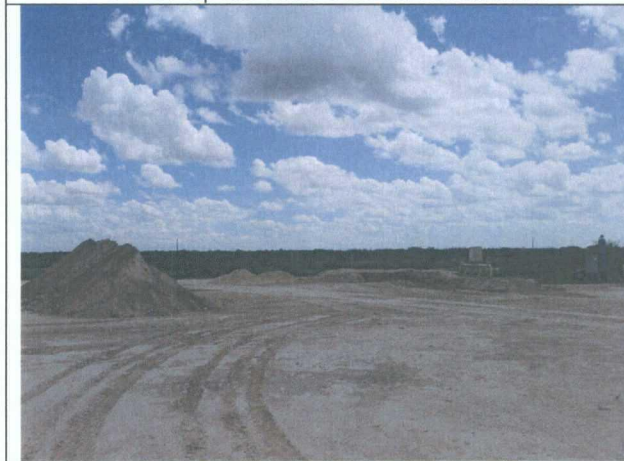
8-1-07 site and spoils after second excavation

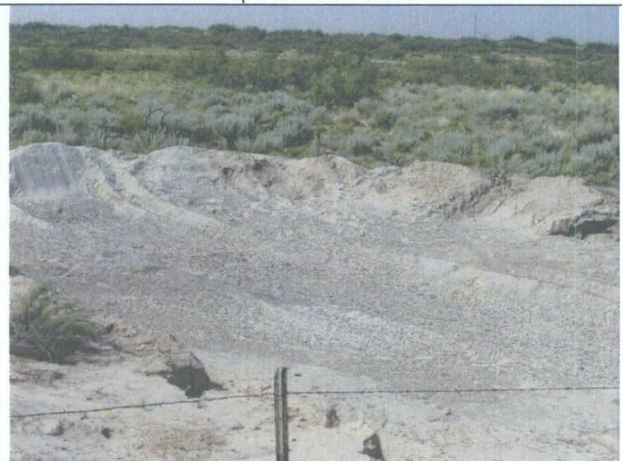
8-16-07 site prior to third excavation south of firewall area across fence

The analytical results from the samples collected on 8-1-07 from the excavated area indicated Soil samples number 5A (refer to site Map) was still elevated with Chlorides or above OCD regulations and further excavation was needed in these areas. Contact was made by WBES employees to Plantation Operating LLC. to request further excavation in these areas. Contact was made to RMA Roustabout Service, Inc and on 8-16-07 this area was over excavated and one confirmation sample was collected to verify all contaminated soil has been removed from the site. The sample was transported to ASK Laboratories, Inc. located in Amarillo, TX to be analyzed for Chlorides method 300 Ion Chromatography.

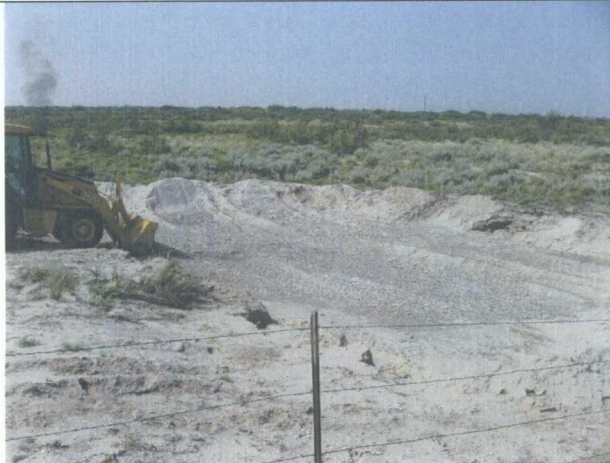
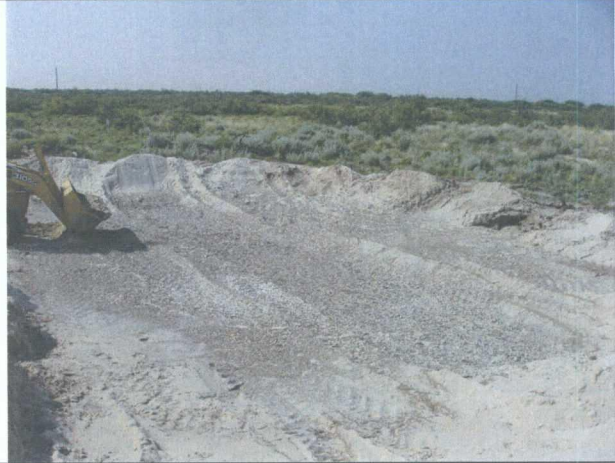
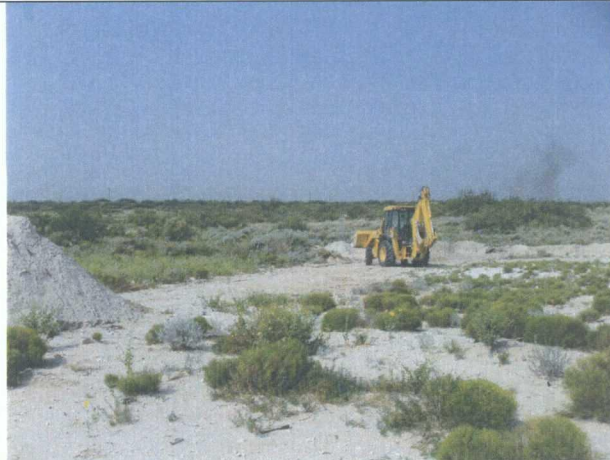
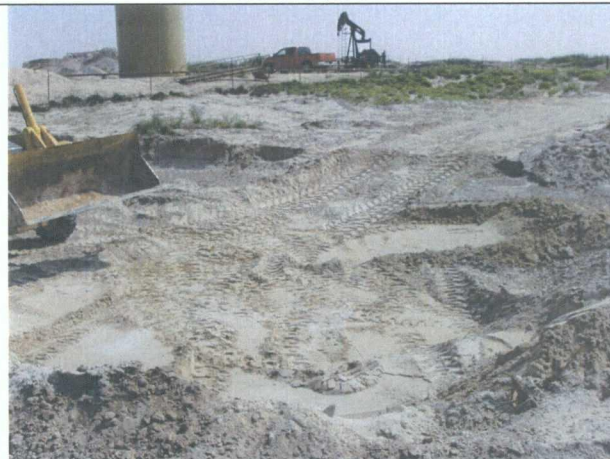
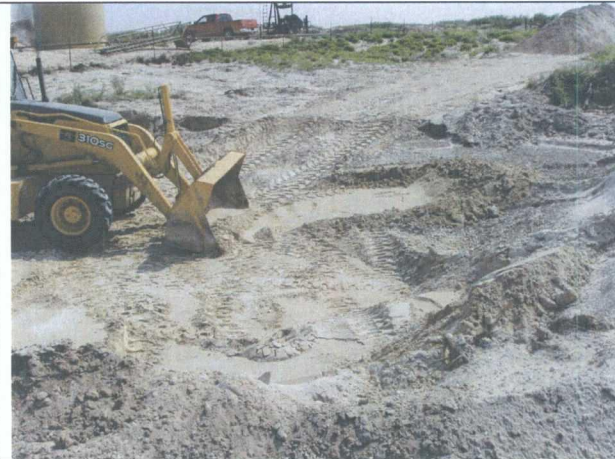
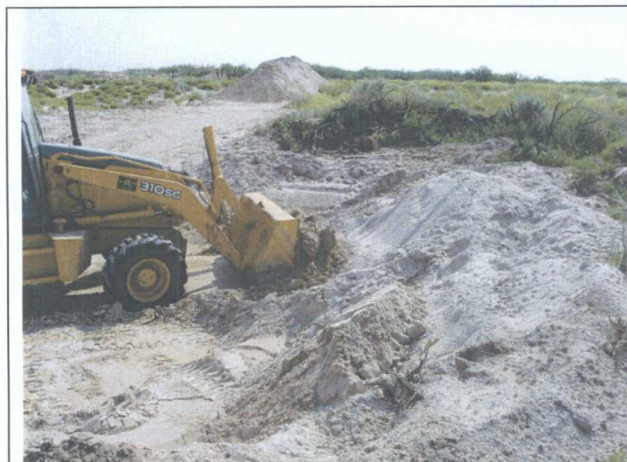
8-16-07 third excavation south of firewall area
across fence

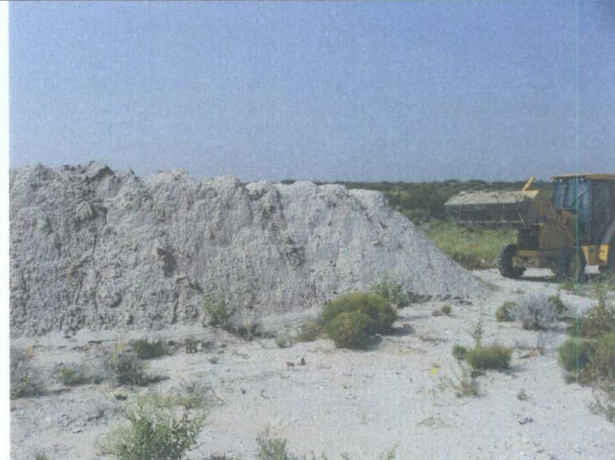
8-16-07 third excavation spoils

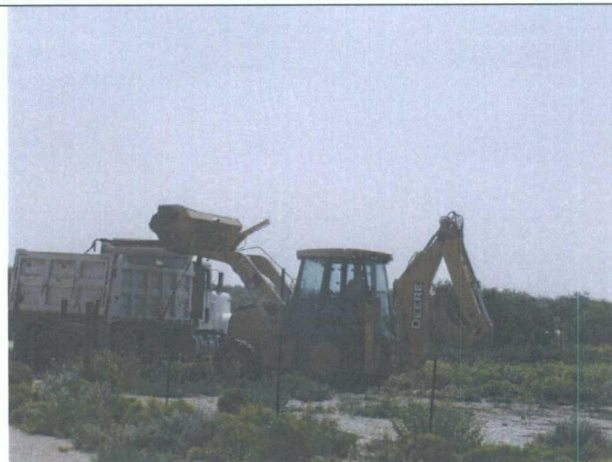
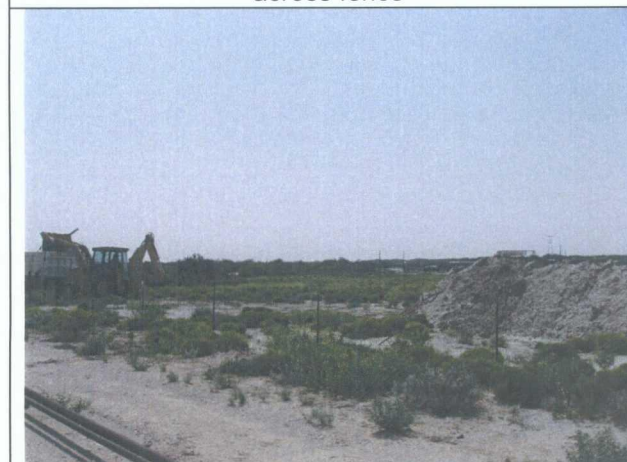
8-16-07 transporting spoils to Sundance Services
Inc. located in Eunice, NM

All results are below the immediate 100 mg/Kg required for Chlorides by the OCD. All excavated materials were properly removed and disposed at Sundance Services Inc. located in Eunice, NM..
