RE: Request for Final Closure, Lovington Abo 1G  
Unit G, Section 1, 17S, 36 E  
**NMOCD Case # 1R 0415**

As you may recall, we submitted a full Closure Report for this site in April of this year. This letter presents recent work at the above-referenced site and requests formal closure of the Rice Operating Company (ROC) file associated with it.

Recent Aerial Photo Noting Monitoring Wells

2006 Potentiometric Surface

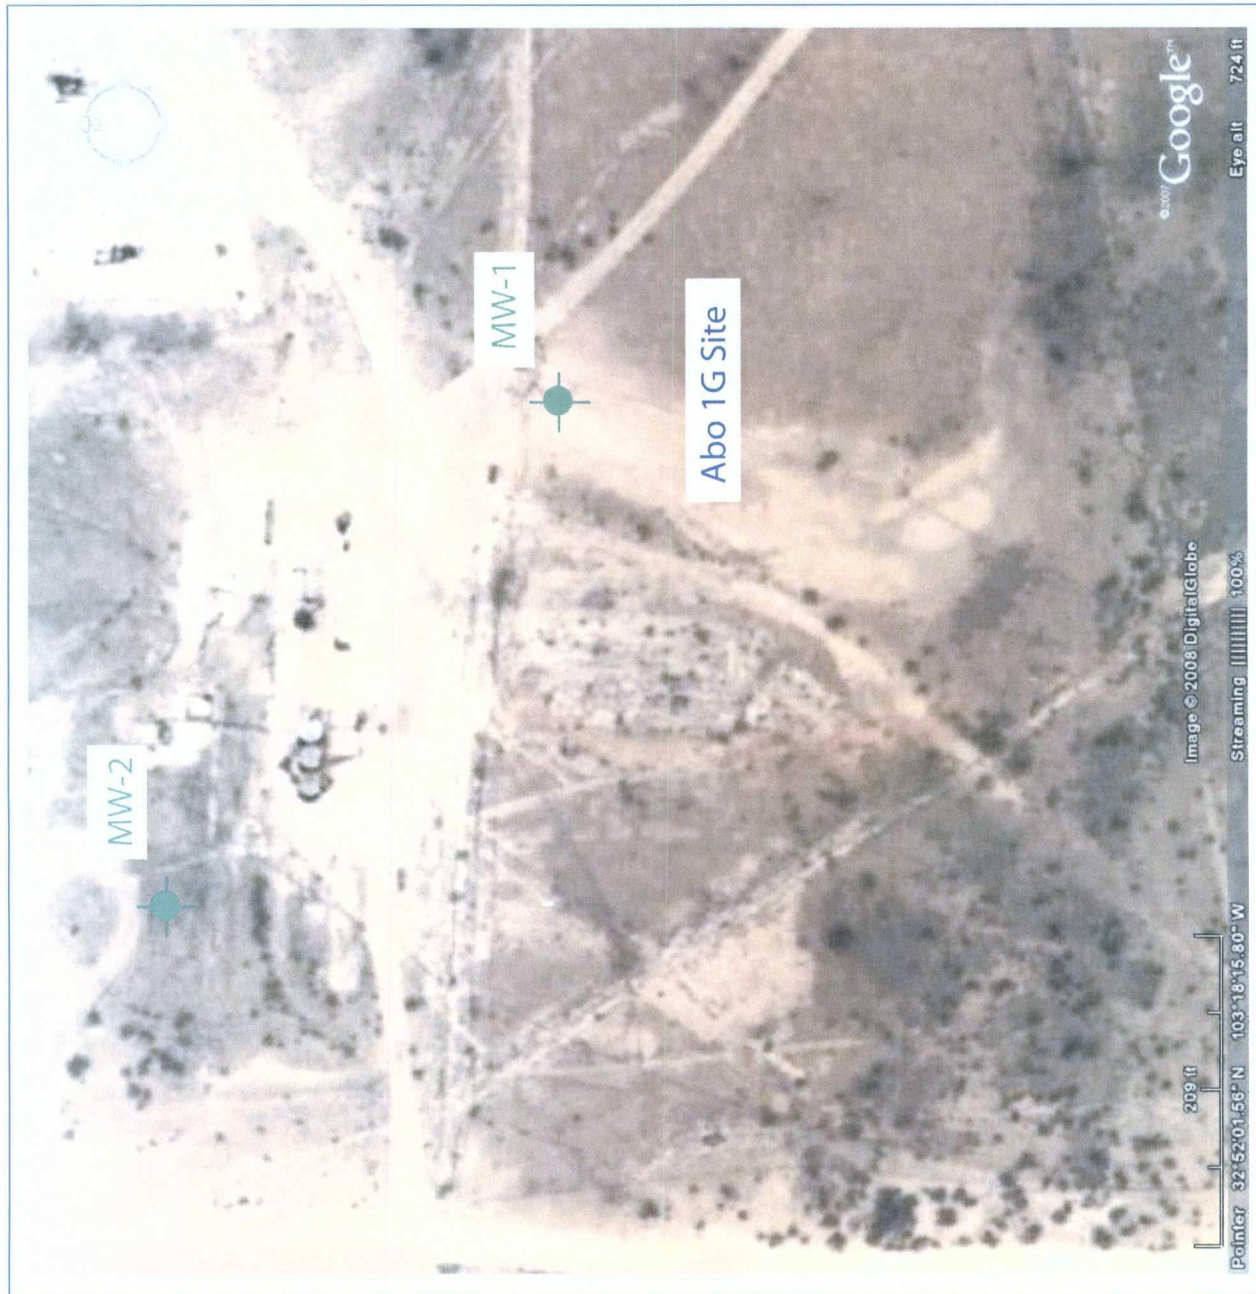
Approximate MW  
Location

Per our meeting with NMOCD, the City of Lovington, and ROC earlier this year; ROC completed a second monitoring well (MW-2) to the northwest of MW-1 and sampled ground water. MW-2 was drilled on 7/18/08 about 450 feet northwest of MW-1. Plate 1 shows both wells on a recent aerial photograph and Plate 2 shows the water table elevation map of the area using 2006 USGS ground water data. Appendix A presents the lithologic log and completion diagram for MW-2. After MW-2 was completed and developed following standard industry practices, ground water from both wells were sampled on 7/28/08; the results of laboratory analysis found BTEX below detection limits in both wells. Chloride and TDS results from ground water sampling at the site in 2008 are summarized in Table 1. The laboratory results for 2008 ground water sampling are included in Appendix B.

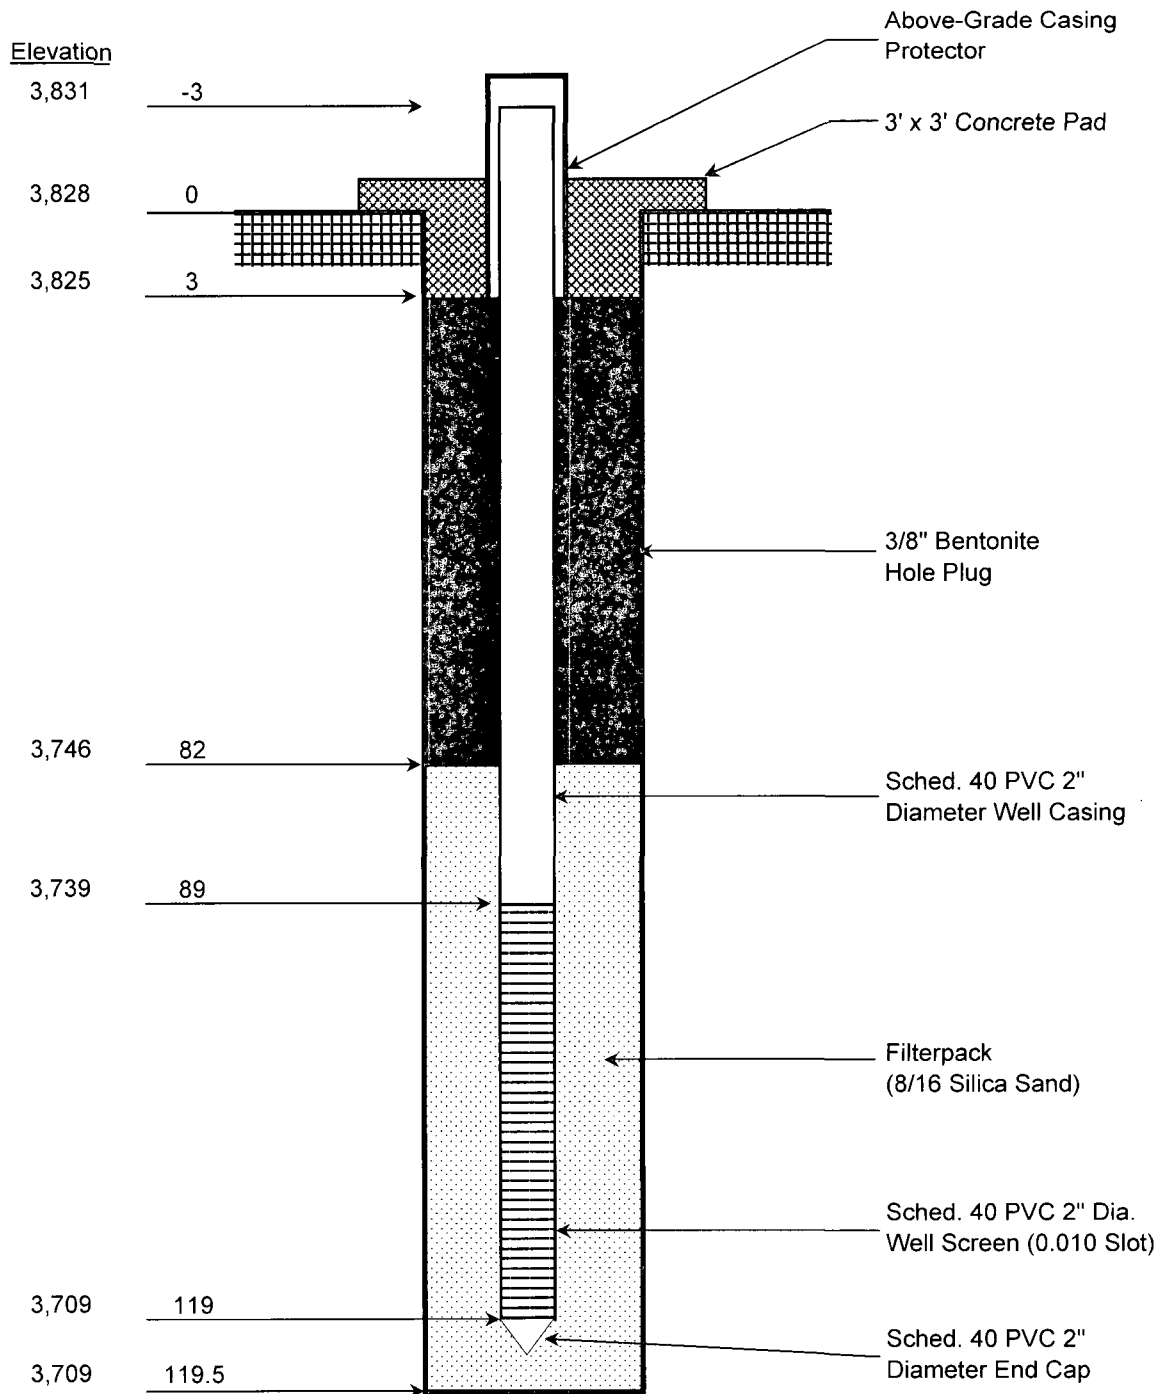
**Monitoring Well  
No. MW-2**

# MONITORING WELL CONSTRUCTION DIAGRAM

SITE: Lovington Abo 1G	
DATE: 7/18/2008	REV. NO.: 1
AUTHOR: DTL	TECH: DTL
DRILLER: H & C, Inc	FILE: G-1 Lithlogs
