**Lovington Abo 1G Site
NMOCD Case # 1R 0415**

Closure Report

R. T. Hicks Consultants, Ltd.

April 2008

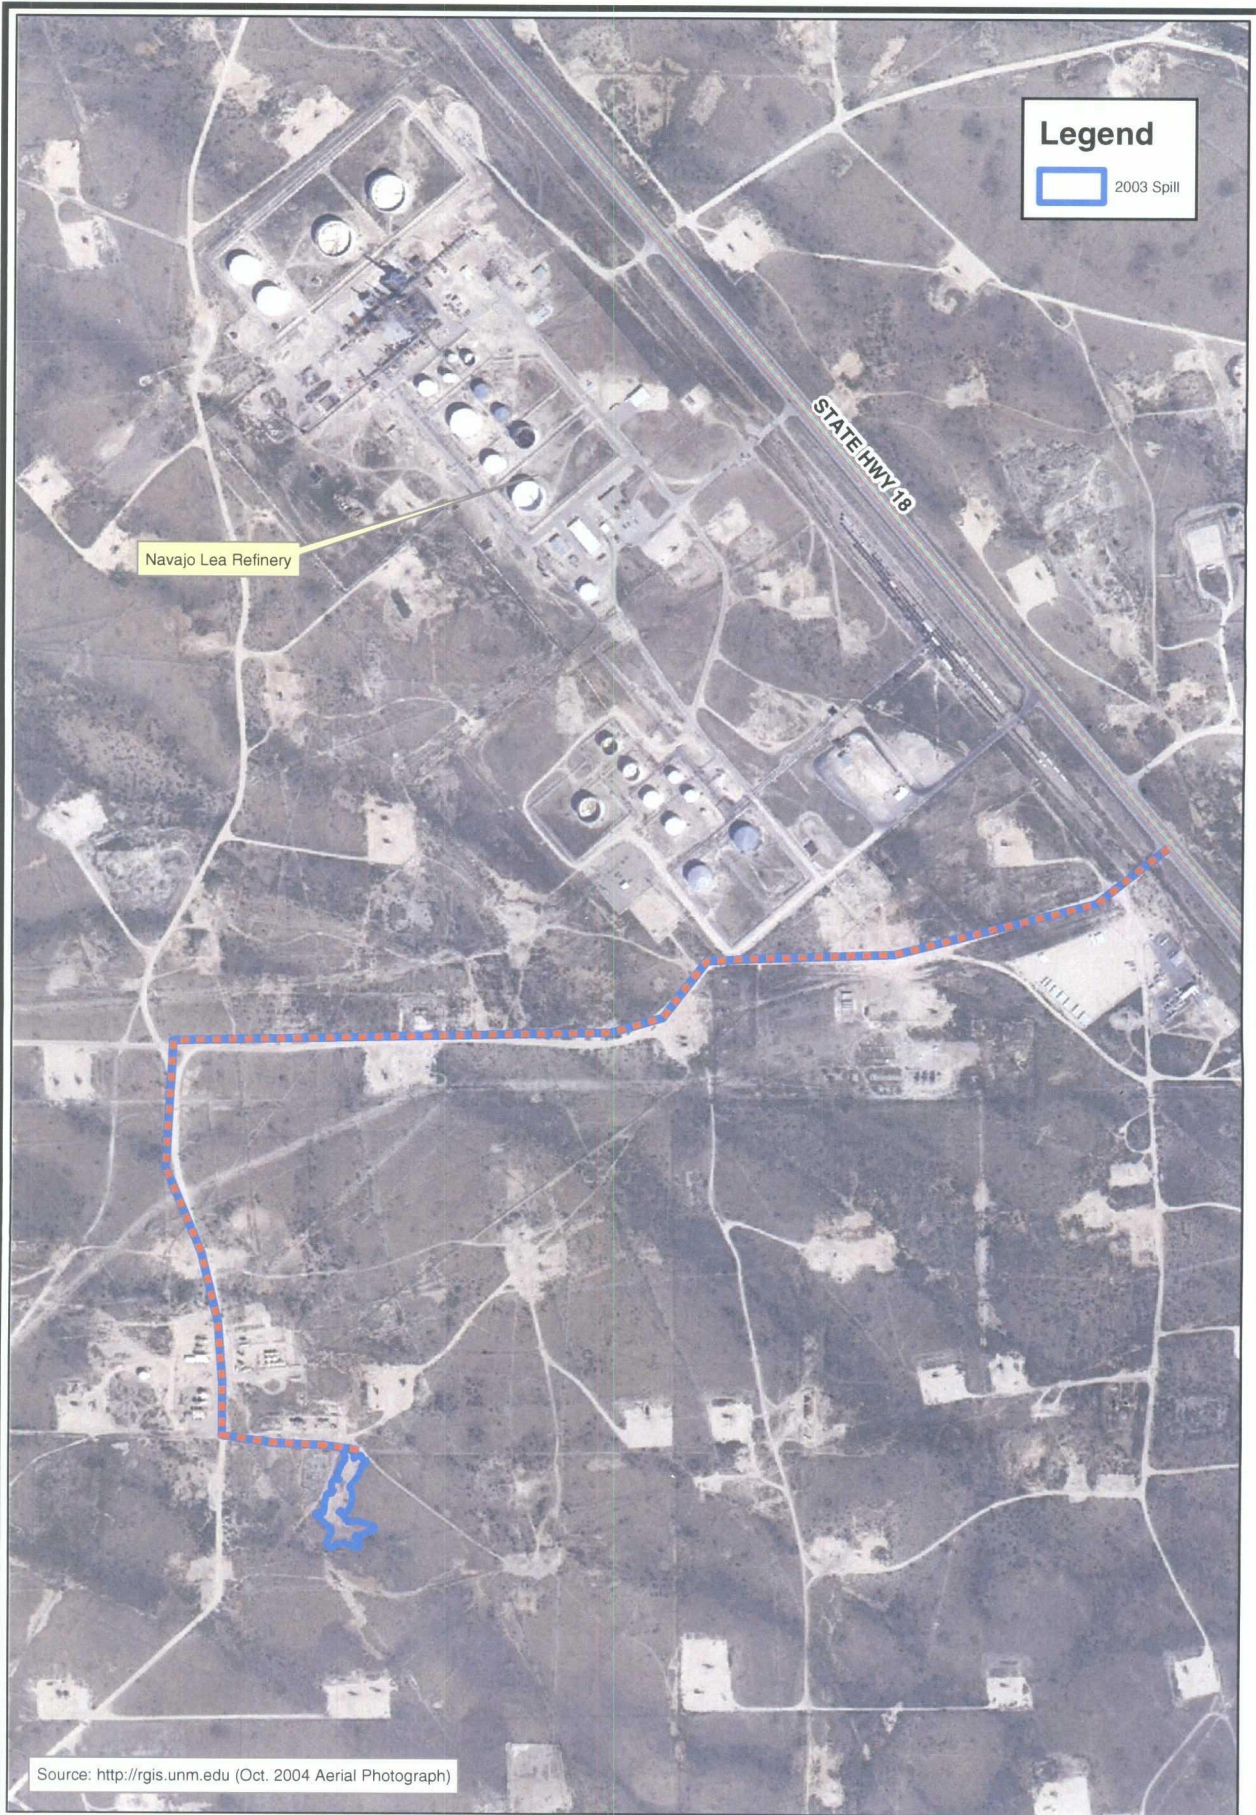
Source: <http://rgis.unm.edu> (Oct. 2004 Aerial Photograph)

- G-1 Leak Site
- Trench Location
- Soil Boring
- ROC Monitoring Well
- 2003 Release

Plate 1 shows the location of the Abo 1-G site relative to Lovington, New Mexico. Plate 2 is an aerial photograph of the site. Plate 3 shows locations of all subsurface investigations (borings, trenches, and moisture ports) and installed clay caps relative to the release boundaries.

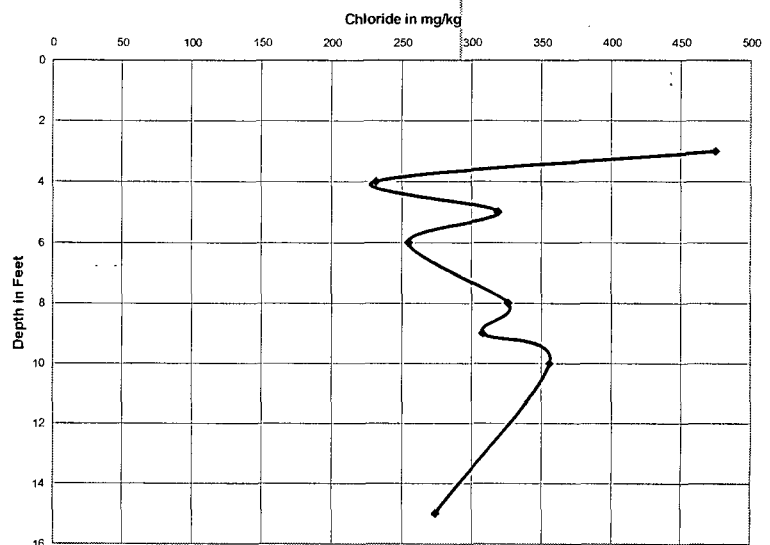
Figure 2. SB-2 Field Chloride concentrations

Soil boring SB-2 is uphill from the spill site and we considered this a "background" location, however the term "ambient" is more accurate. At this soil boring, the chloride near the ground surface is 475 ppm. From 4-feet below grade to the total
