RE: PNM Star Lake Natural Gas Compressor Station (GW-263) – Corrective Action Work Plan for Soil Impacted by Compressor Oil; McKinley County, NM;

**CORRECTIVE ACTION CLOSURE REPORT
FORMER CLARK COMPRESSOR BUILDING
STAR LAKE COMPRESSOR STATION**

**NW ¼ of SEC. 34, T 20N, R6W
McKinley County, New Mexico**

Date Issued: January 27, 2008

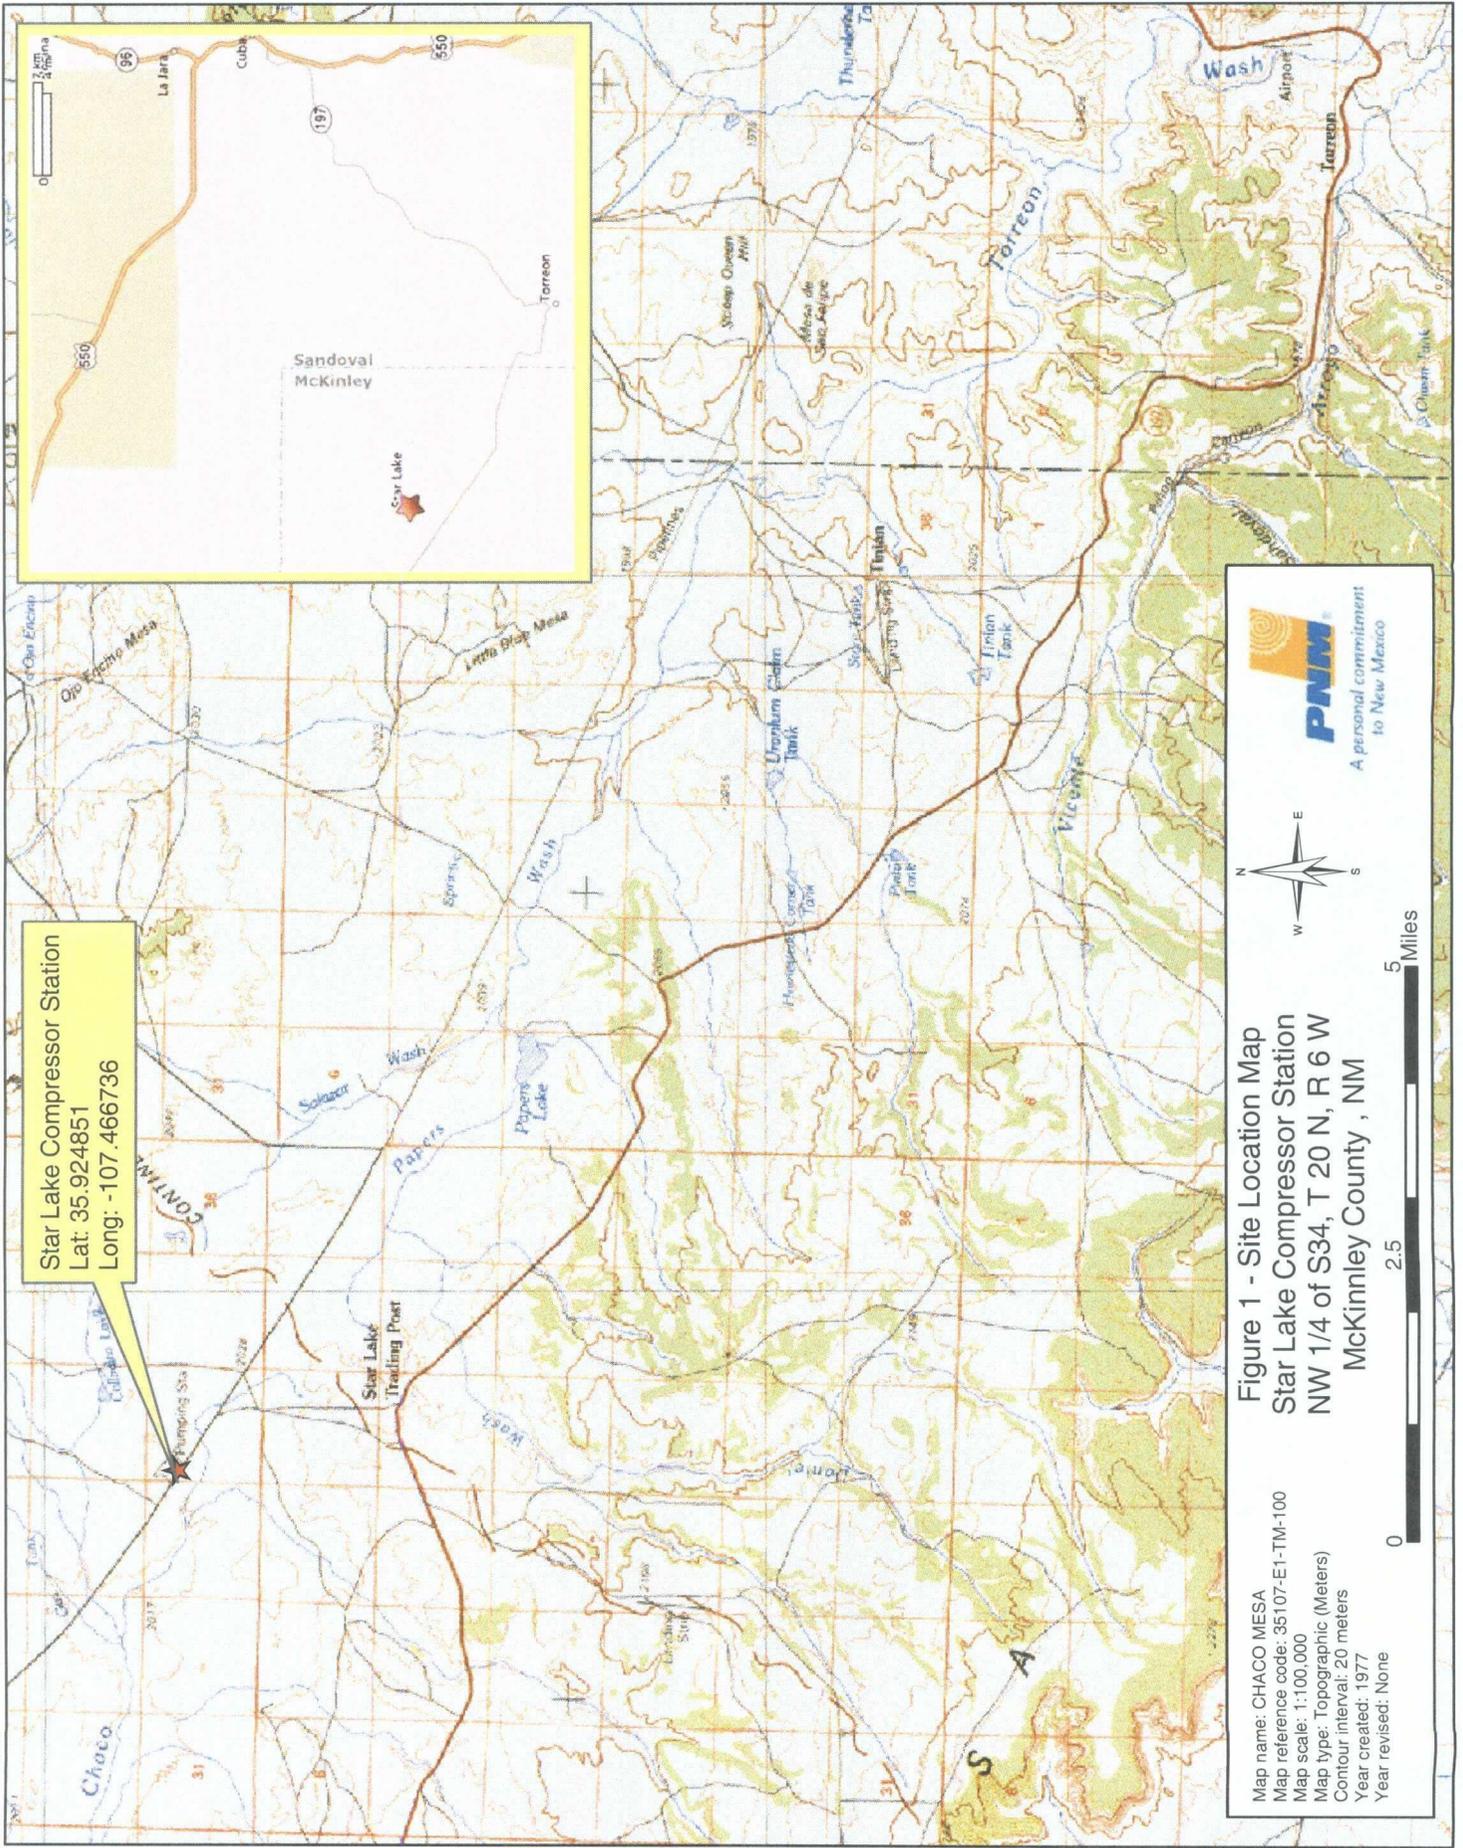
Figure 1 - Site Location Map
 Star Lake Compressor Station
 NW 1/4 of S34, T 20 N, R 6 W
 McKinley County, NM

Star Lake Compressor Station
 Lat: 35.924851
 Long: -107.466736

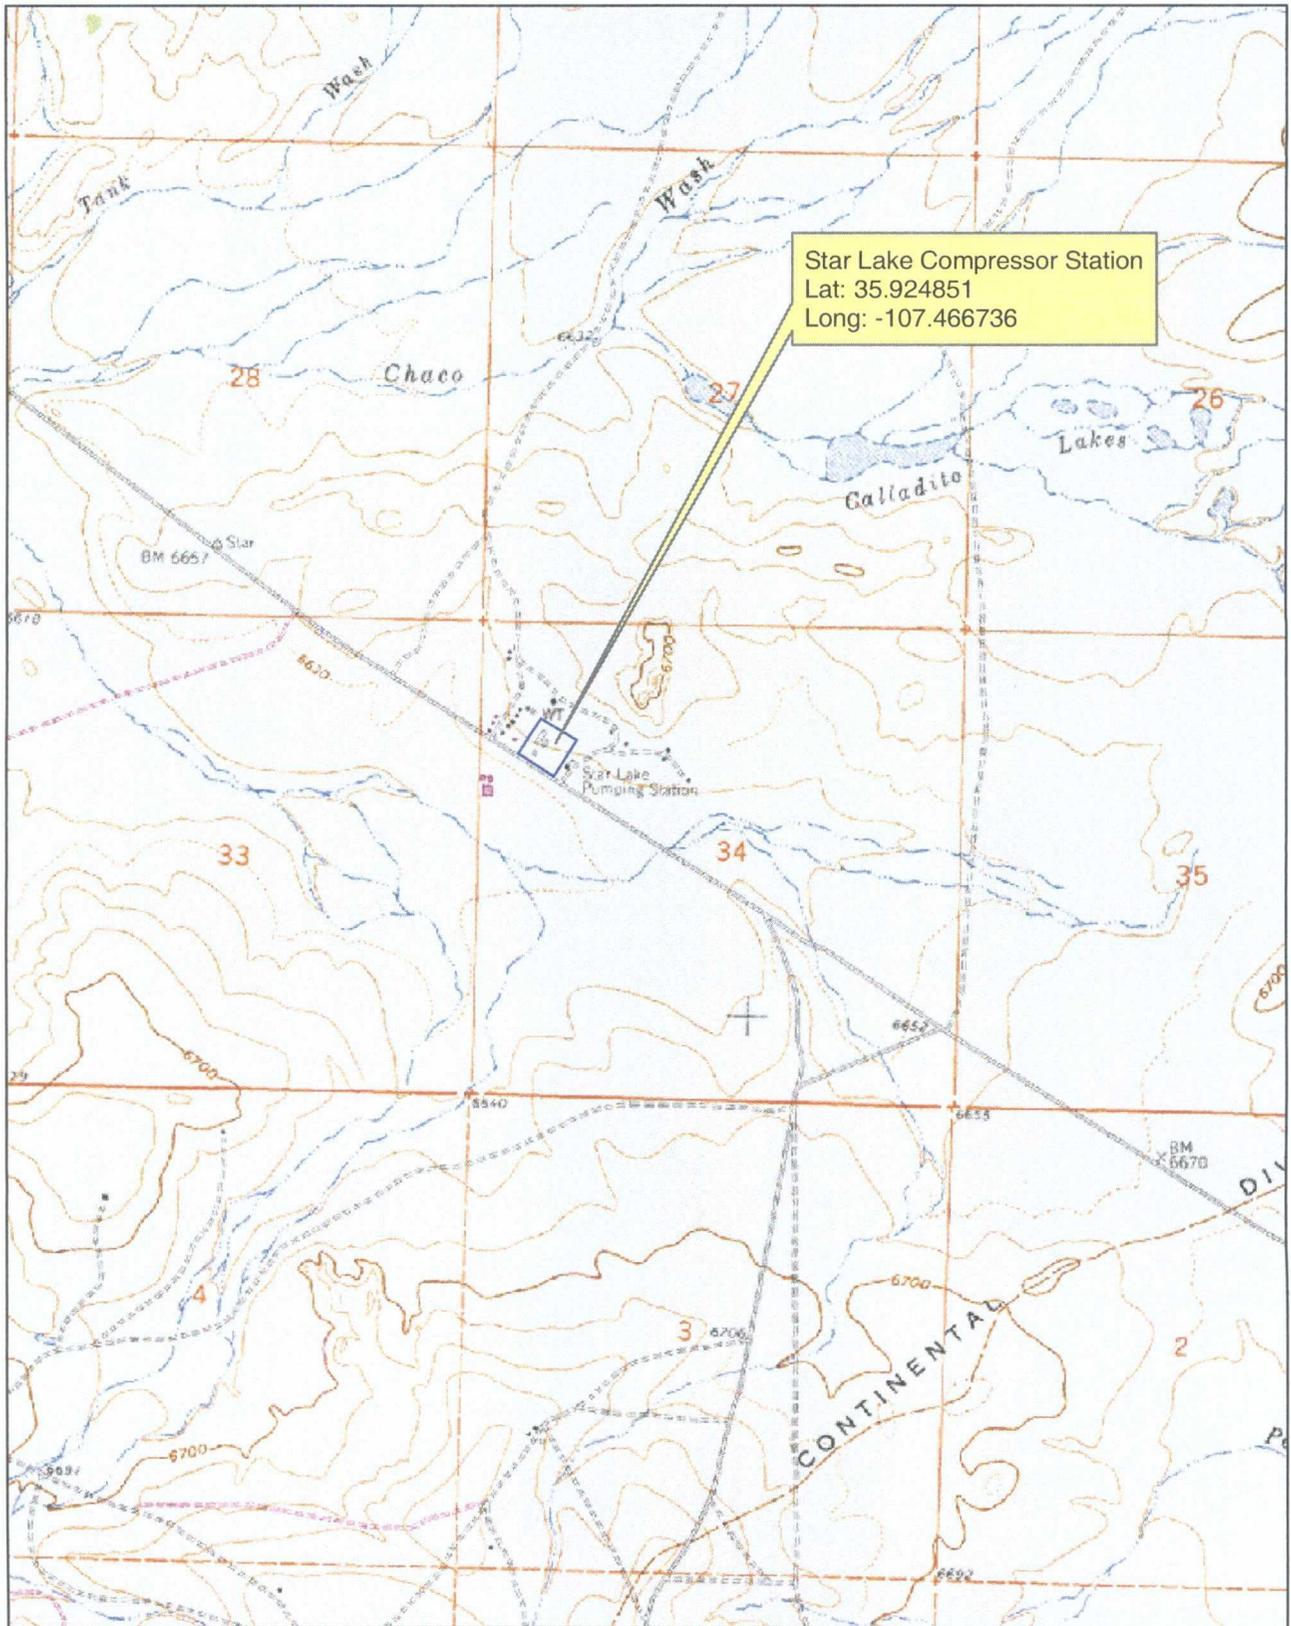
Figure 2 - Site Topographic Map
 Star Lake Compressor Station
 NW 1/4 of S34, T 20 N, R 6 W
 McKinley County, NM

Map name: STAR LAKE
 Map reference code: 35107-H4-TF-024
 Map scale: 1:24,000
 Map type: Topographic (Feet)
 Contour interval: 20 feet
 Year created: 1961
 Year revised: 1989

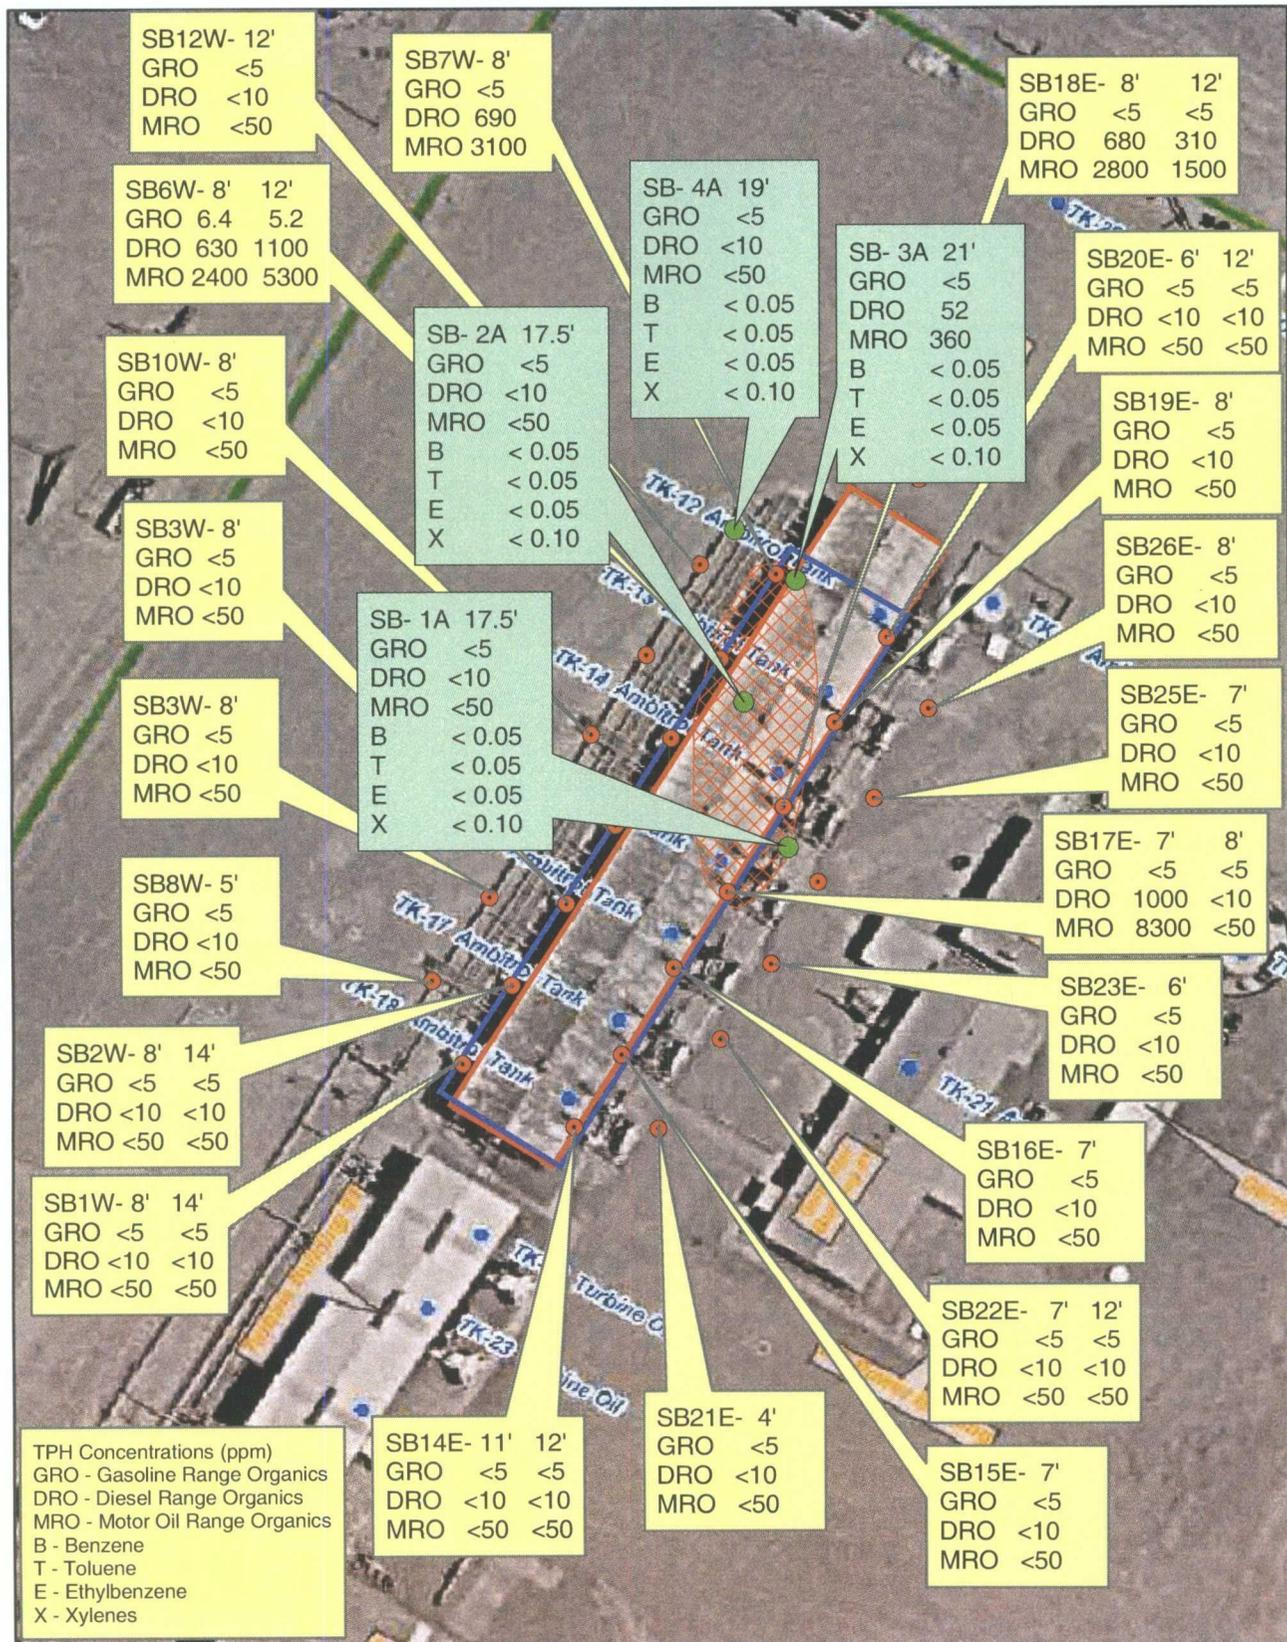
SITE AERIAL PHOTO WITH SOIL BORINGS/ANALYTICAL

- Soil Boring
- Compressor Bldg
- Contamination
- Excavation/Remediation
- Secondary Borings

On March 18, 2008, a Phase II Investigation was performed utilizing a direct push geoprobe. A total of twenty-six (26) soil borings were performed with samples collected in four foot intervals. The investigation was conducted on the east and west sides of the former Clark Compressor building (see Figure 3).

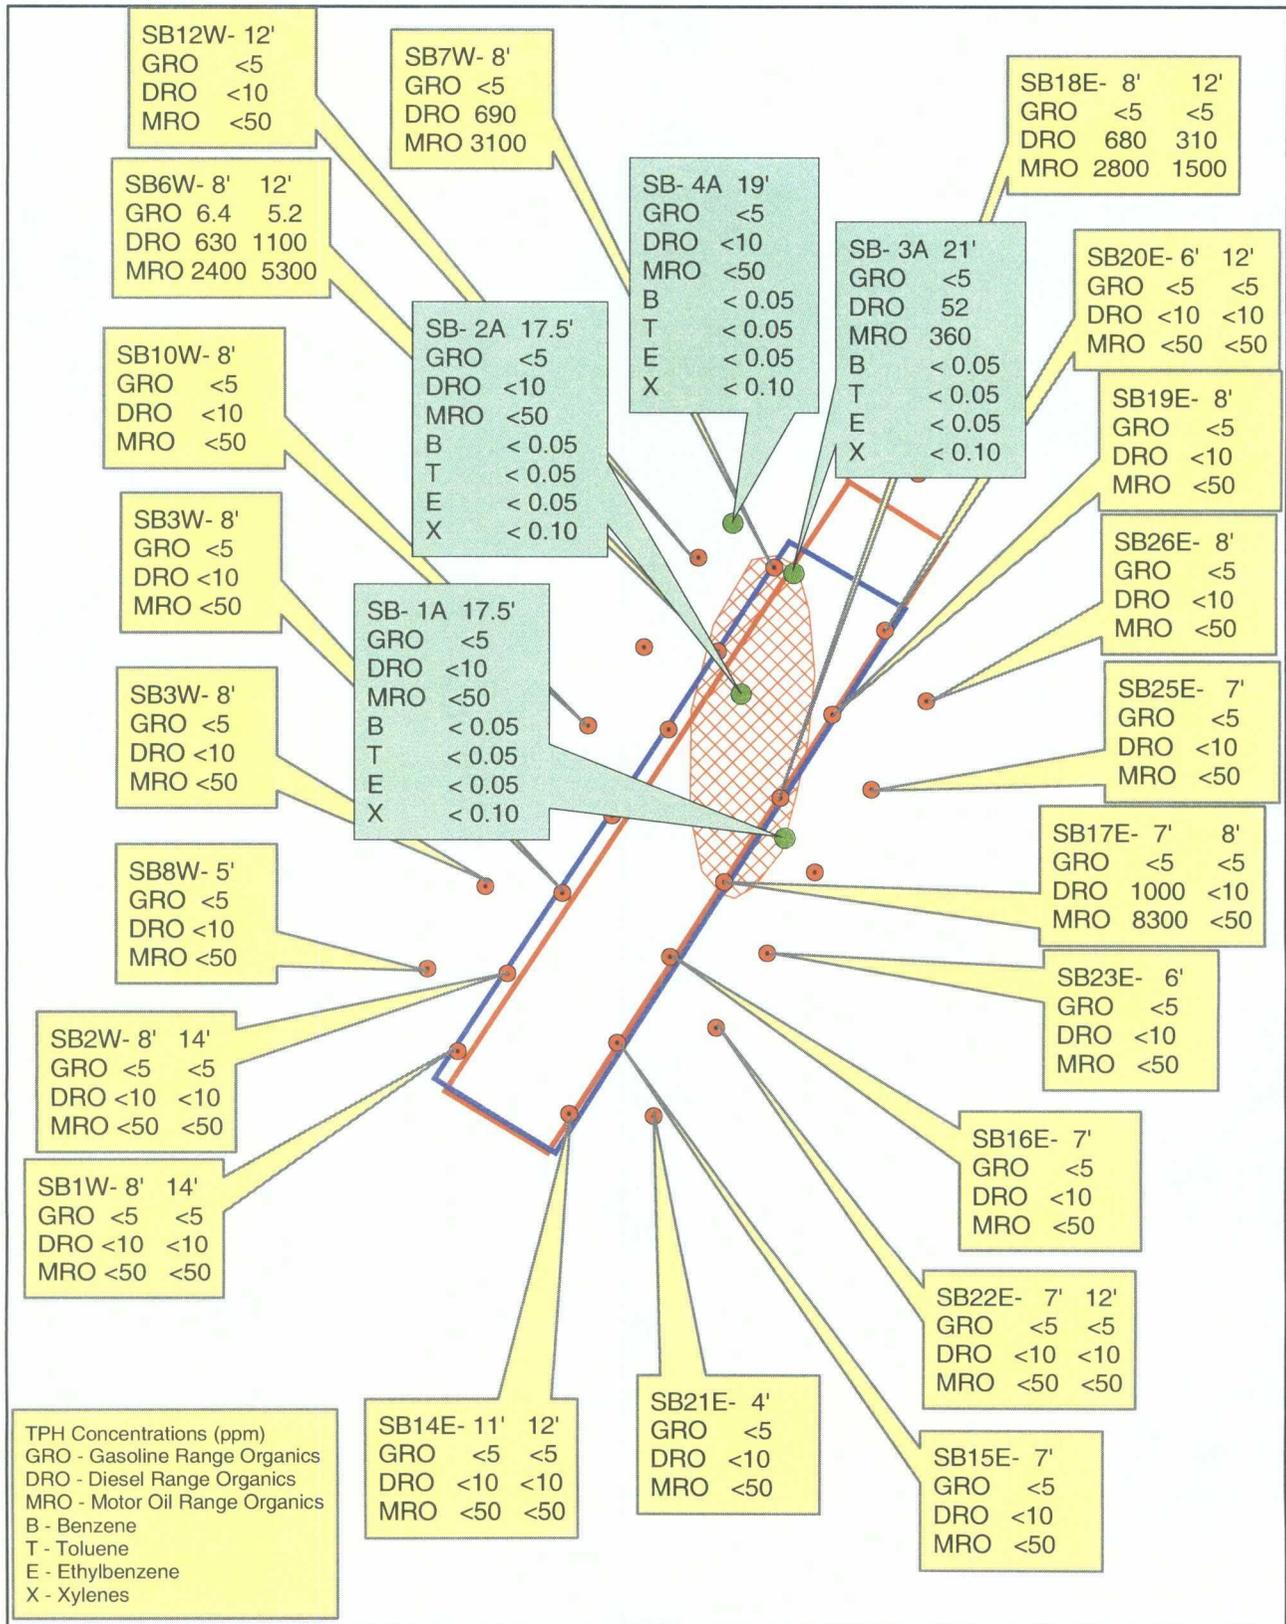
SITE MAP WITH SOIL BORINGS/ANALYTICAL

- Soil Boring
- ▭ Compressor Bldg
- ▨ Contamination
- ▭ Excavation/Remediation
- Secondary Borings

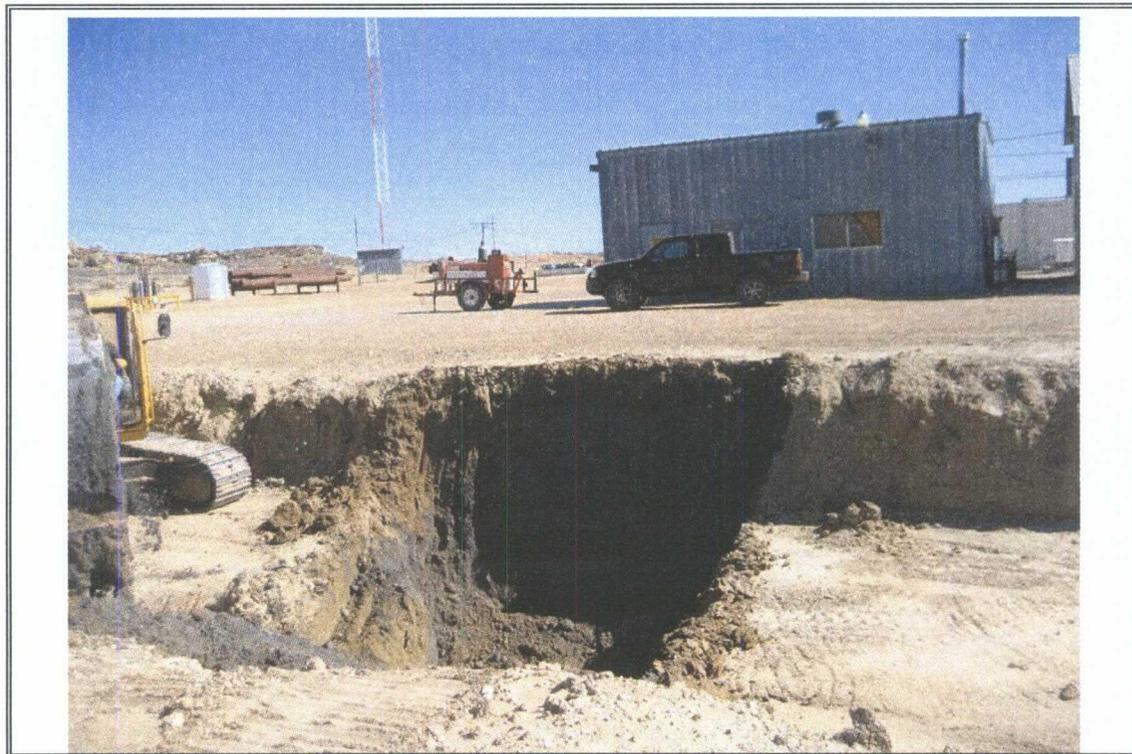
Photograph Number 1: View of remediation along east wall of former Clark building.

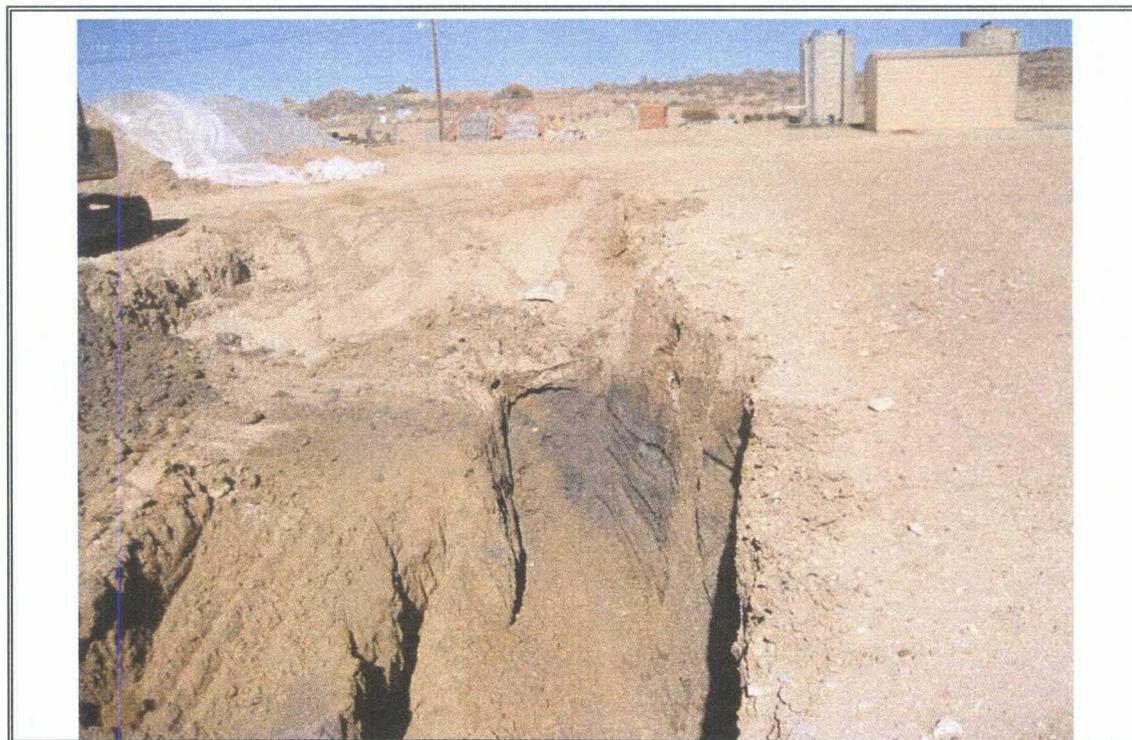
Photograph Number 2: View to the north of remediation along east wall of former Clark building.

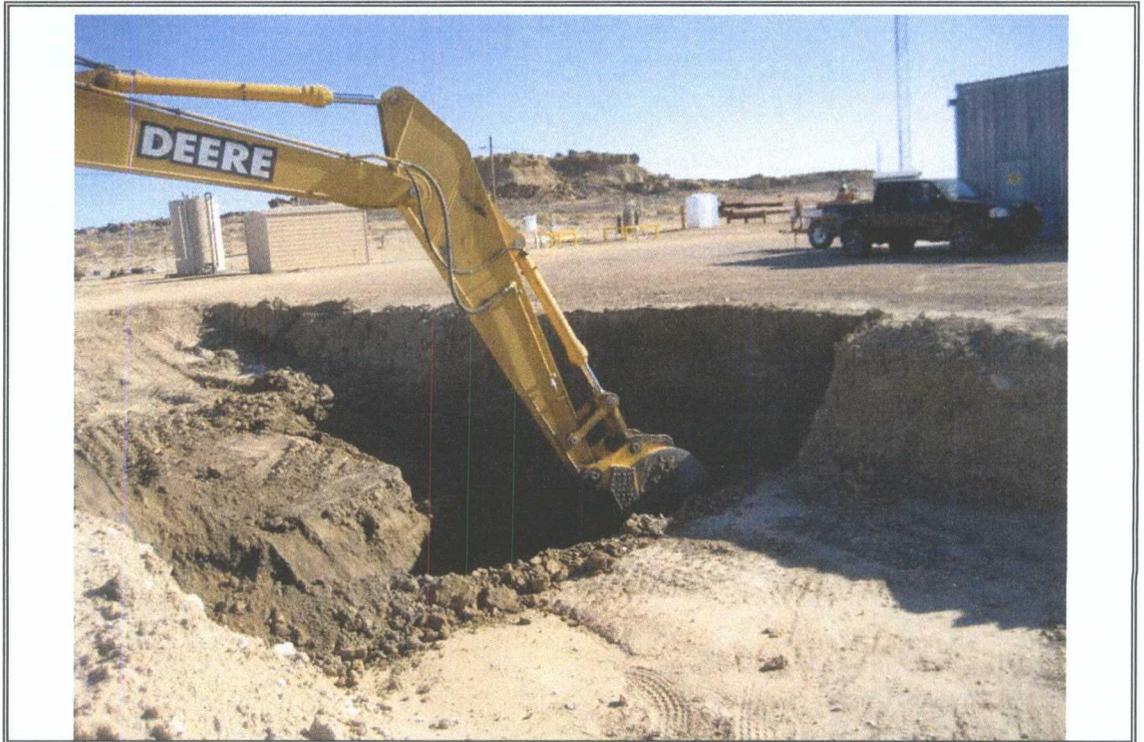
Photograph Number 3: View to the northeast of remediation along east wall of former Clark building

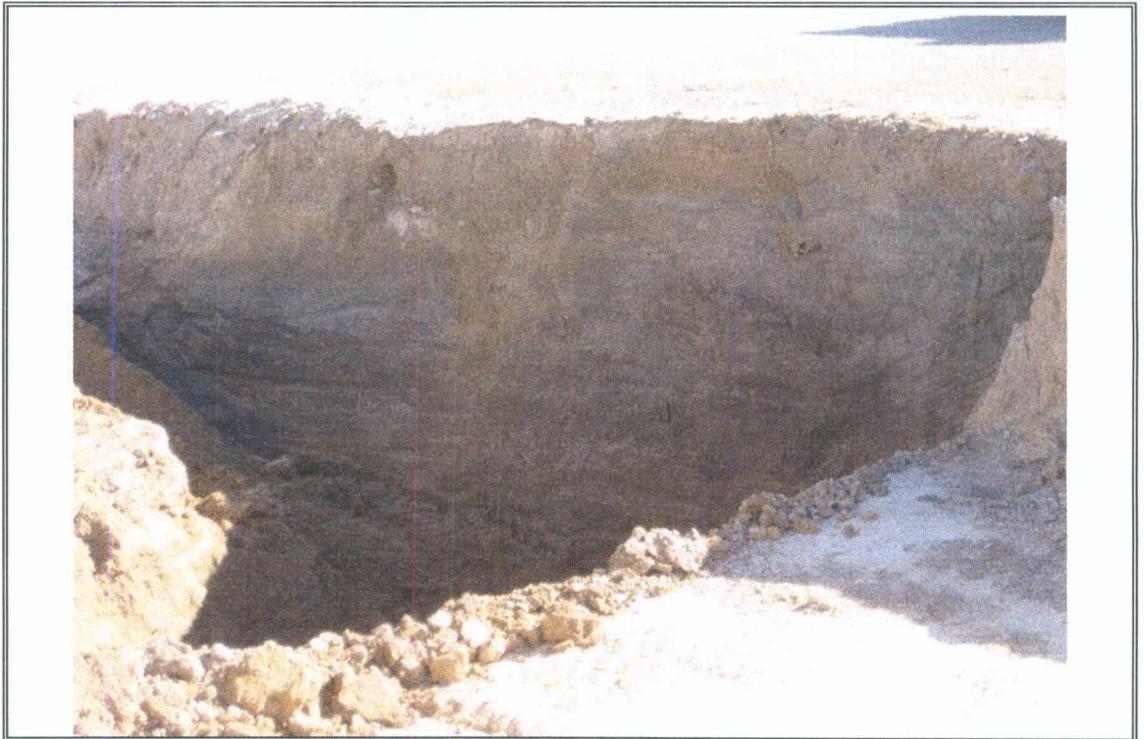
Photograph Number 4: View of east wall of former Clark building.

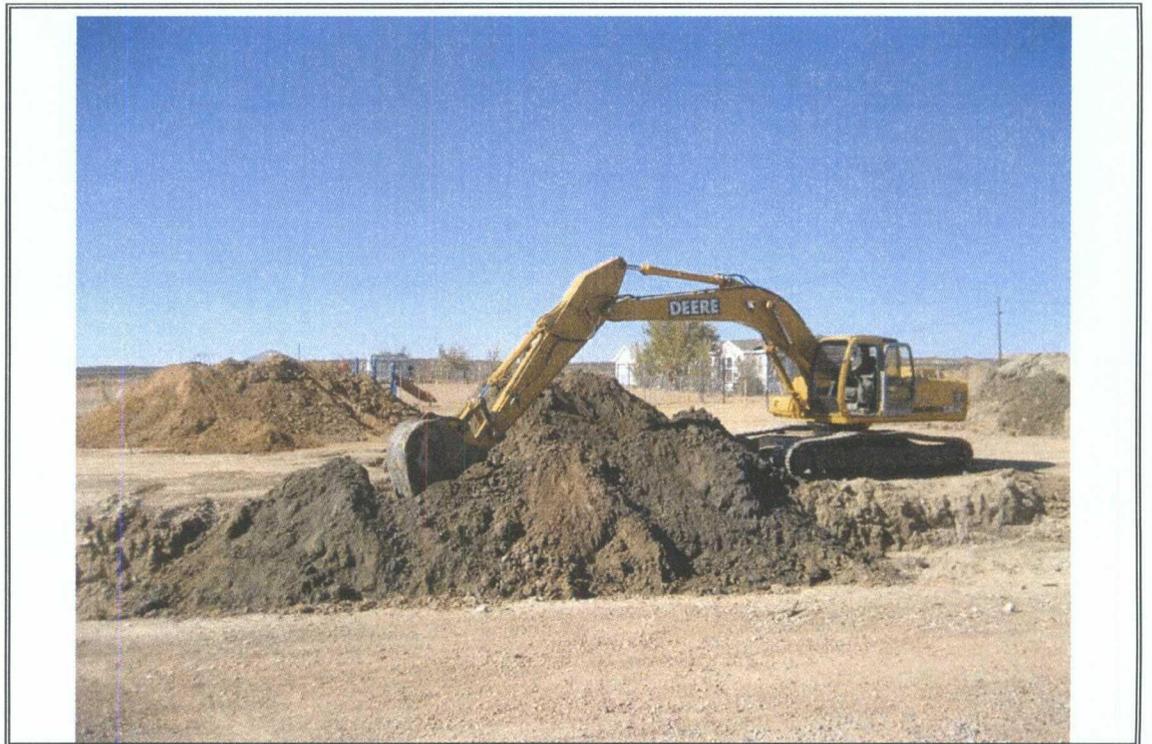
Photograph Number 5: View of contaminated soil staged west of the former Clark building.

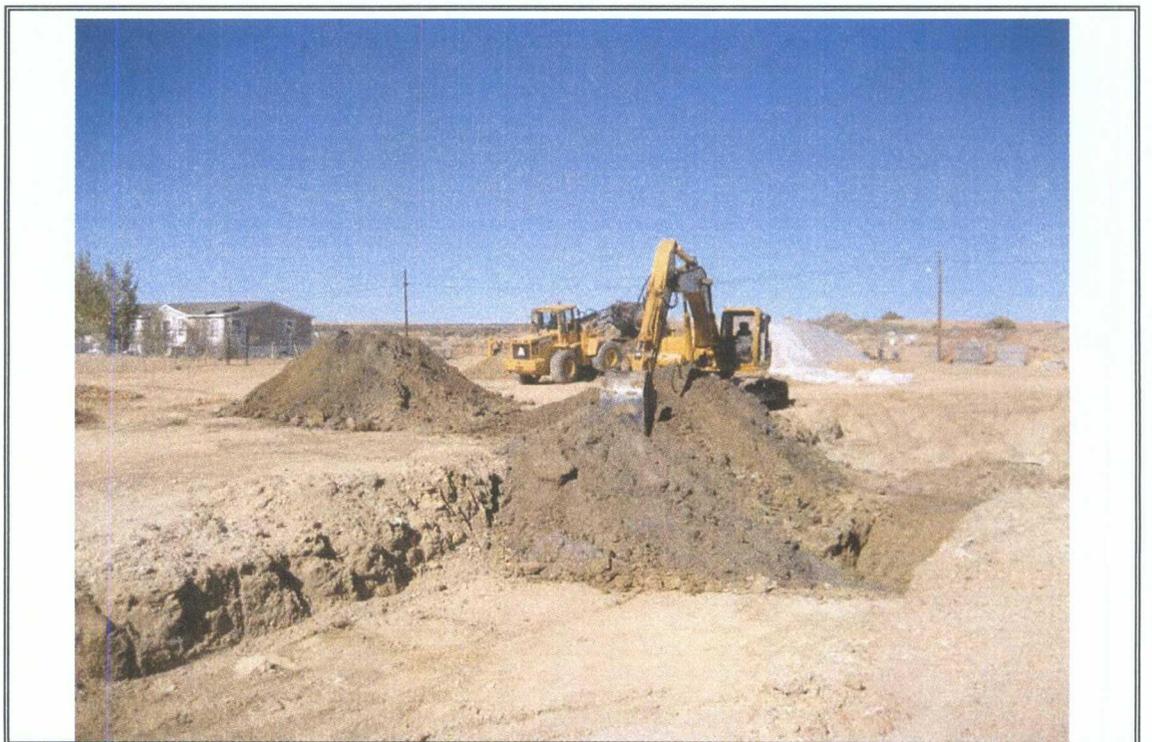
Photograph Number 6: View of contaminated soil staged west of the former Clark building.

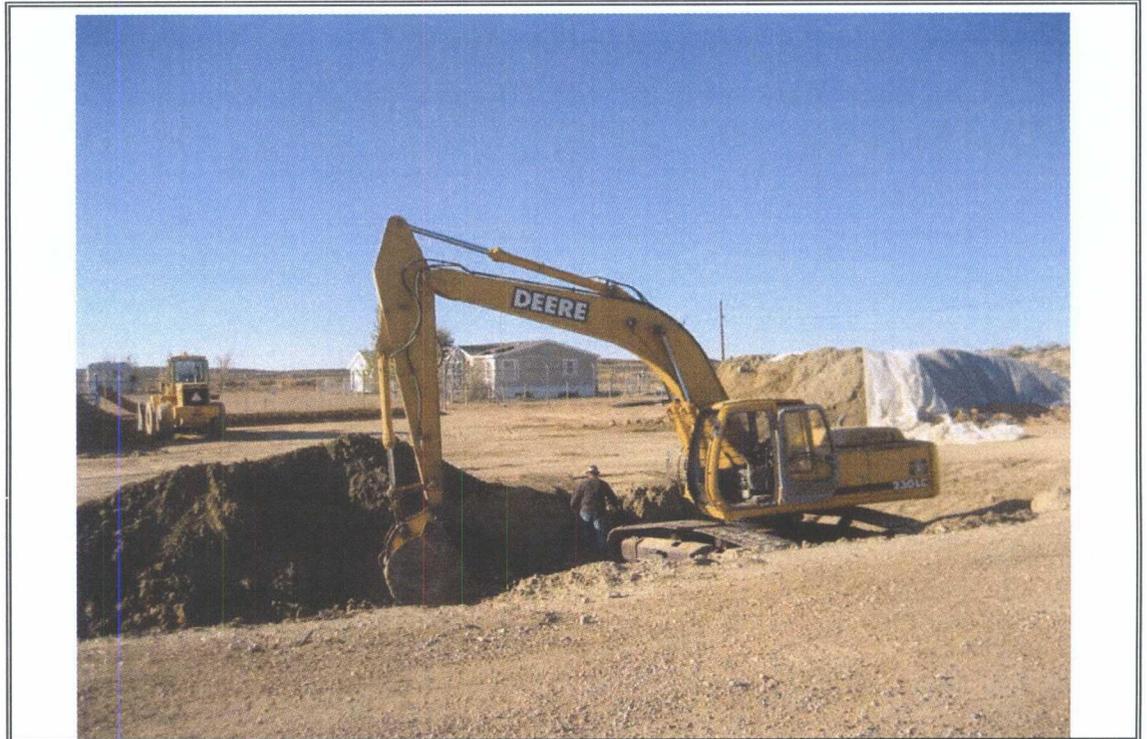
Photograph Number 7: View of remediation along the west wall of the former Clark building.

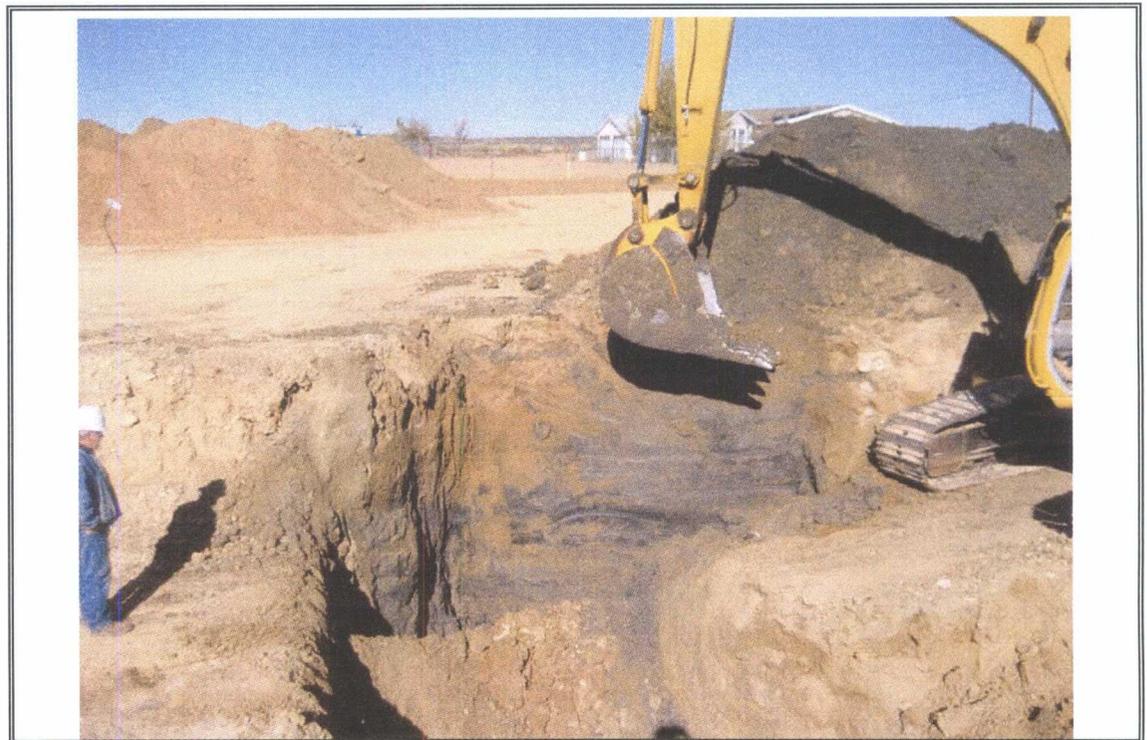
Photograph Number 8: View of remediation along the west wall of the former Clark building.

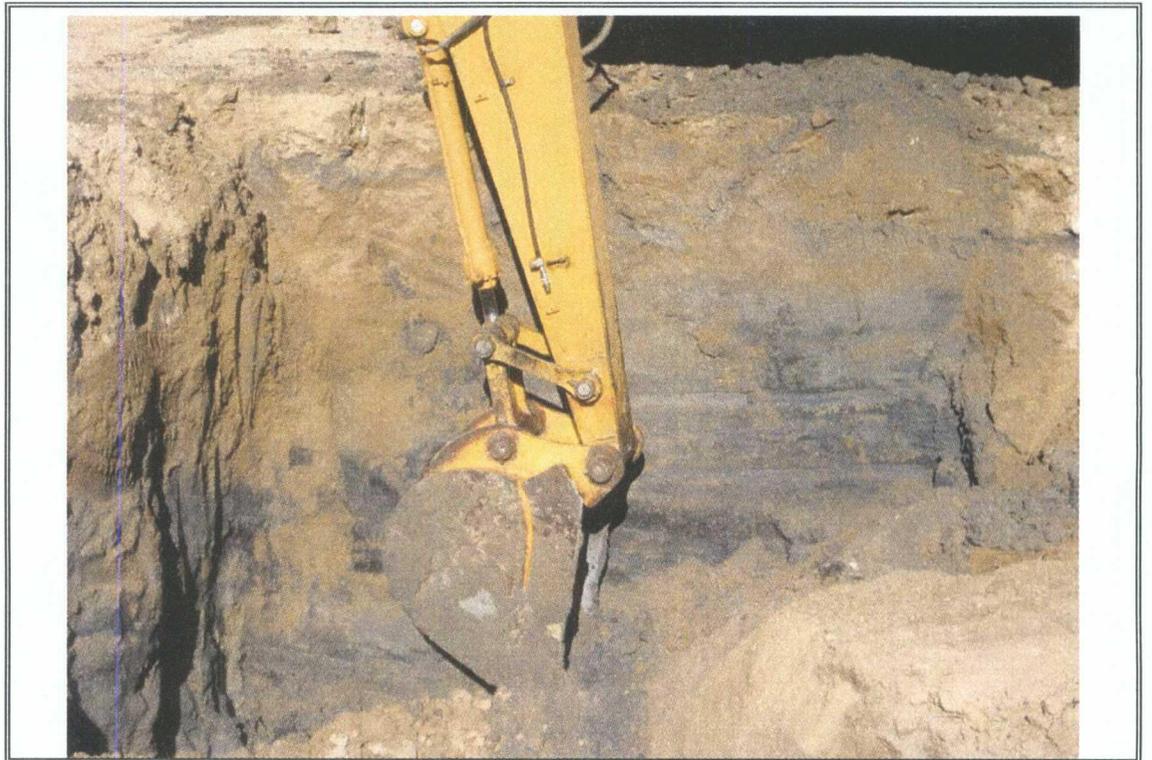
Photograph Number 9: View of remediation along the west wall of the former Clark building.

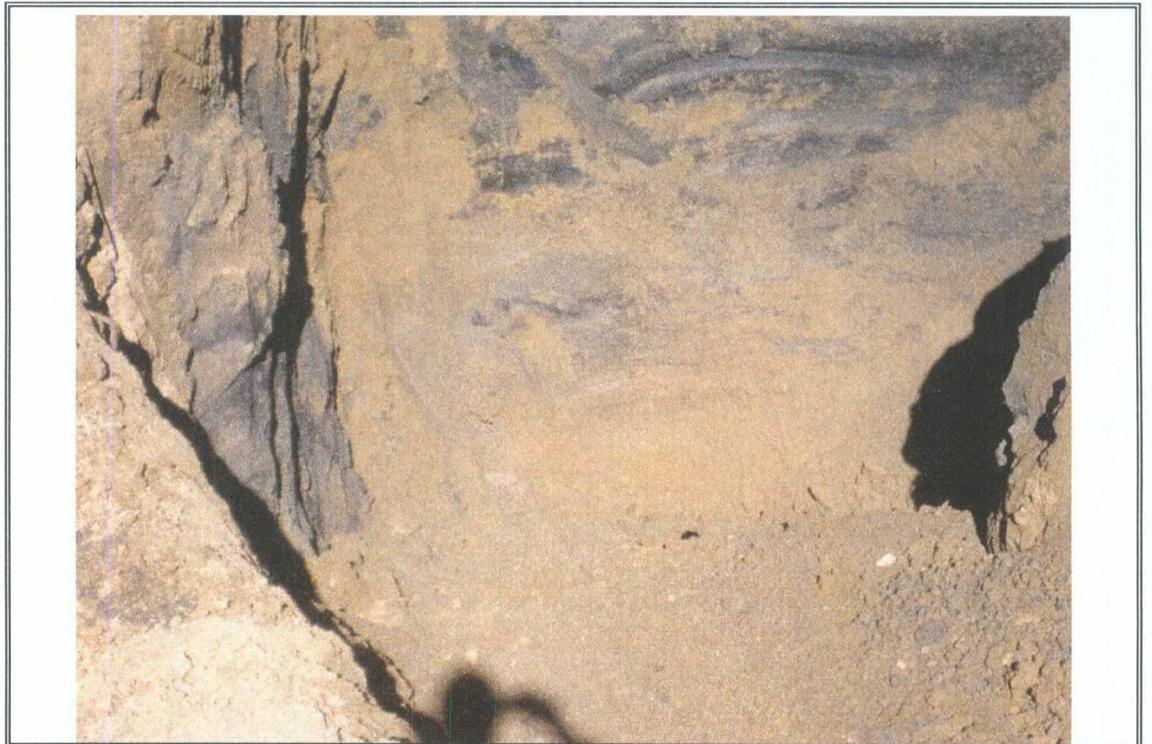
Photograph Number 10: View of remediation along the west wall of the former Clark building at a depth of 15-feet below ground surface.

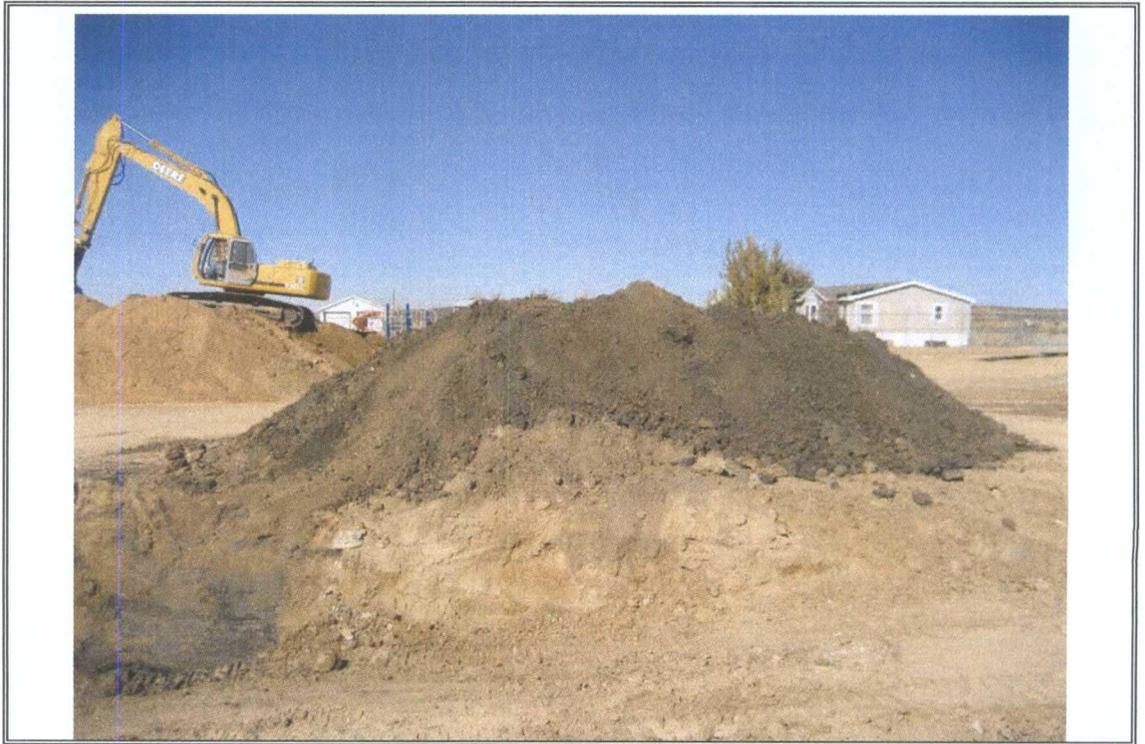
Photograph Number 11: View of contaminated soil staged for transport to TNT Land Farm.

During the week of October 27 through October 31, 2008, the contaminated soil was hauled to T-n-T Environmental Inc in Lindrieth, NM. A track hoe excavator was used to perform additional source removal in the area identified with high TPH concentration in the soil. Clean backfill was trucked to the Star Lake facility to fill in the void from the concrete foundation and soil remediation. Approximately 1000 cubic yards of contaminated soil were hauled to T-n-T for disposal. Prior to hauling, a C138 form requesting approval to accept the waste was submitted to T-n-T. Each truck load was tested in the field for chlorides prior to acceptance. Copies of the commercial landfarm haul tickets are provided as attachment in Appendix C.

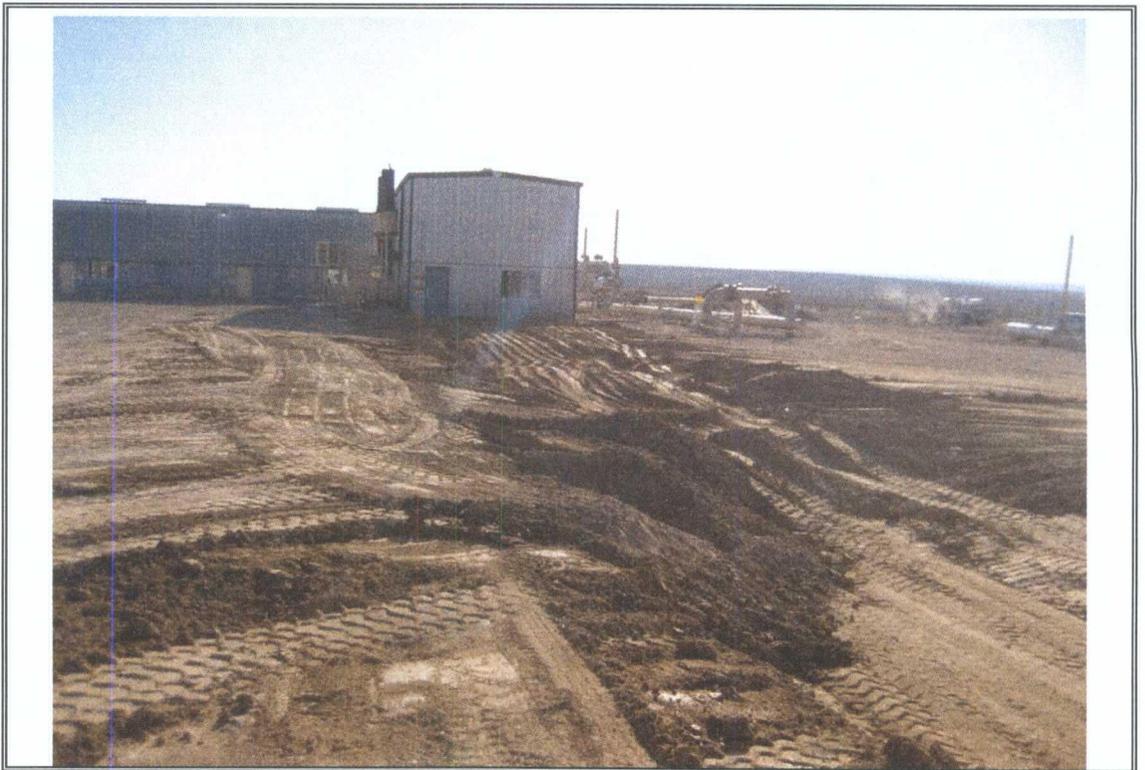
Photograph Number 12: View of the former Clark building in process of backfilling.

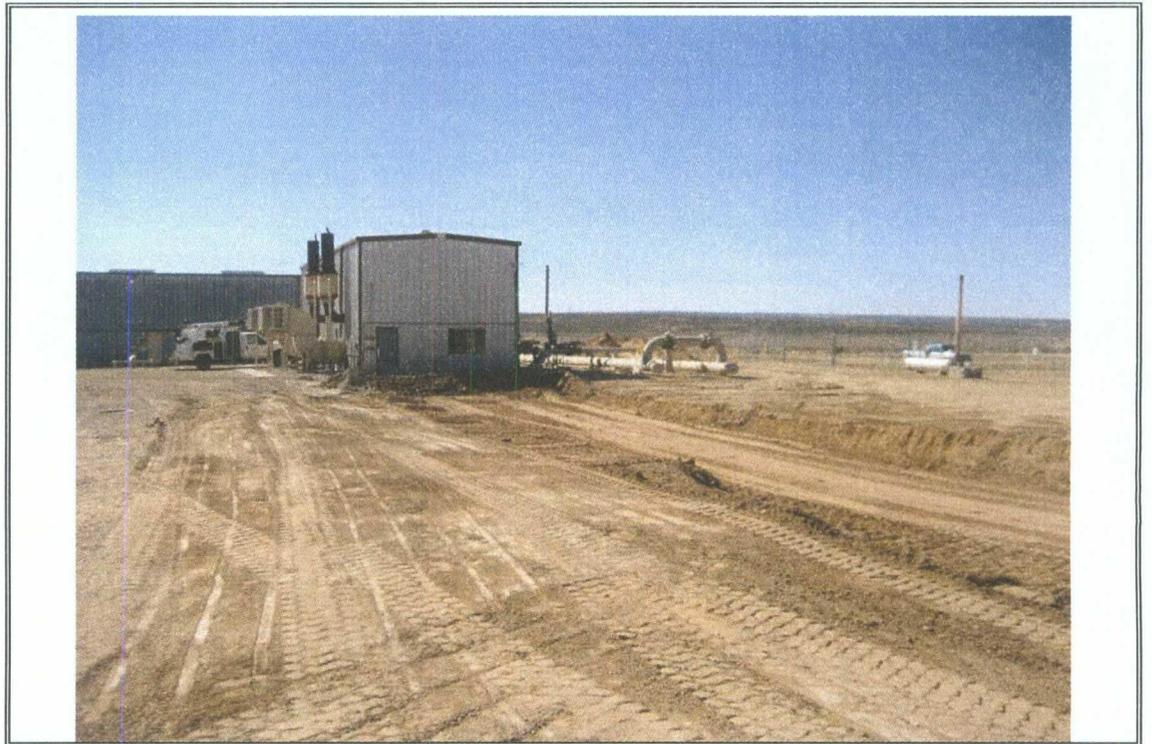
Photograph Number 13: View of the former Clark building in process of backfilling.

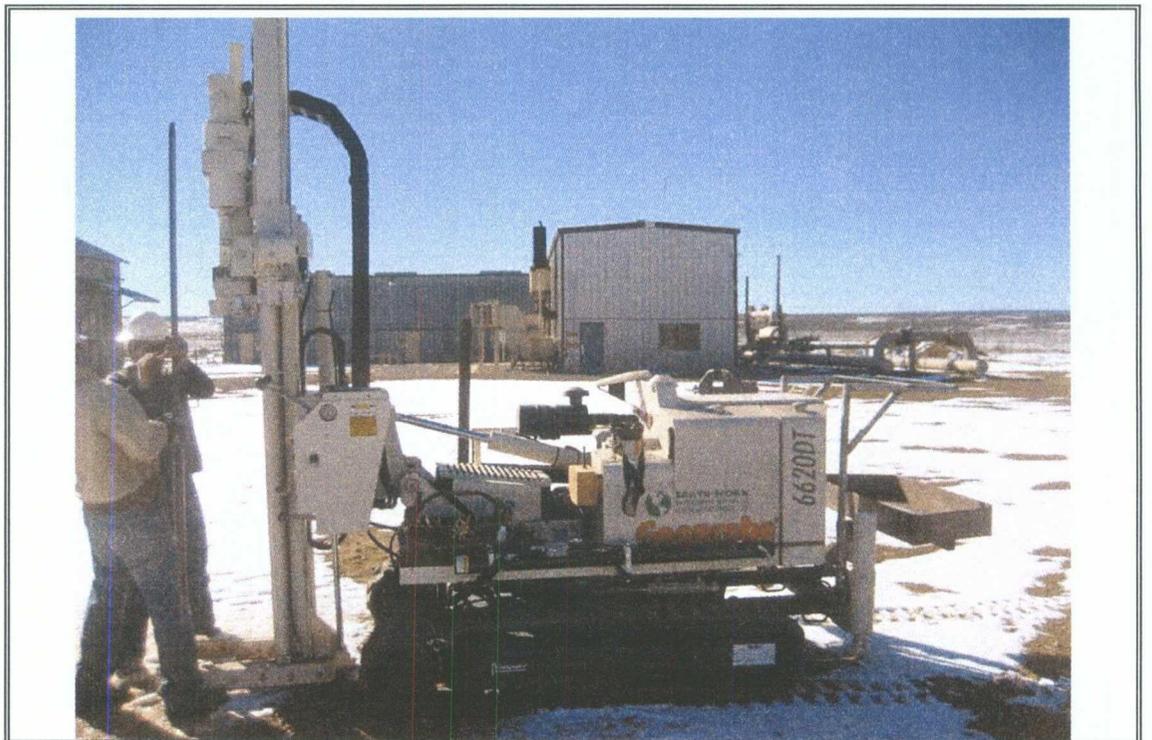
Photograph Number 14: View to the south of geo probe direct push unit performing soil borings.

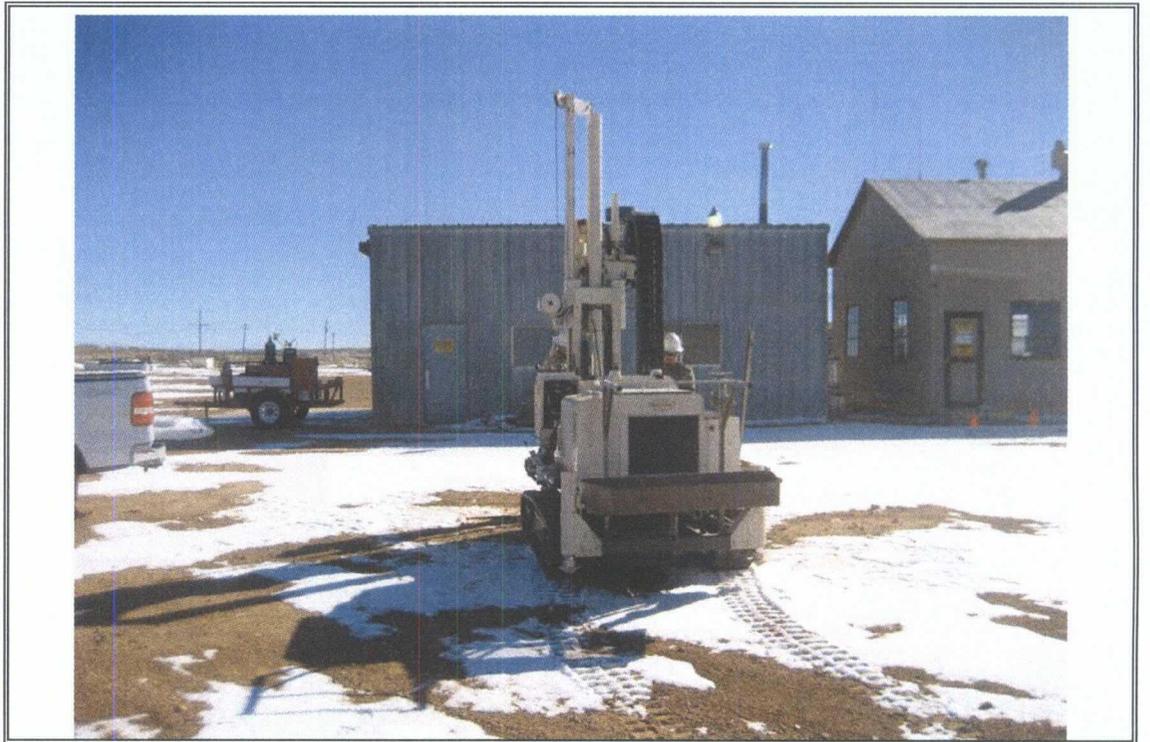
Photograph Number 15: View to the east of geo probe direct push unit performing soil borings
