RE: PNM Star Lake Natural Gas Compressor Station (GW-263) – Corrective Action Work Plan for Soil Impacted by Compressor Oil; McKinley County, NM;

**CORRECTIVE ACTION CLOSURE REPORT
FORMER CLARK COMPRESSOR BUILDING
STAR LAKE COMPRESSOR STATION**

**NW ¼ of SEC. 34, T 20N, R6W
McKinley County, New Mexico**

Date Issued: January 27, 2008

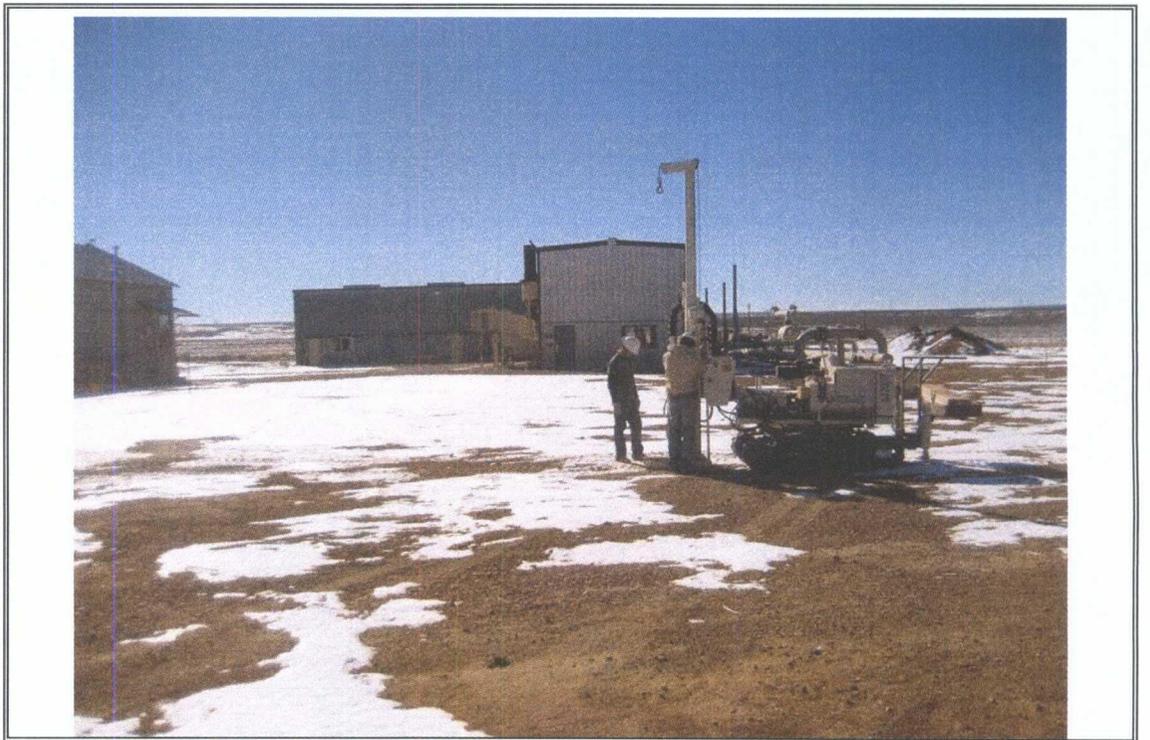
Photograph Number 16: View to the south of geo probe direct push unit performing soil borings.

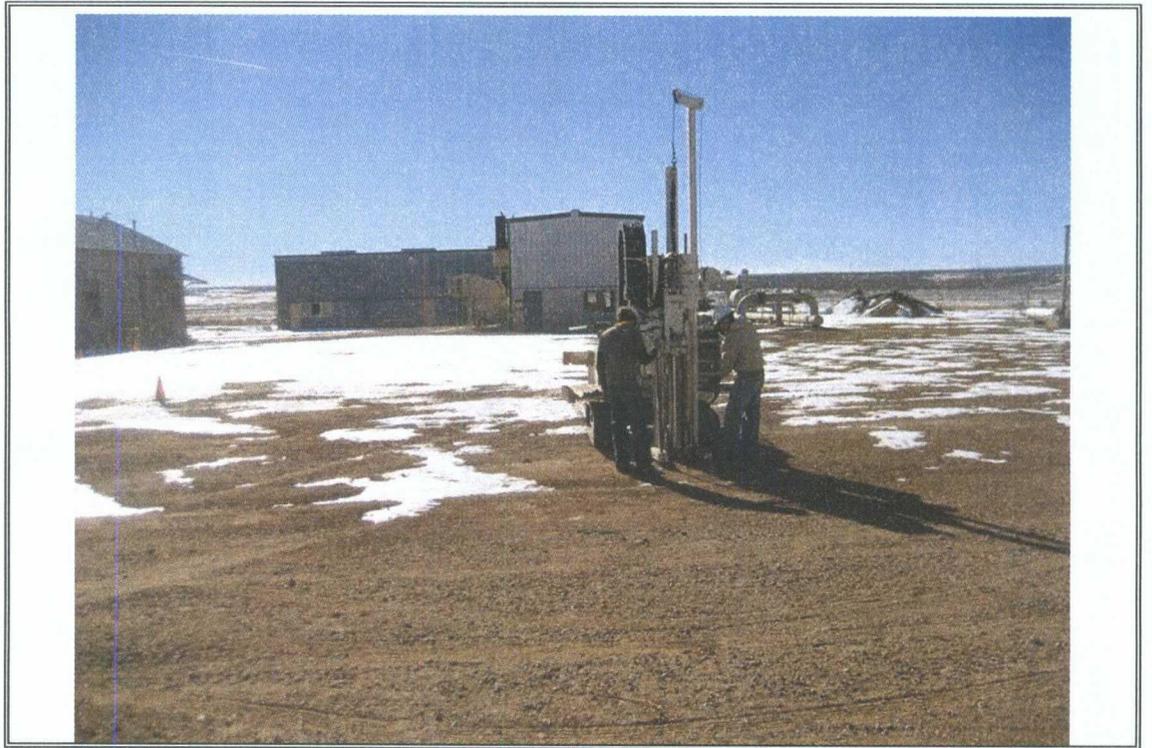
Photograph Number 17: View to the south of geo probe direct push unit performing soil borings.

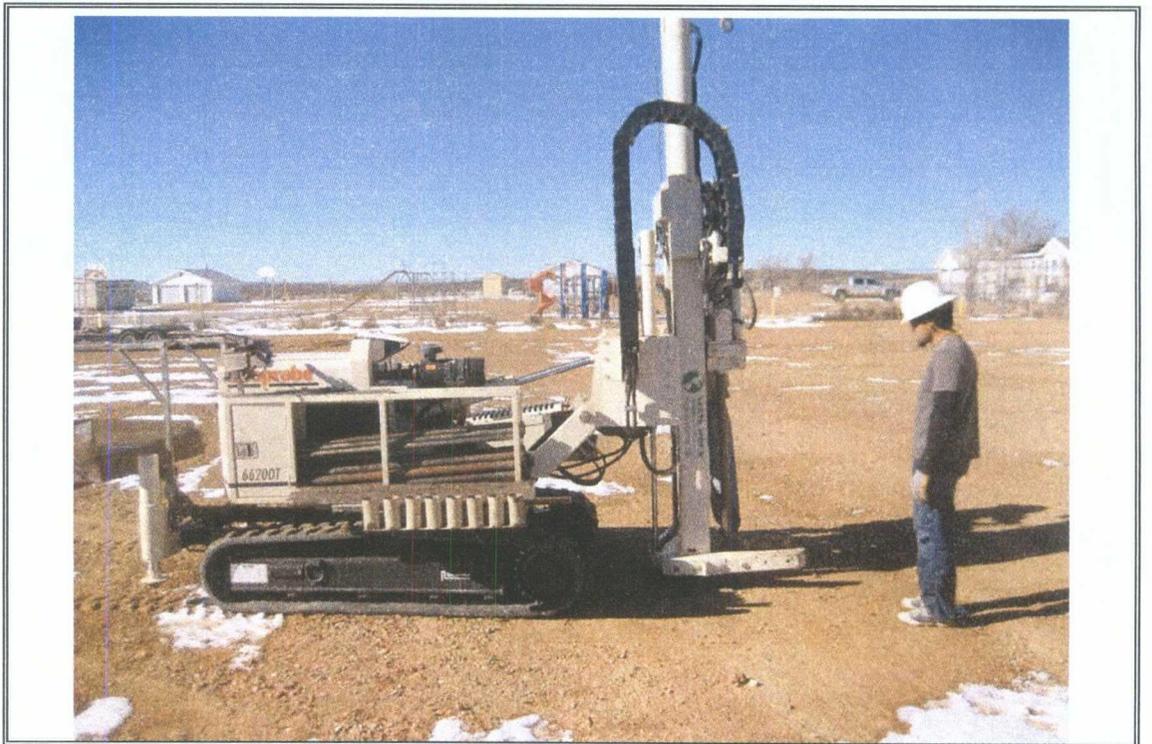
Photograph Number 18: View to the west of geo probe direct push unit performing soil borings

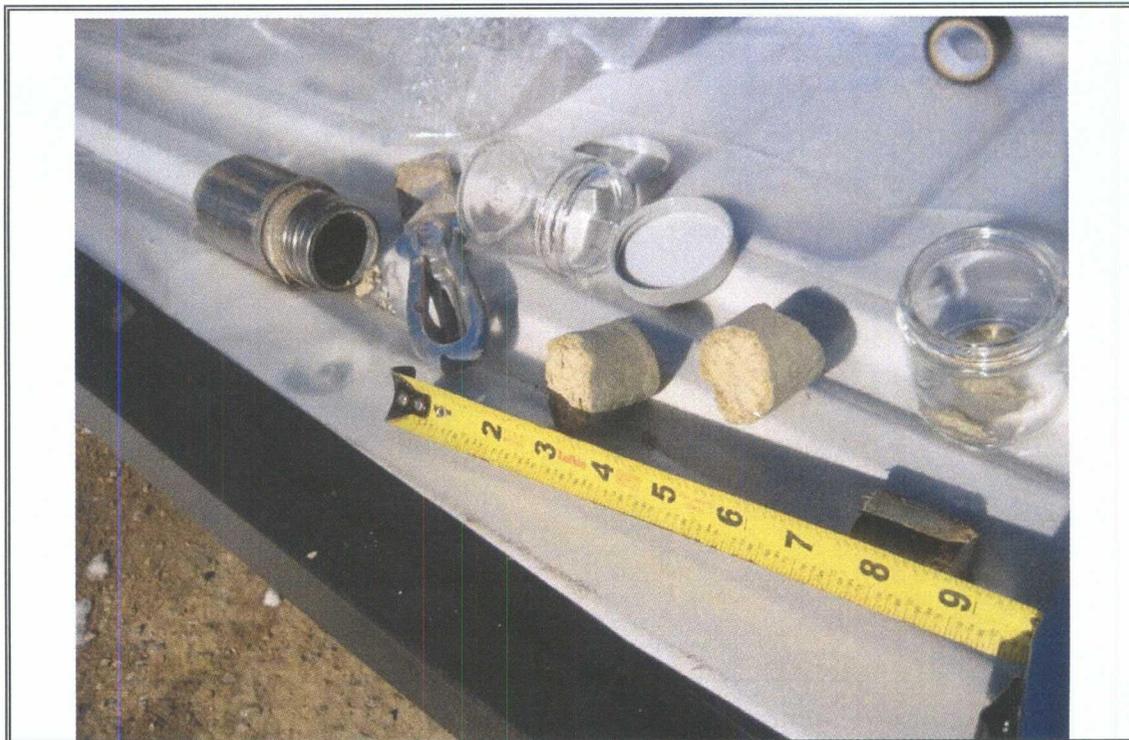
Photograph Number 19: View of sandstone encountered at approximately 17.5 feet below ground surface. The sand stone became harder at depth with geo probe refusal ranging from 17.5 to 21 feet below ground surface.

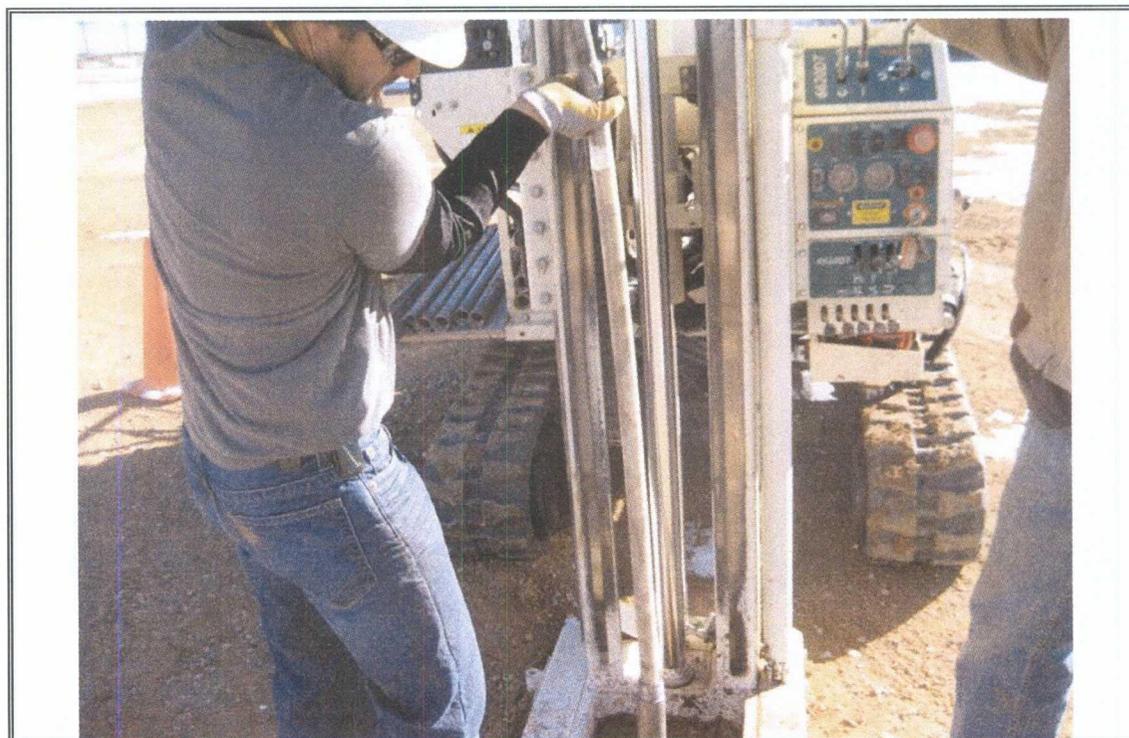
Photograph Number 20: View of polycarbonate sample core.

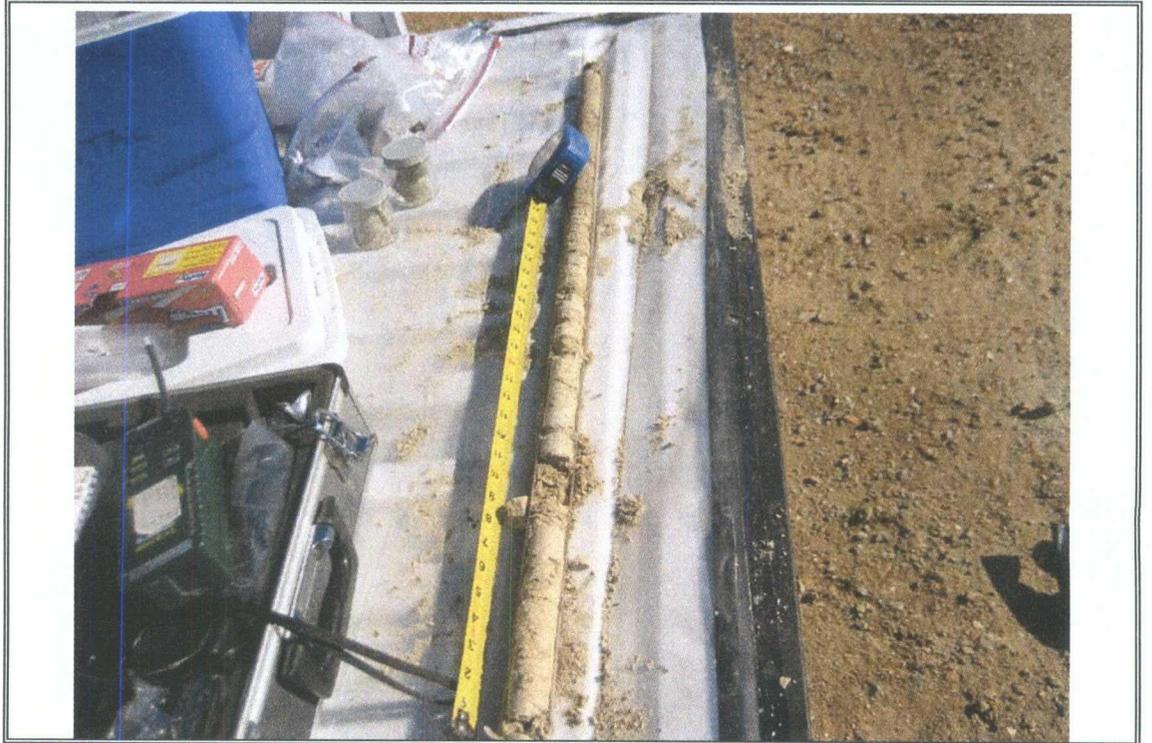
Photograph Number 21: View of polycarbonate sample core.

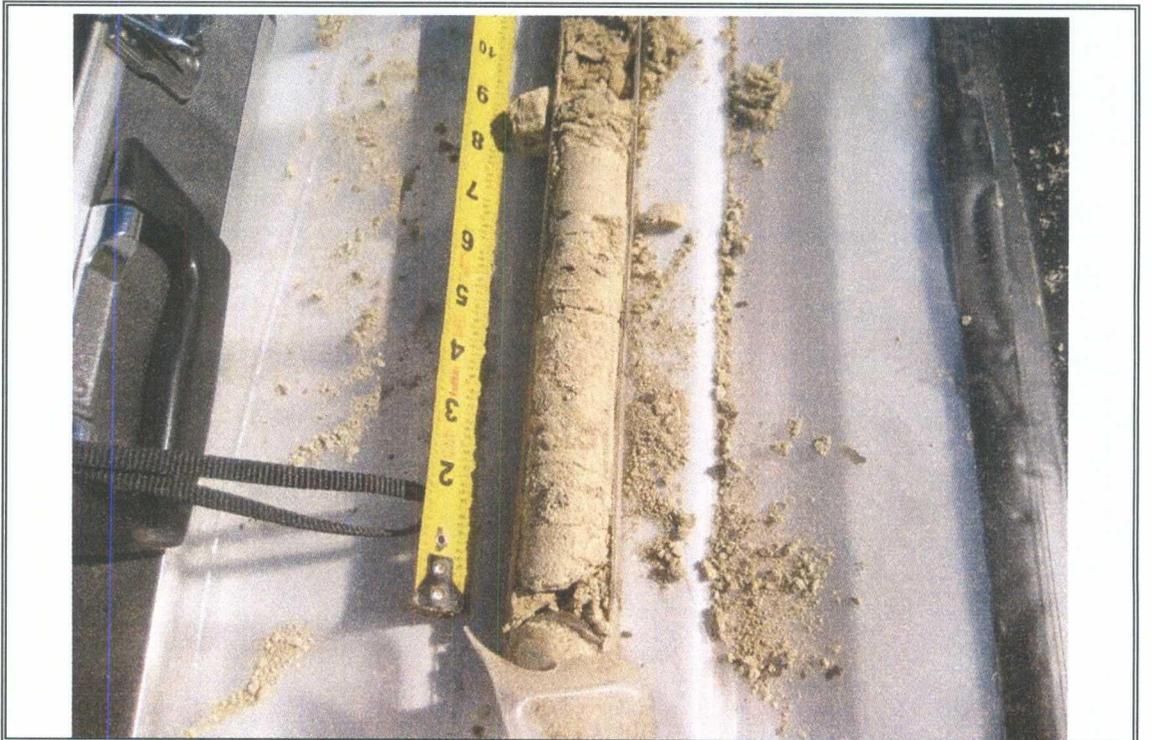
Photograph Number 22: View of polycarbonate sample core. Sandstone refusal occurred at approximately 18 to 21 feet below ground surface.

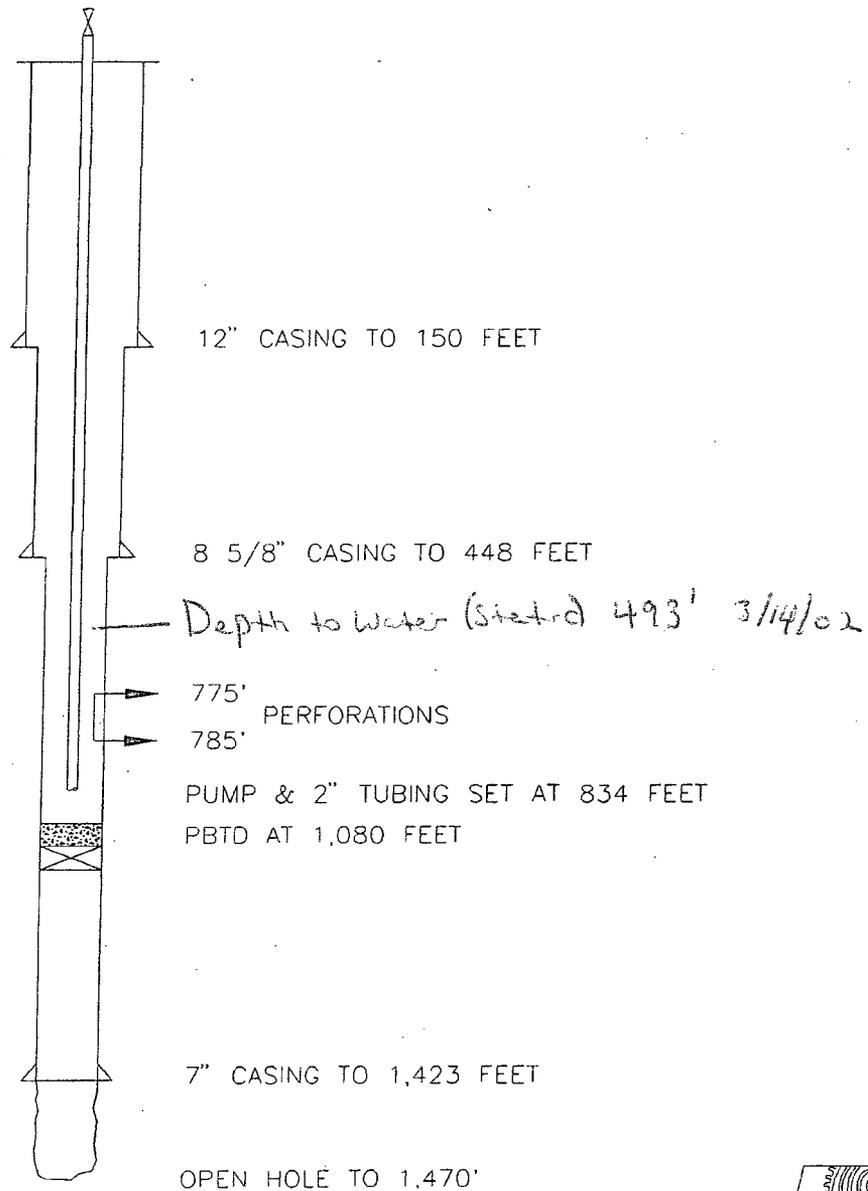
ACAD FILE #KL95-010 (SLWW-1)

STAR LAKE #1 WATER WELL
SEC. 34 , T20N , R06W - MCKINLEY CO. NEW MEXICO
ELEVATION 6920'
