Release Notification and Corrective Action

***Federal 34 #1  
Remediation Report***

***DAVID H. ARRINGTON OIL & GAS, INC.  
EDDY COUNTY, NEW MEXICO***

163-1724-000

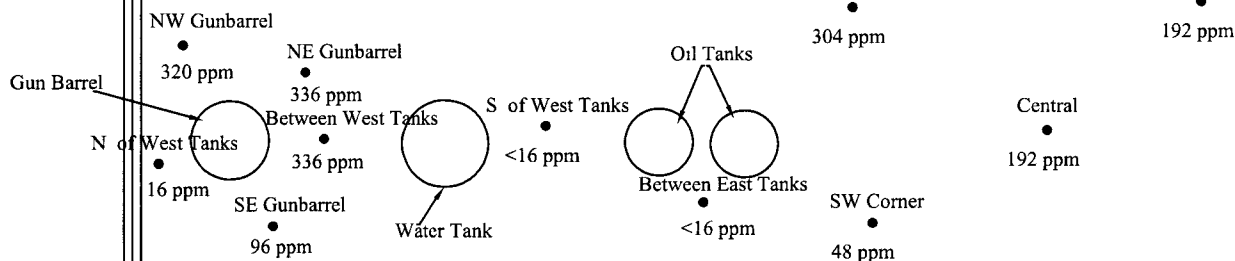
## Remediation Site Map

Wellhead

Free Water Knock Out Tank

Separator

Uphill Side of Location

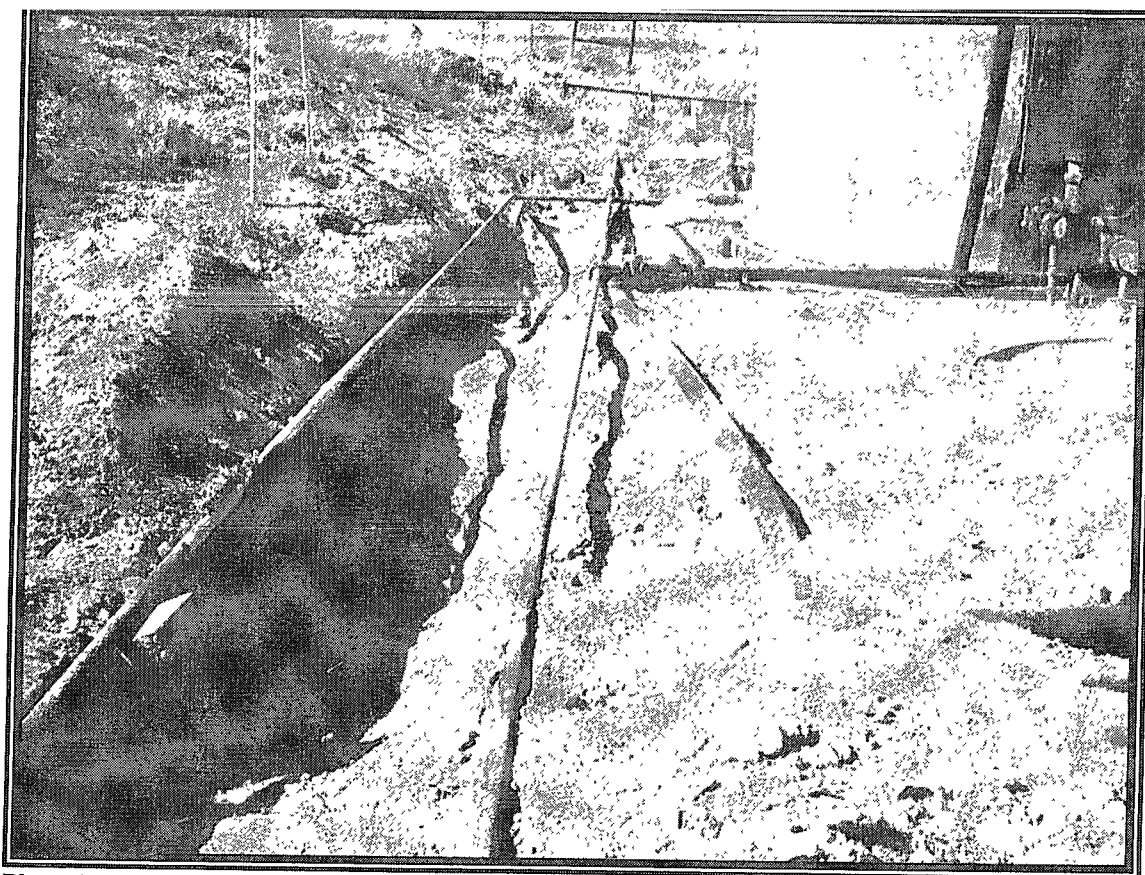
**Photo 1 - Backside of tank battery after excavation.**

Initial remediation activities were started at the site in October 27 2008. This phase of the remediation involved the excavation and stockpiling of the impacted soil. Impacted soil was excavated from around the storage tanks and all areas within the firewall of the tank battery. The excavation was completed until bedrock was encountered at approximately 2 to 3 feet in depth.

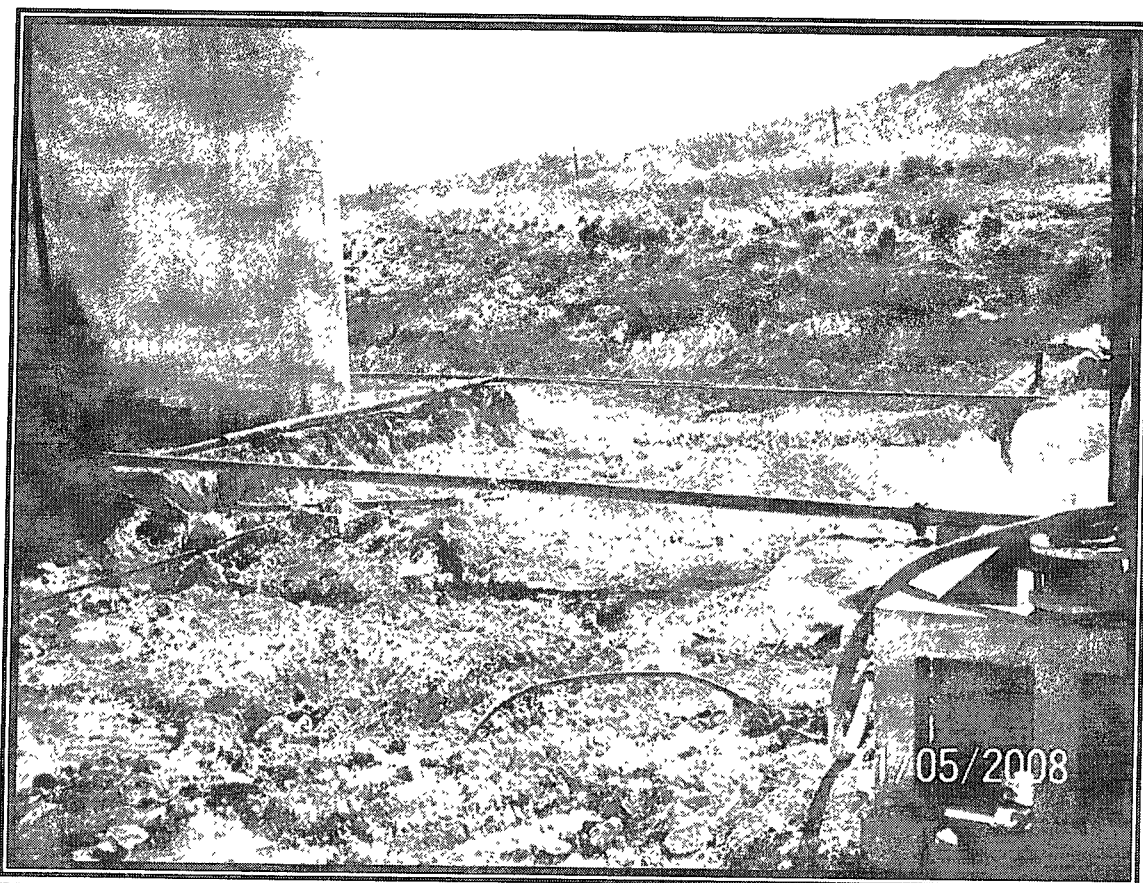
**Photo 2 - Between tanks after excavation.**

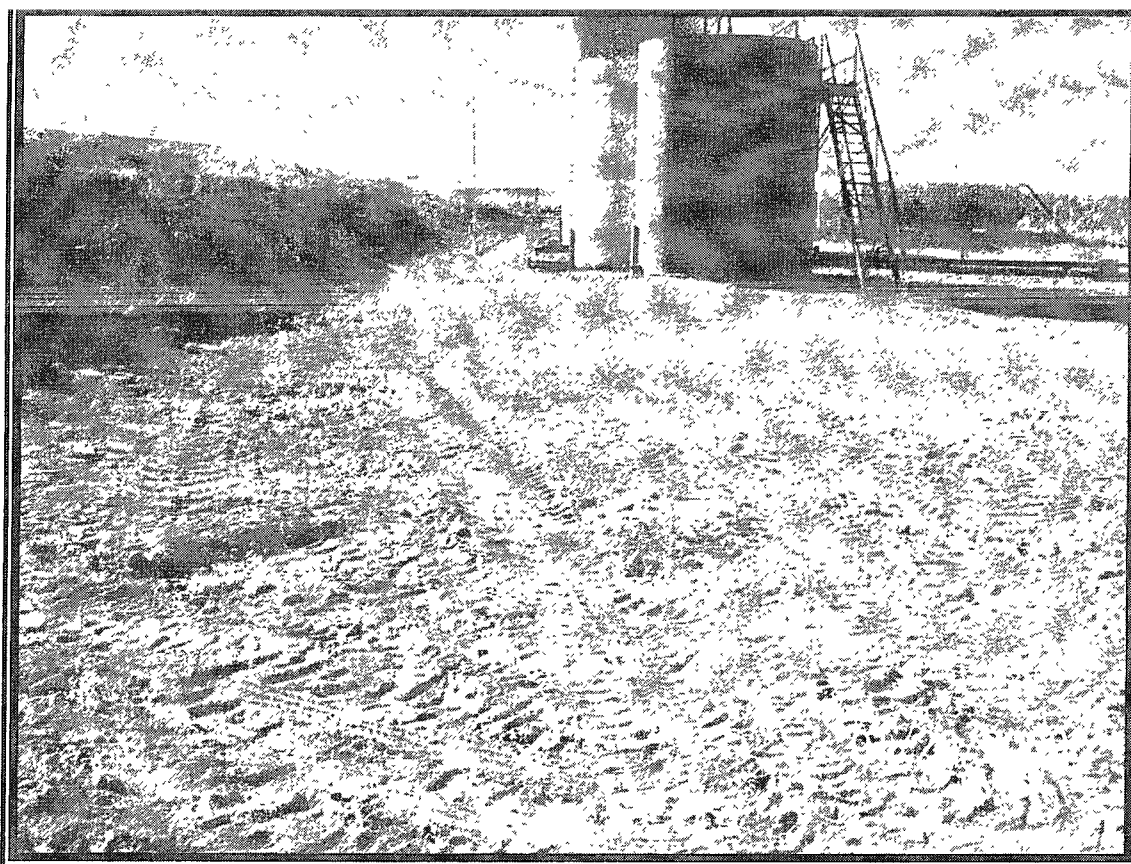
**Photo 3 - Tank battery after backfilling.**

The final phase of the remediation was started January 27, 2009. Samples were collected of the remaining impacted soil to document levels of contamination. Backfilling of the excavation, construction of the firewalls and lining of the area was completed by February 2, 2009.

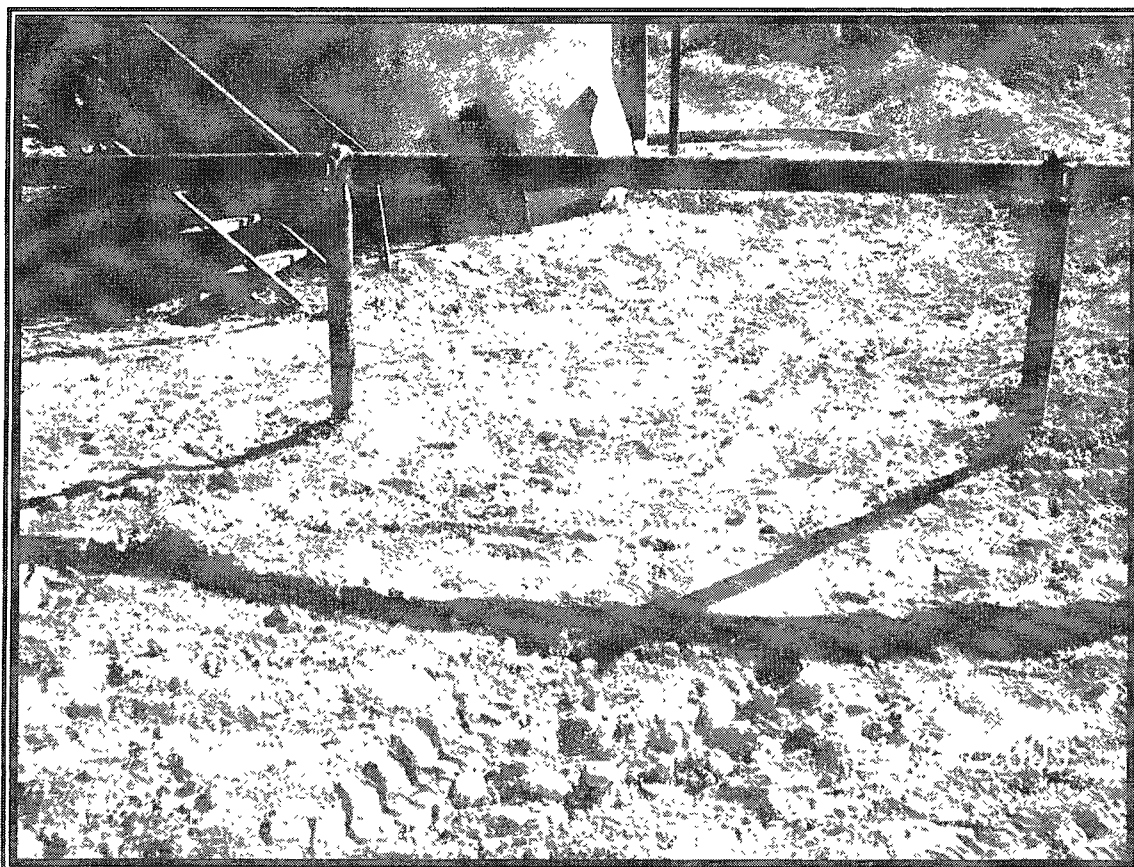
**Photo 4 - Gunbarrel after backfilling.**

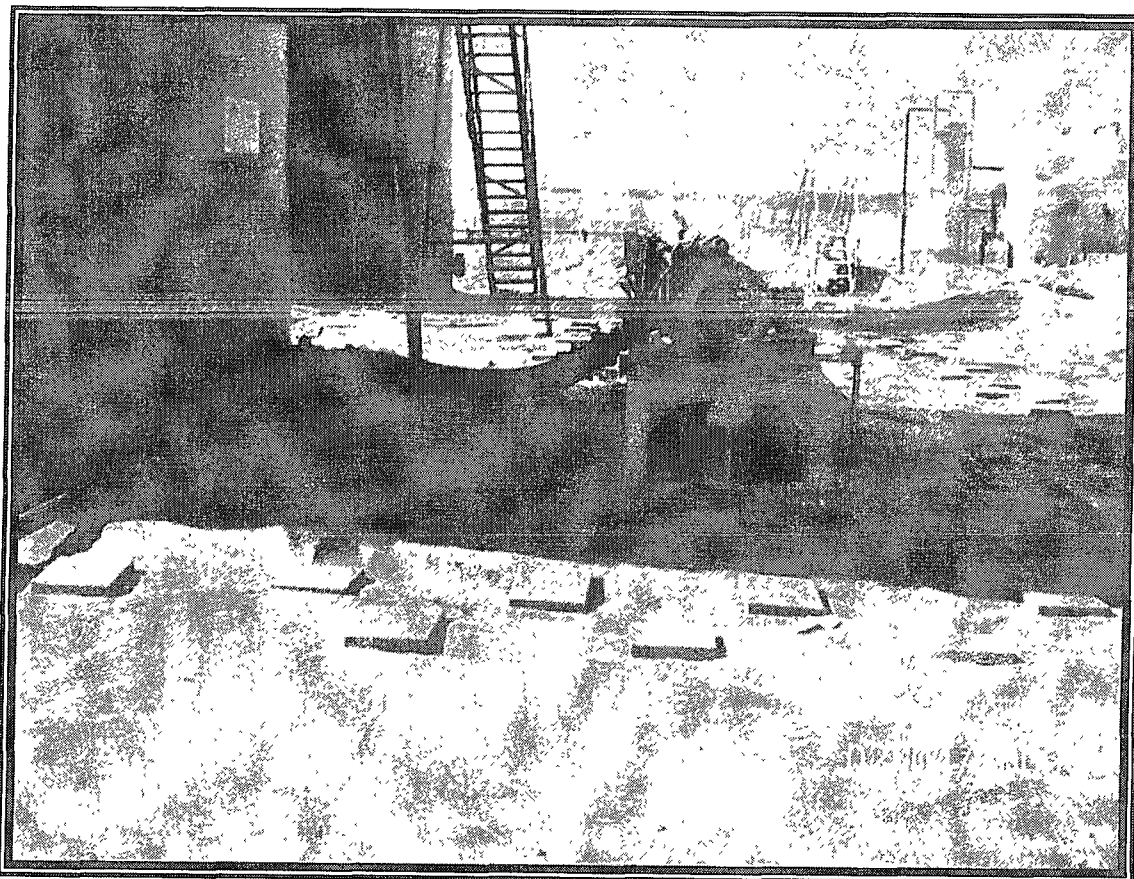
**Photo 5 - Front side of tank battery after lining.**

The final remedial method agreed to was to complete the backfilling of the excavation with the impacted soil and clean soil. Next the area of impacted soil would be covered with a 20 mil thick polyethylene liner. The liner would be cut out around the tanks and equipment and would be over the firewall surrounding the tank battery. This liner would reduce the amount of rainfall hitting the impacted soil and would capture most of any future releases at the site.

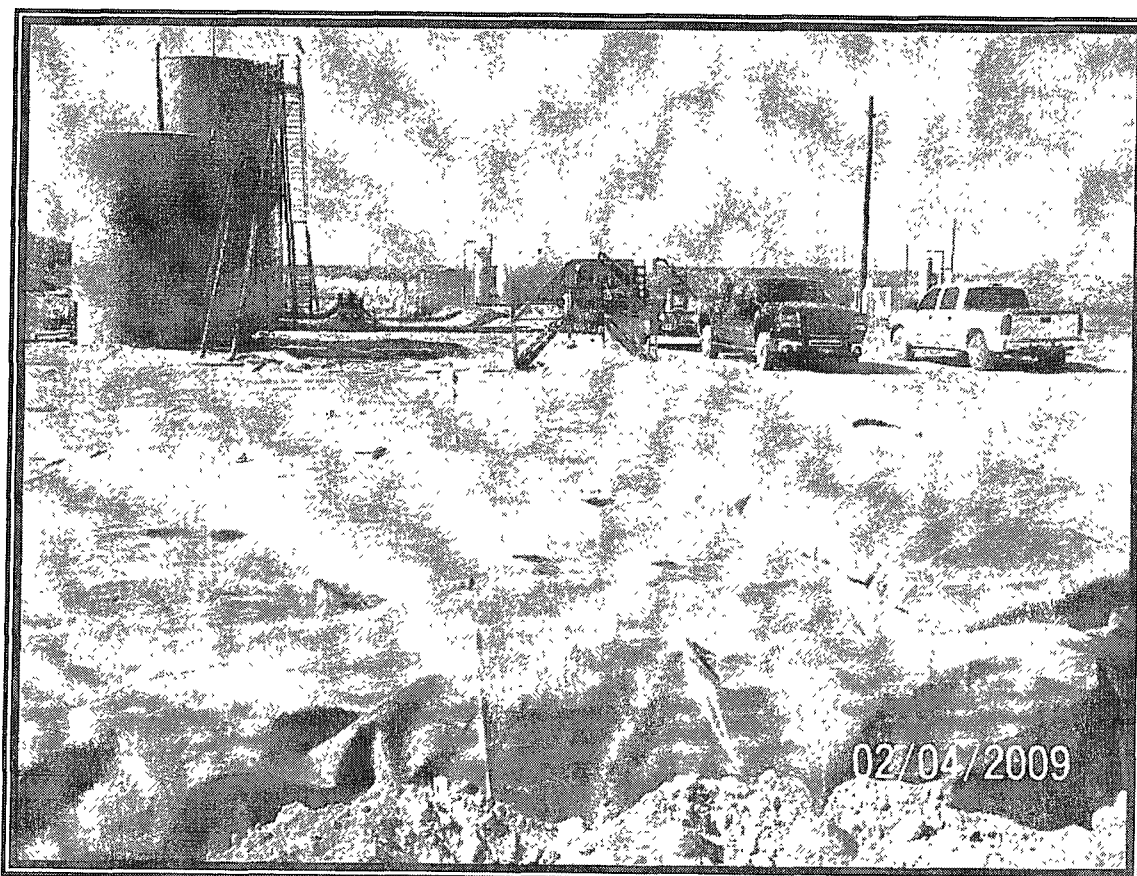
**Photo 6 - Tank battery after remediation and lining.**
