Release Notification and Corrective Action

Closure Report

Coyote 21 #2 Battery (Spill #2) Eddy County, NM

Re: Closure Report for Oxy USA – Coyote 21 #2 Battery (Spill #2)
UL 'N' Sec. 21 T24S R29E Eddy County
2RP-319

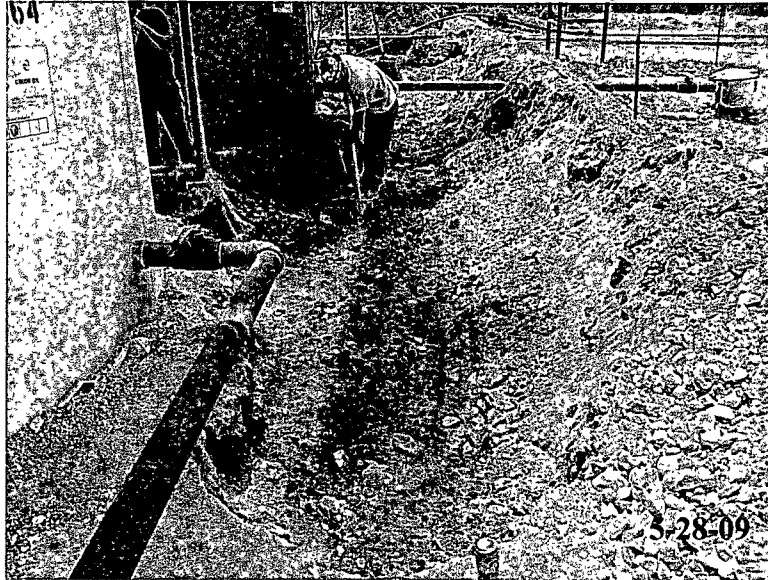
Excavation of impacted soil by hand around the tanks.

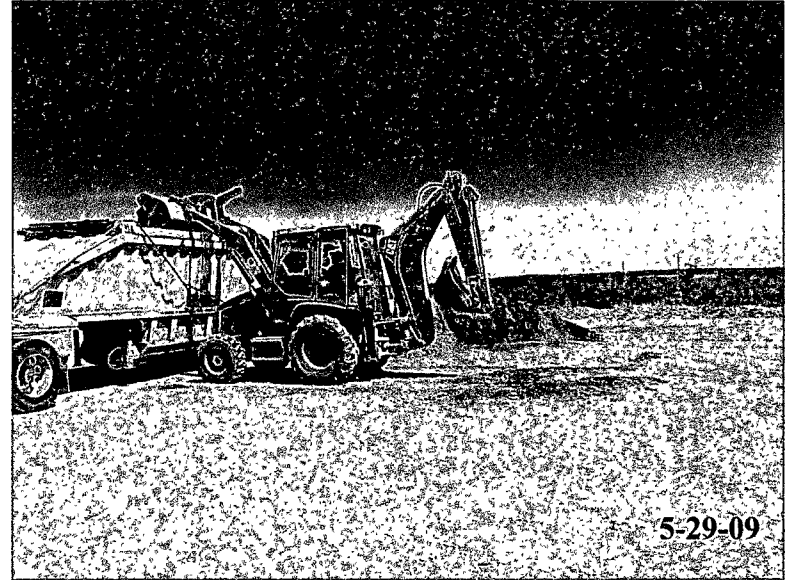
Loading impacted soil on trucks for disposal.
