**Release Notification and Corrective Action** Initial Report **OPERATOR** Final Report Contact Natalie Gladden Name of Company Apache Corporation Address Eunice, NM 88231 Telephone No. 575-390-4186 P.O. Box 1849 NEDU #247 Facility Type Produced Water Injection Well Facility Name Surface Owner State of NM Mineral Owner State of NM API No. 30-025-38508 LOCATION OF RELEASE Unit Letter Feet from Feet from Longitude-W Section Township Range Latitude-N County West Line South Line K 2 **21S** 37E 103.1361 32.5103 Lea 3465 1775 NATURE OF RELEASE Type of Release Volume of Release Volume Recovered Produced Water w/ significant hydrocarbon component Greater than 500 bbl 140 hbl Date and Hour of Occurrence Date and Hour of Discovery Source of Release 8" Steel Injection Line (loss of integrity) Subsurface before discovery 12/27/07 8:15 AM If YES, To Whom? Was Immediate Notice Given? YES □ NO Not Required NMOCD - Hobbs - Gary Wink By Whom? Natalie Gladden Date and Hour 12/28/07 3:23 PM If YES, Volume Impacting the Watercourse Was a Watercourse Reached? ✓ NO YES If a Watercourse was Impacted, Describe Fully\* Describe Cause of Problem and Remedial Action Taken, \* Loss of integrity of 8" steel P

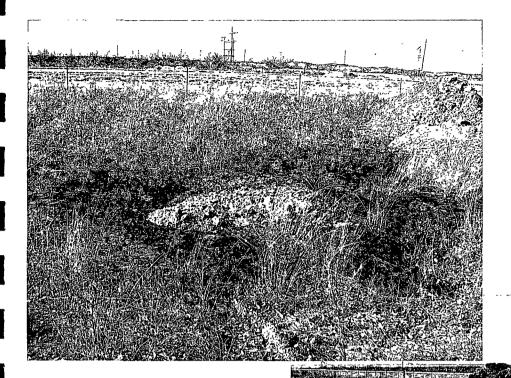
< 12/27/07 – Pasture south of release point.

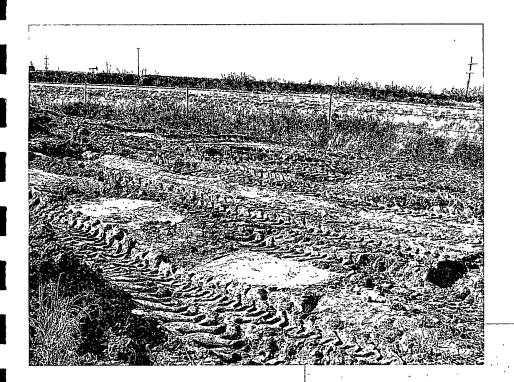
< 12/27/07 – Pasture west of release point.

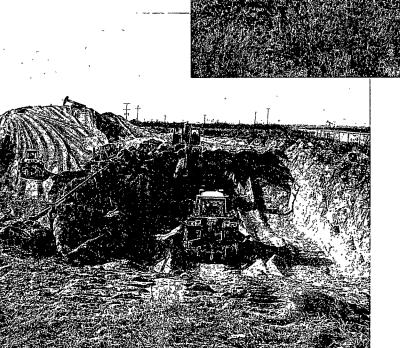
1/22/08 – Excavating and stockpiling soil for blending on surface. >

< 1/23/08 – Excavating and stockpiling soil for blending on surface.

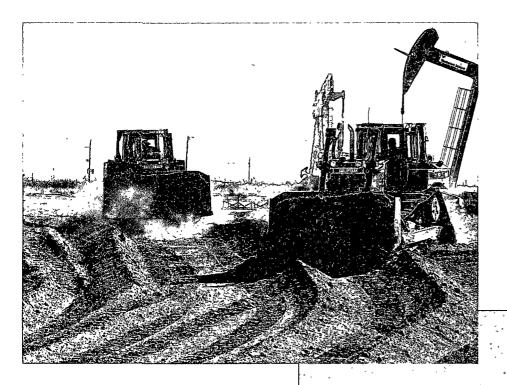
< 1/29/08 – Blending and backfilling the excavation nearly completed

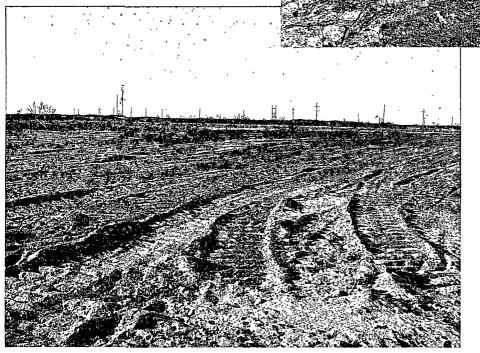
1/31/08 – Topsoil applied and location contoured. >

< 1/31/08 – Topsoil applied and location contoured.
