# Remediation of Chloride Impacted Soils North Benson Queen Unit Well #16

<b>Prepared By:</b>	<b>Etech Environmental &amp; Safety Solutions, Inc.</b>
<b>Date Prepared:</b>	<b>June 30, 2009</b>
<b>Project Number:</b>	<b>094-1749-000</b>

## Remediation of Chloride Impacted Soils North Benson Queen Unit Well #16

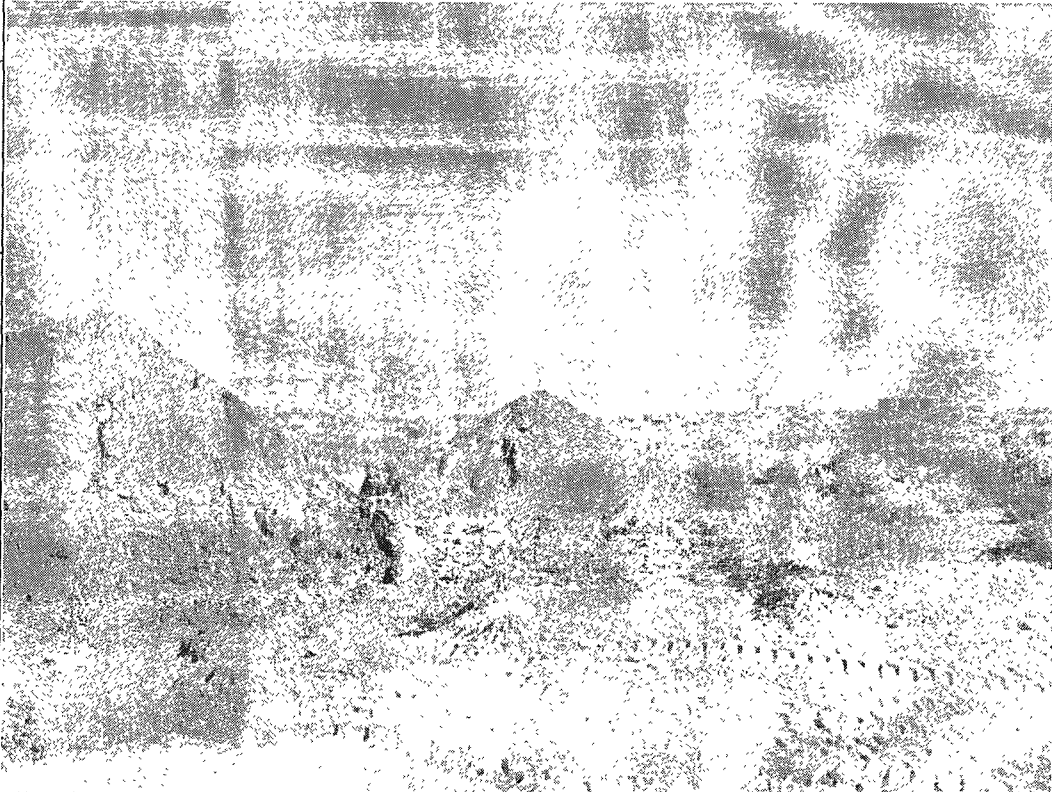
<b>Photo No:</b> 1.

<b>Direction Taken:</b> East	
<b>Description:</b> Excavated soils from the west pooled area

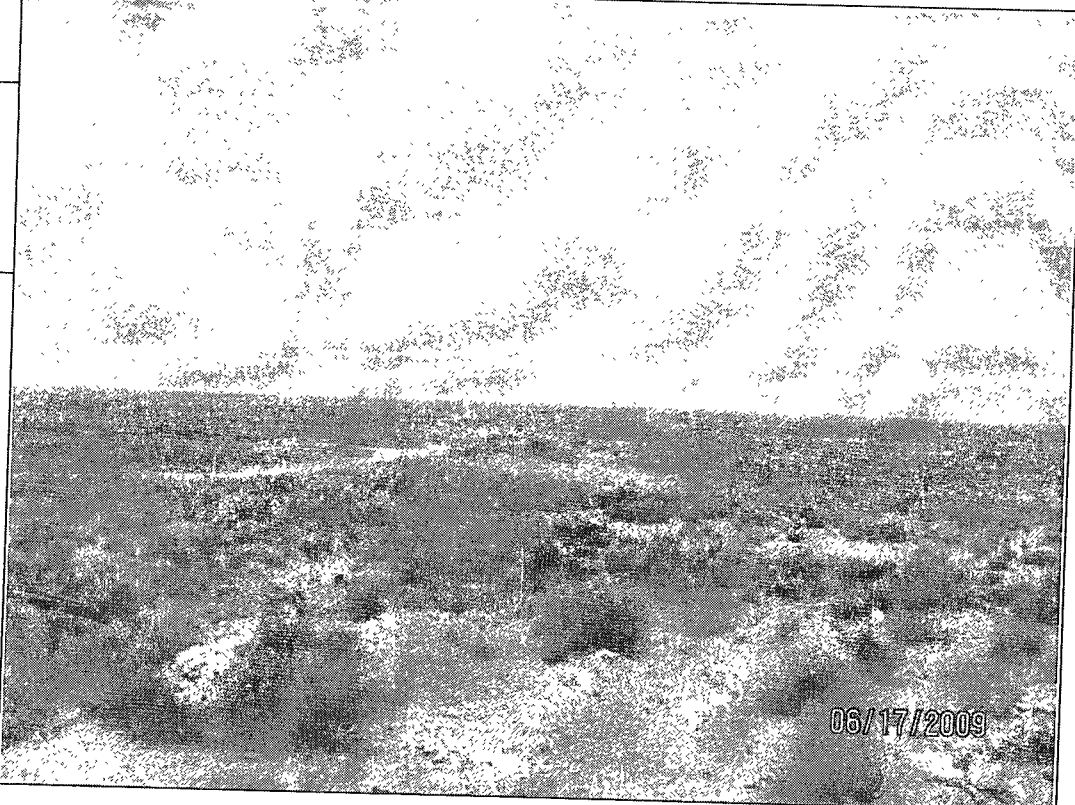
<b>Photo No:</b> 7.

<b>Direction Taken:</b> West	
<b>Description:</b> General overview of the west area following reclamation.

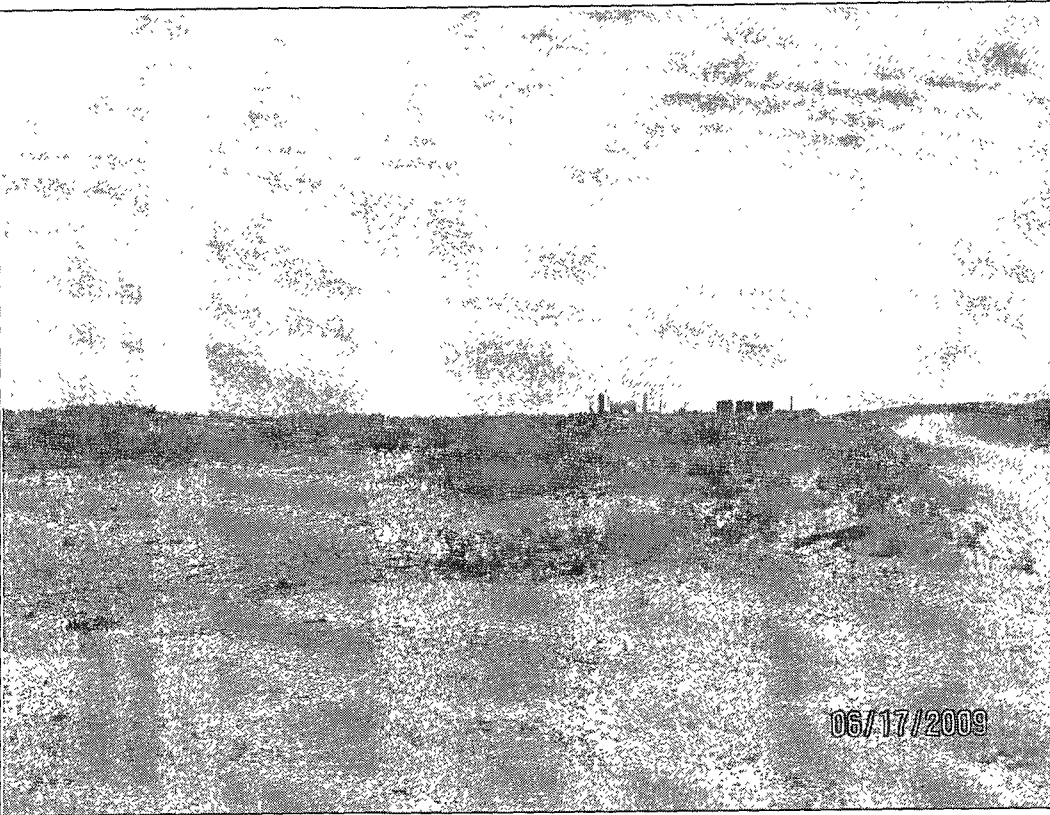
<b>Photo No:</b> 11.

<b>Direction Taken:</b> East	
<b>Description:</b> View of the west pool area looking east back towards the battery after reclamation.
