RE: **Investigation and Characterization Report
EME B-8 Release Site (NMOCD Case No. 1R0480)
T20S-R37E-Section 8, Unit Letter B
Lea County, New Mexico**

EME B-8 Release Site (1R0480)
 T20S - R37E - Section 8, Unit B
RICE Operating Company

**Lithologic Logs
And
Monitoring Well Construction Diagrams**

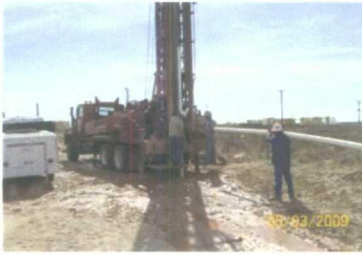
LITHOLOGIC LOG AND MONITORING WELL CONSTRUCTION DIAGRAM

MONITOR WELL NO.: MW - 1
 SITE ID: EME B-8 Line Leak
 CONTRACTOR: Harrison & Cooper, Inc.
 DRILLING METHOD: Air Rotary
 START DATE: 03/03/09
 COMPLETION DATE: 03/03/09
 COMMENTS: Monitoring well located approximately 35 ft southeast of leak point.
 Photo at left taken near leak point facing southeast.

0935	Split Spoon	199		Groundwater encountered at ~26 ft bgs
30				SW	
	0937				
35				SC	
	0939				
40				SC	
	0941				
45				SC	
	0943				
50				SC	
	0947

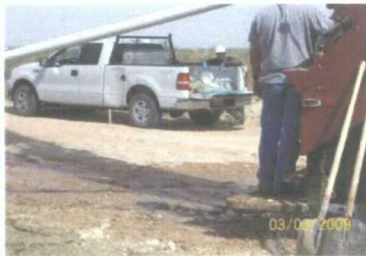
LITHOLOGIC LOG AND MONITORING WELL CONSTRUCTION DIAGRAM

MONITOR WELL NO.: MW - 1 TOTAL DEPTH: 65 Feet
 SITE ID: EME B-8 Line Leak CLIENT: RICE Operating Company
 CONTRACTOR: Harrison & Cooper, Inc. COUNTY: Lea
 DRILLING METHOD: Air Rotary STATE: New Mexico
 START DATE: 03/03/09 LOCATION: T205-R37E-Sec 8-Unit B
 COMPLETION DATE: 03/03/09 FIELD REP.: G. Van Deventer
 COMMENTS: Monitoring well located approximately 35 ft southeast of leak point.
Leak point marked by wood stake near rear wheel of pickup in photo at left.

Sample				Chloride (ppm)	PID (ppm)	USCS	LITHOLOGIC DESCRIPTION: LITHOLOGY, COLOR, GRAIN SIZE, SORTING, ROUNDING, CONSOLIDATION, DISTINGUISHING FEATURES
Depth	Time	Type					
55	0949					SW	
60	0951						
65	0955					SS	
70	1000					GP	
						CL	
							Total depth of boring at 70 ft bgs but loose gravel caved to fill in bottom 5 ft of open boring. Total depth of monitoring well at 65 ft bgs.
75							
80							
85							
90							
95							
100
