# WORKPLANS

## NMOCD Case No. 1R488 - ABO F-31 SWD for Vanguard Natural Resources LLC

# Investigation and Characterization Report and Corrective Action Plan

**ABO F-31 SWD  
UL F Sec 31 T 16S R 37E  
NMOCD Case Number: 1R488**

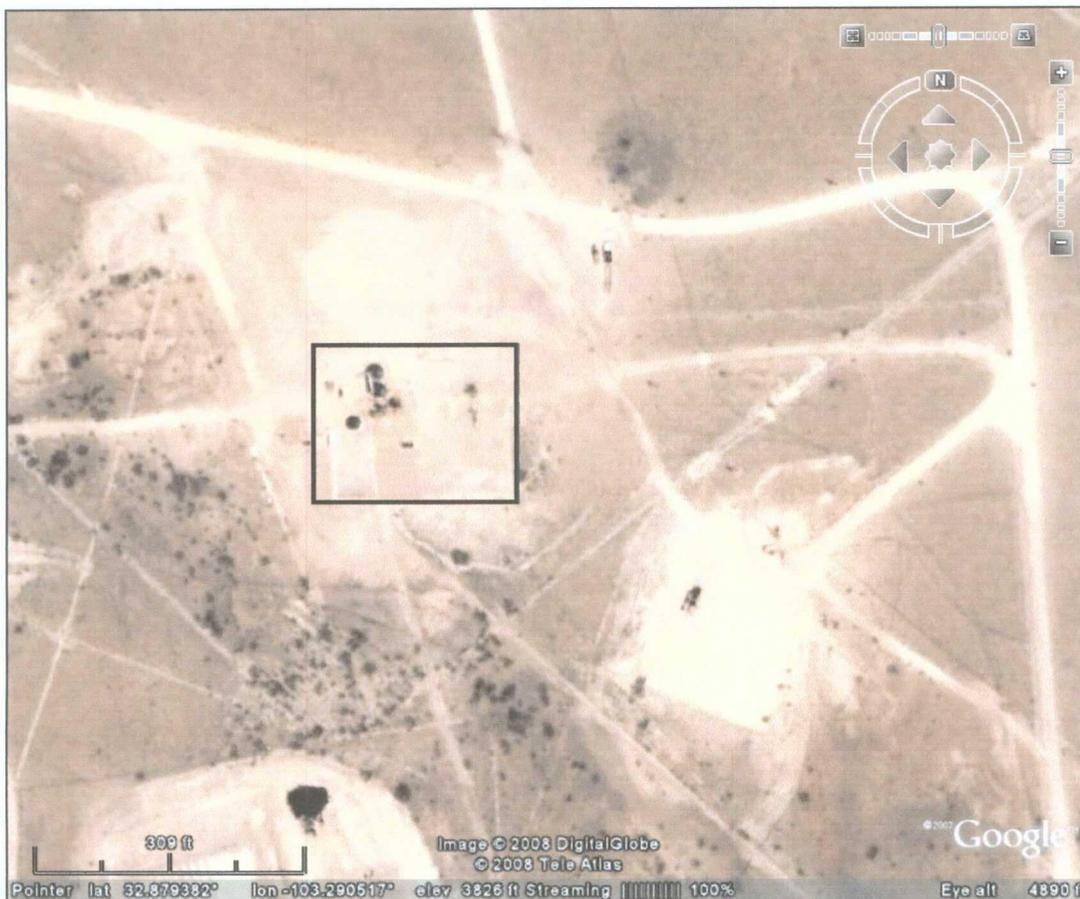
**Figure 3** – Area of investigation (outlined in black box). Google aerial photograph, high-level view. Date unknown.

The field investigation was completed over the course of two days, October 20<sup>th</sup> and 21<sup>st</sup>, 2008. Harrison and Cooper, Inc. provided drilling services and Rice Operating Company personnel performed field chloride titrations and PID analyses. Confirmatory laboratory analyses were subsequently performed by Cardinal Laboratories. The area of investigation and approximate locations of soil borings is given in Figure 3.

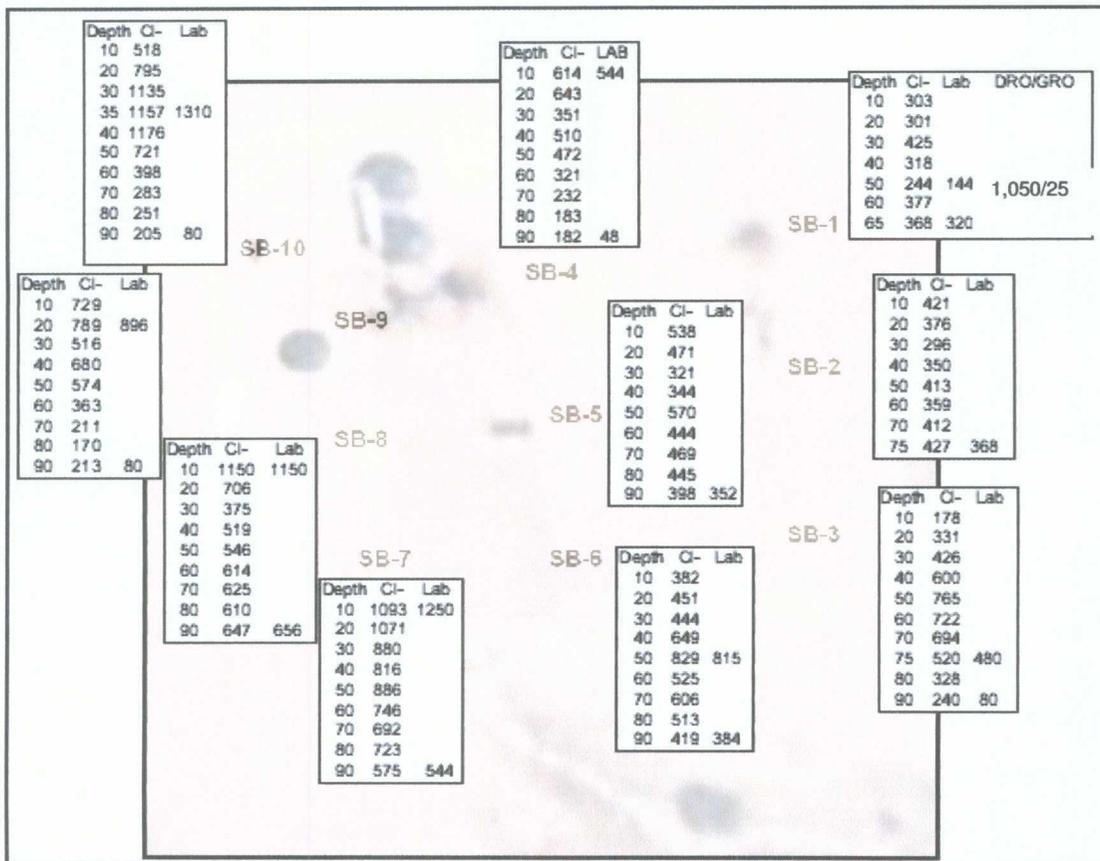
The footprint of past activities and soil investigation encompassed an area of approximately one acre (Figure 4). Soil chloride concentrations averaged below 500 ppm near the surface, dropping to approximately 300 ppm near the water table capillary fringe at 90 ft bgs (Figures 4 and 5). Residual soil petroleum hydrocarbons were found at only one sampling location and depth (SB-1 @ 50 ft bgs) but were otherwise not found to be significant during this investigation; (see Figure 4 and the individual soil boring logs in the Appendix).

Figure 4 - ABO F-31. ICP field evaluation: approximate locations of soil borings with field measured and laboratory verified soil chloride concentrations... Background aerial photo is a "Goggle map" of unknown date. Tankage and other surface facilities were removed prior to this investigation.

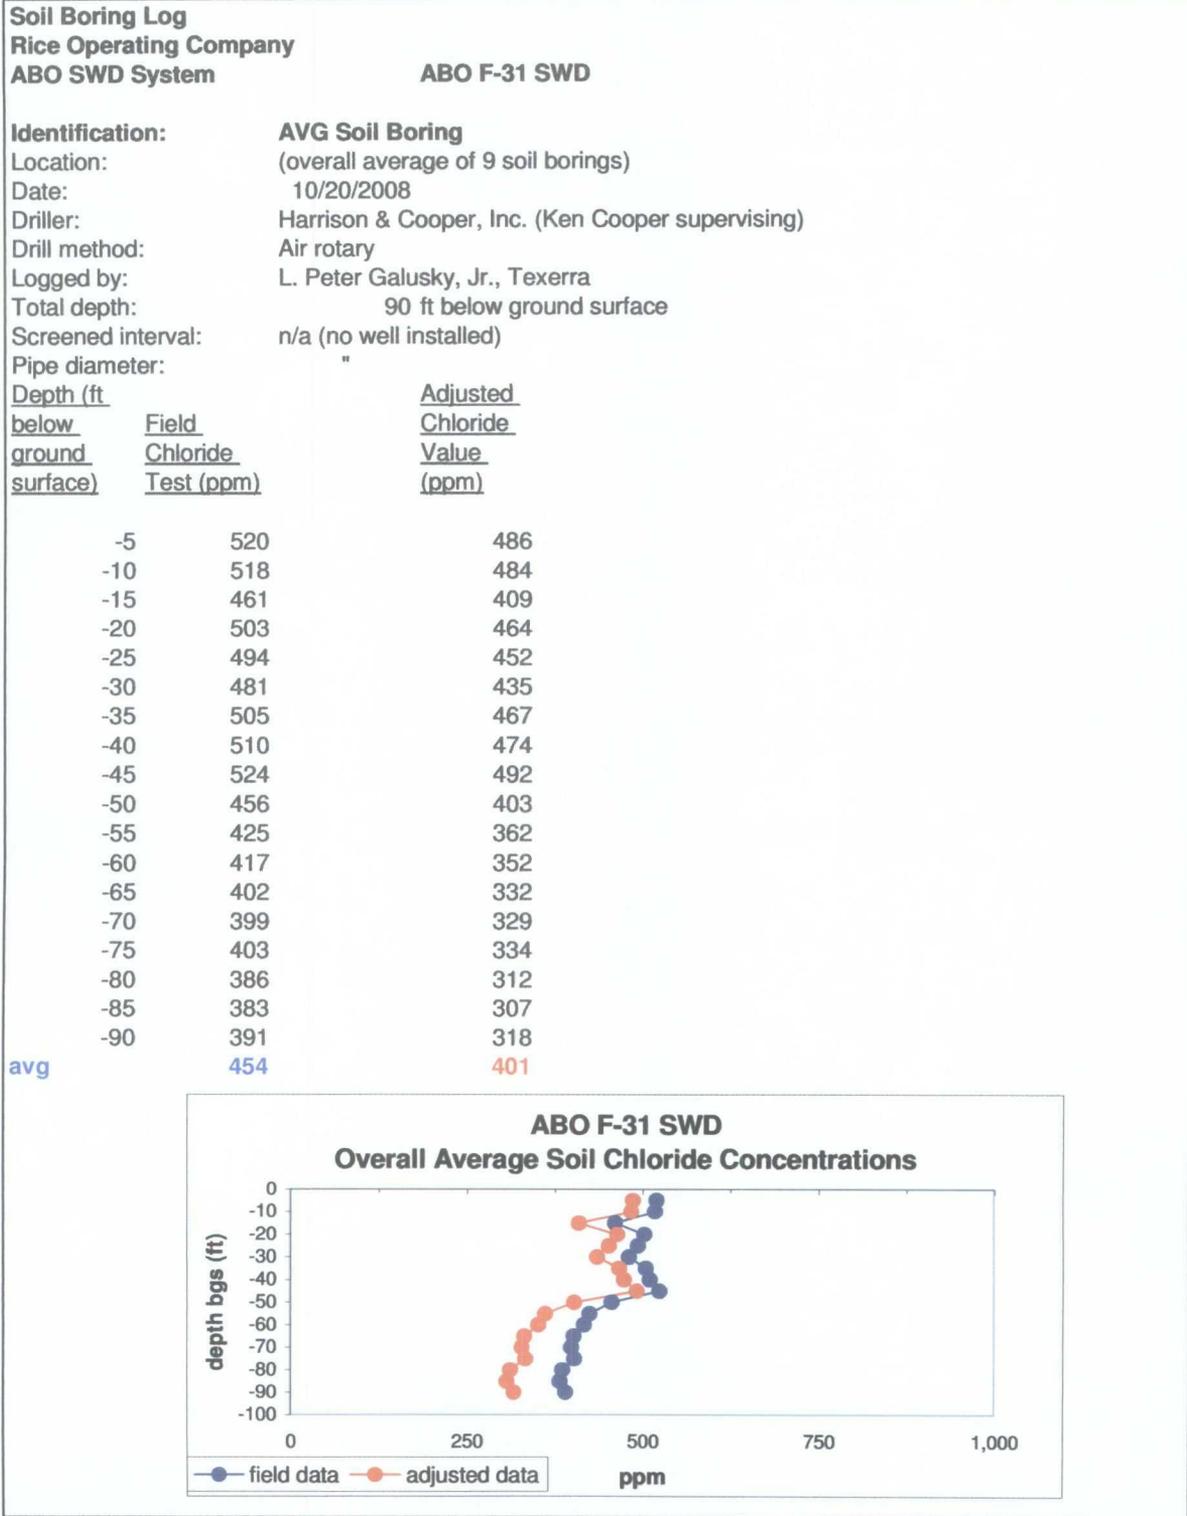
**Figure 5** – Average soil chloride concentrations from ten soil borings. Field-measured values were adjusted based on regression analysis comparison against a laboratory measured subset.

**Note:** The laboratory (and presumed actual) soil chloride values were very close to the field measured values. Nevertheless, the resulting statistical regression equation was used to adjust the field measured values in the computation of the overall site-averaged soil chloride concentrations (Figure 5).

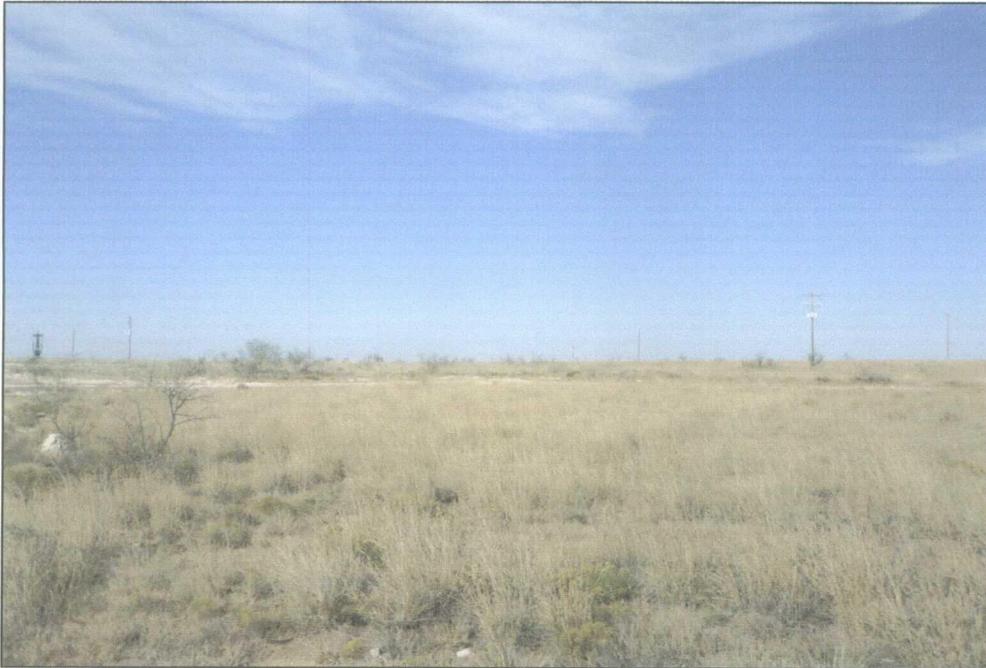
**Figure 6** – Desired end-point of surface restoration. This recent (Fall, 2008) photograph is of natural prairie vegetation to the east of the affected area.

1. The ground surface should be graded and sloped to prevent the accumulation of storm runoff from upslope areas. The existing berms presently around the affected area should be removed and graded into the restored surface.
2. Soils should be plowed, disked and amended with organic materials (i.e. – straw) to facilitate the retention of sufficient soil moisture to facilitate and support the reestablishment of native prairie vegetation.
3. The site will be seeded with a native vegetation seed mixture.
4. Periodic irrigation of the surface should occur during the first growing season of reestablishment should natural rainfall be deficient.

The desired end-point of surface restoration should be similar to that shown in Figure 6, which is a photograph of vegetation taken adjacent to the subject site.

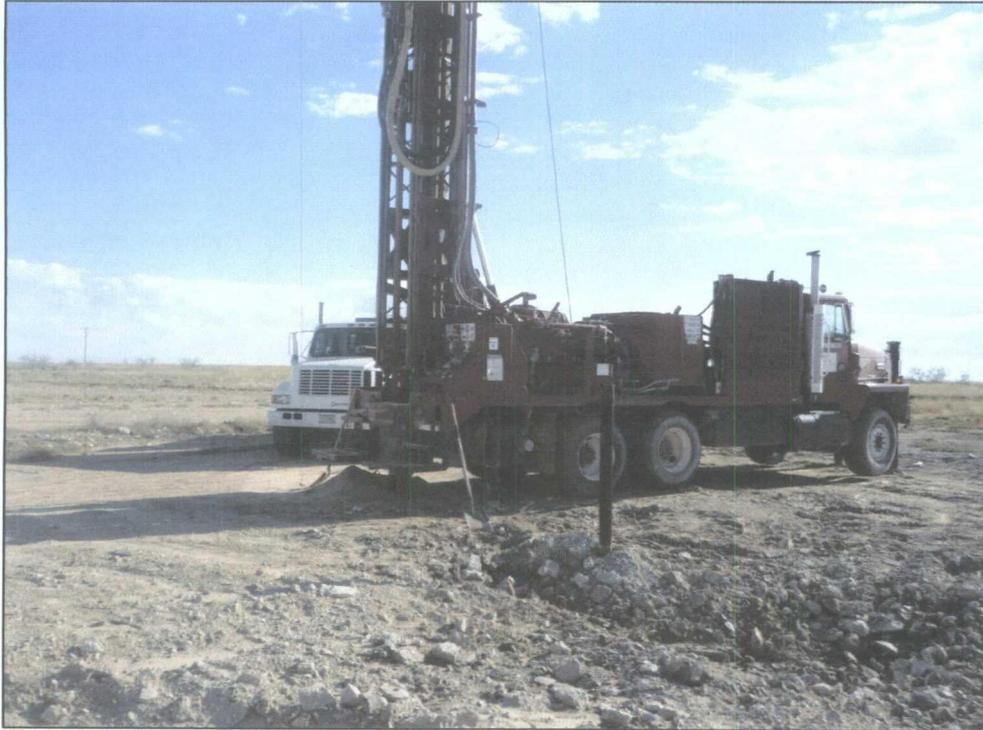
Photo 1 – View NE drilling SB-1.

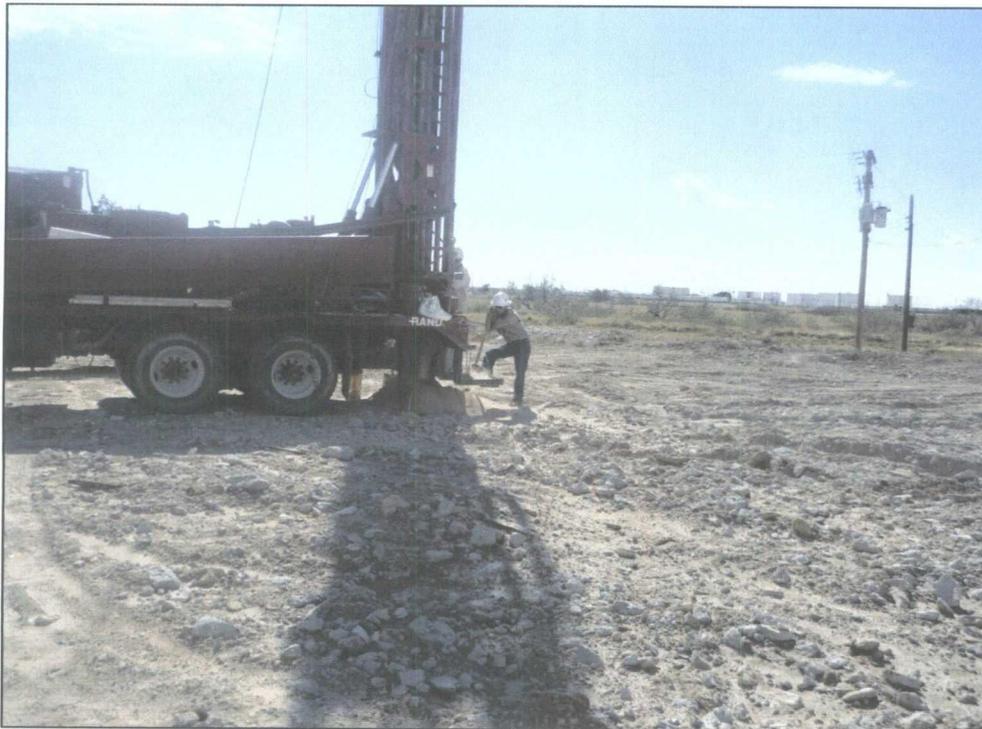
Photo 2 – View W drilling SB-4.

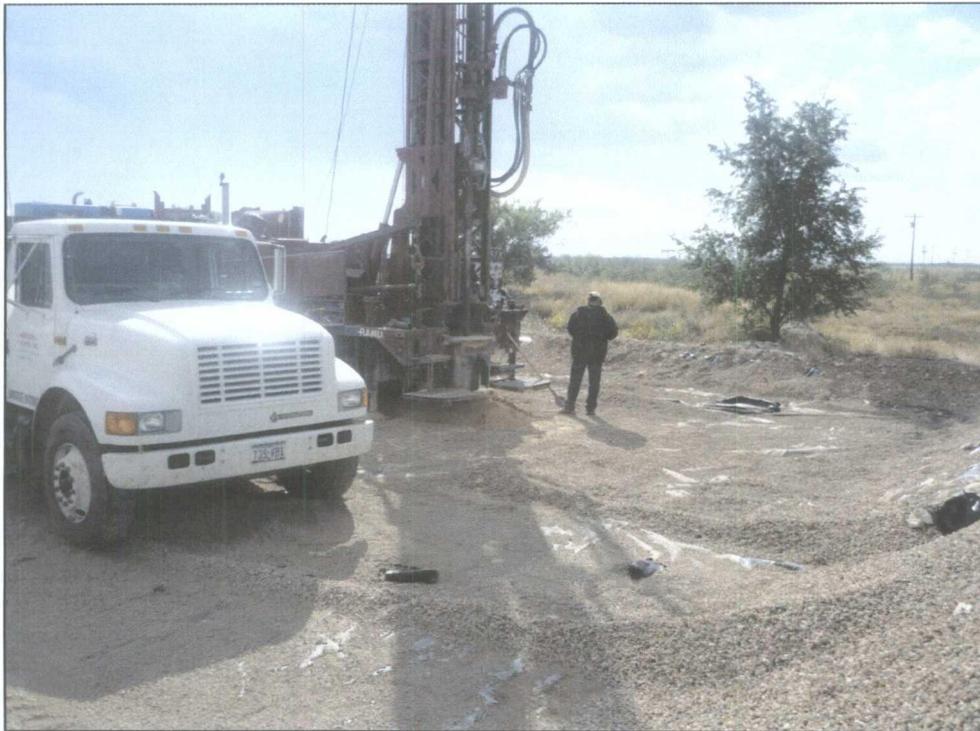
Photo 3 – View S drilling SB-7.

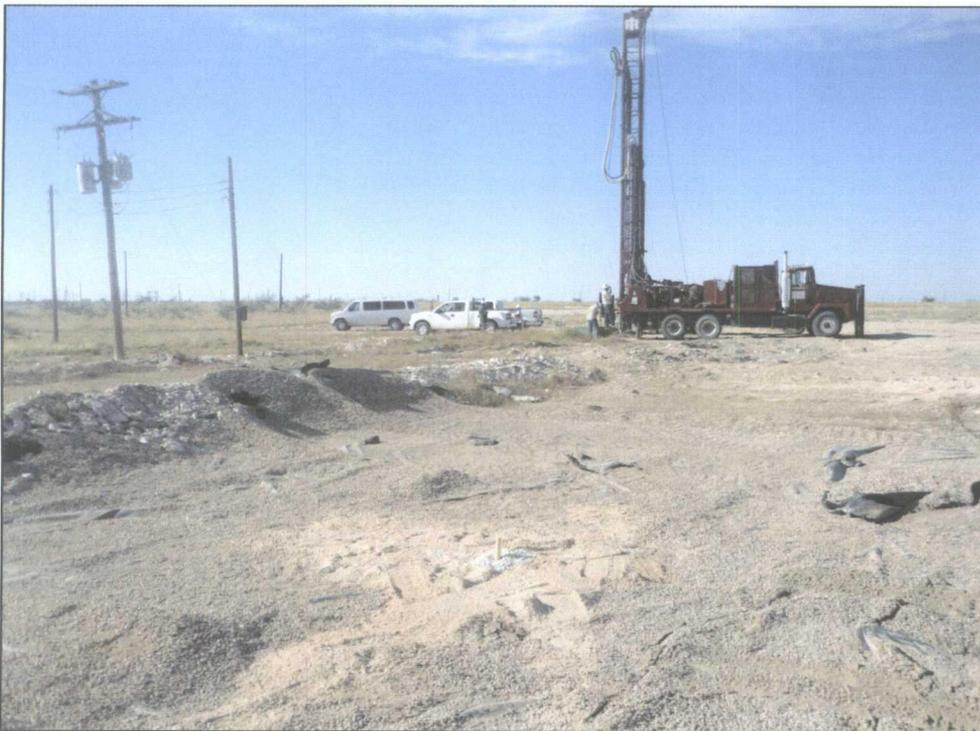
Photo 4 – View NNW toward SB-10.
