Vacuum Jct I-34

CLOSURE

**RICE OPERATING COMPANY
JUNCTION BOX FINAL REPORT**

Unit I, Section 34, T17S, R35E

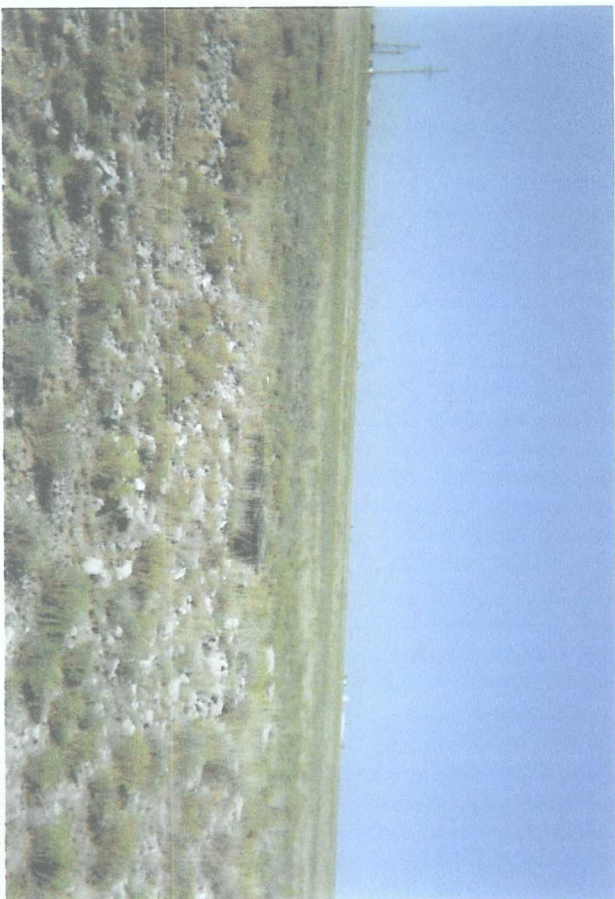
11/15/2005

undisturbed junction box, facing north

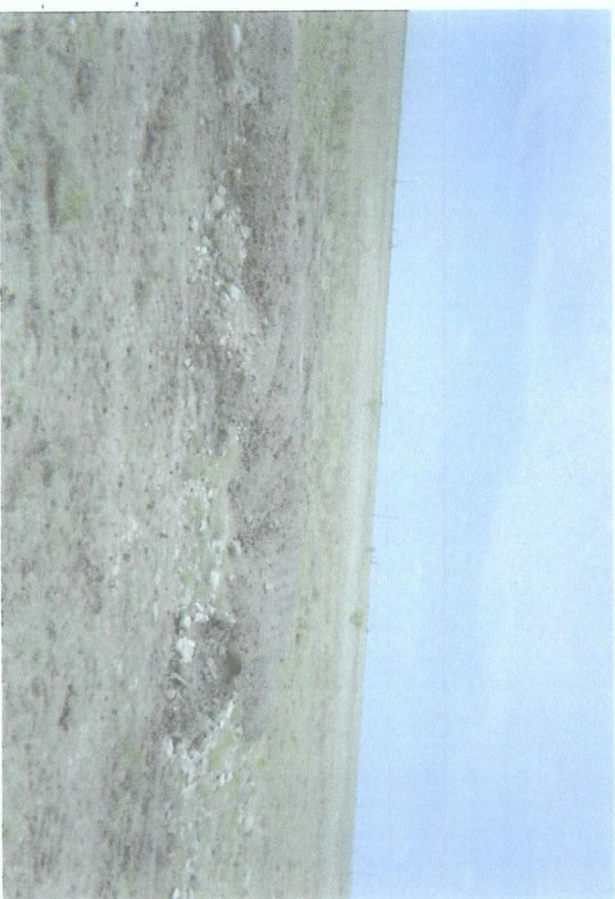
5/15/2008

spreading clean, imported topsoil on site

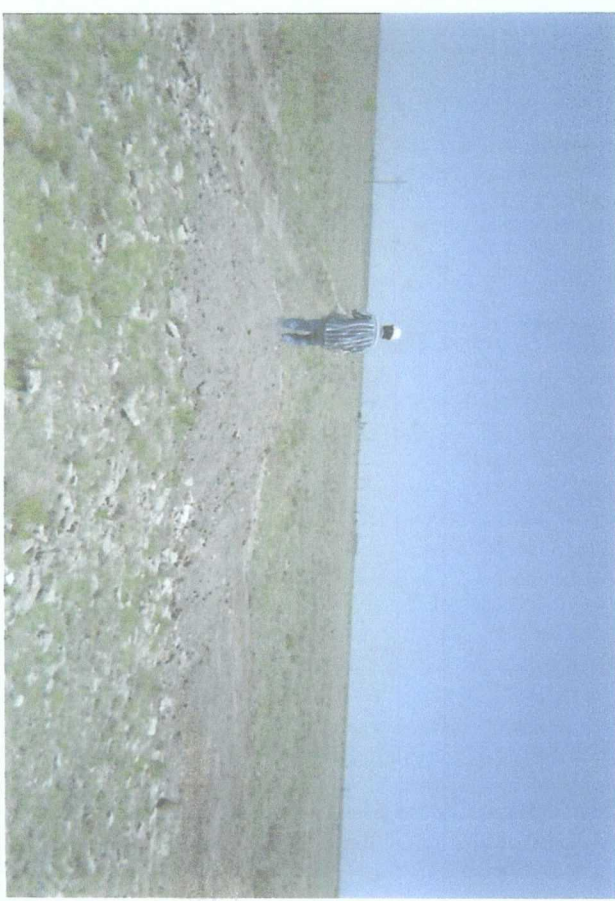
5/20/2008

seeding backfilled site

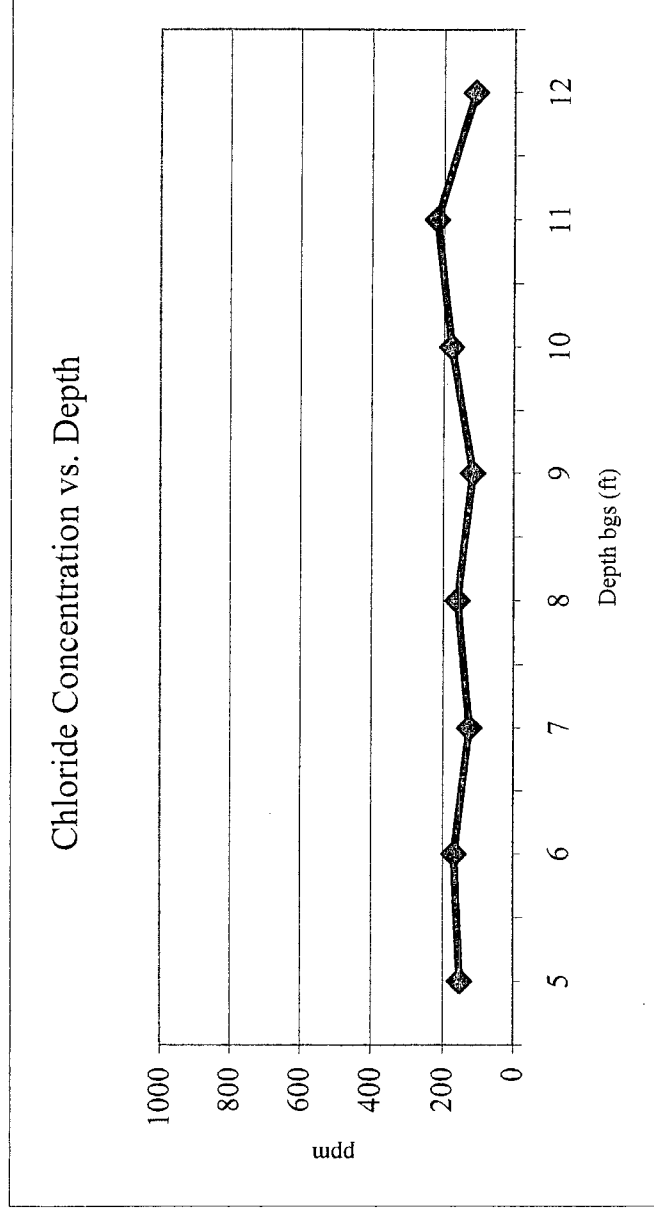
CHLORIDE CONCENTRATION CURVE

Backhoe samples at junction (source)

Depth-bgs (ft)	Cl ⁻ ppm
5	152
6	169
7	125
8	160
9	116
10	178
11	220
12	111

Groundwater = 100 ft

LOCATION	DEPTH	mg/kg
background	6"	115
vertical delineation at the former junction (source)	5'	152
	6'	169
	7'	125
	8'	160
	9'	116
	10'	178
	11'	220
	12'	111
