**RICE OPERATING COMPANY
JUNCTION BOX DISCLOSURE* REPORT**

SWD SYSTEM	JUNCTION	UNIT	SECTION	TOWNSHIP	RANGE	COUNTY	BOX DIMENSIONS - FEET		
Vacuum	vent L-34	L	34	17S	35E	Lea	Length	Width	Depth
							no box; system abandonment

Vacuum vent L-34

Unit L, Section 34, T17S, R35E

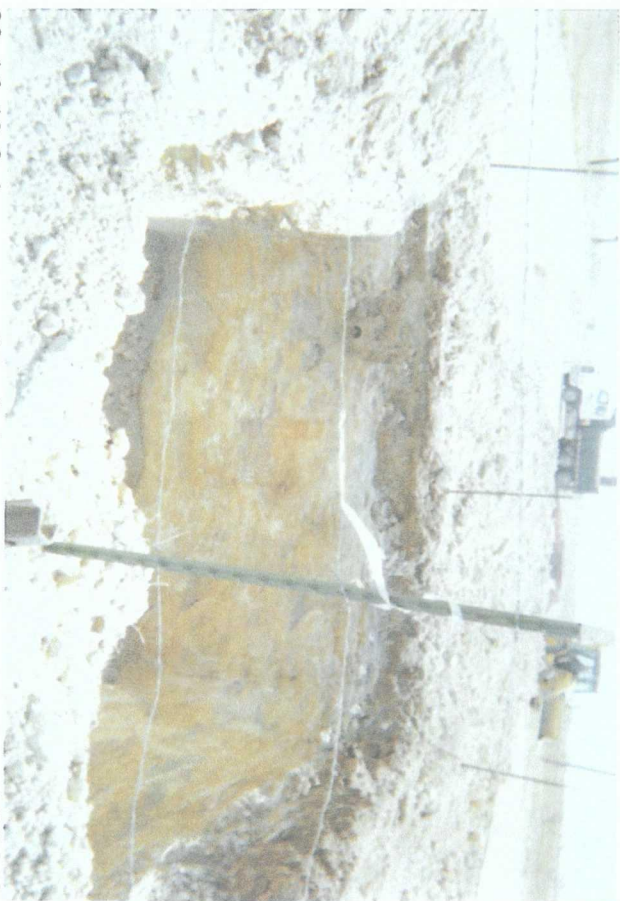
4/3/2008

20x16x12-ft-deep excavation, facing east

General Description of Remedial Action: This junction was addressed under the Vacuum SWD System abandonment. After this junction was removed, an investigation was conducted using a backhoe to collect soil samples at regular intervals producing a 20x16x12-ft-deep hole. Chloride field tests were performed on each sample, which yielded chloride levels that did not sufficiently relent with depth. Organic vapors were measured using a PID, which yielded elevated concentrations. Representative composite samples were sent to a commercial laboratory for analysis of chloride, TPH, and BTEX. The excavated soil was blended on-site and returned to the excavation. Clean caliche was imported and used to fill the excavation to ground surface and to contour to the surrounding area. An identification plate was placed on the surface of the backfilled site to mark the location of the former junction for future environmental consideration. NMOCD was notified of potential ground water impact on 9/23/2008.

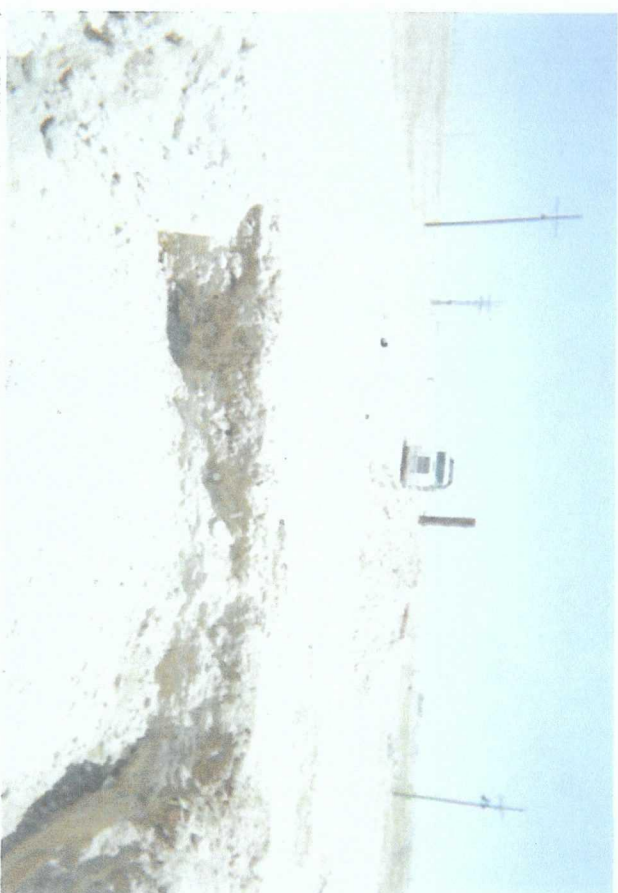
4/18/2008

backfilling the excavation, facing east

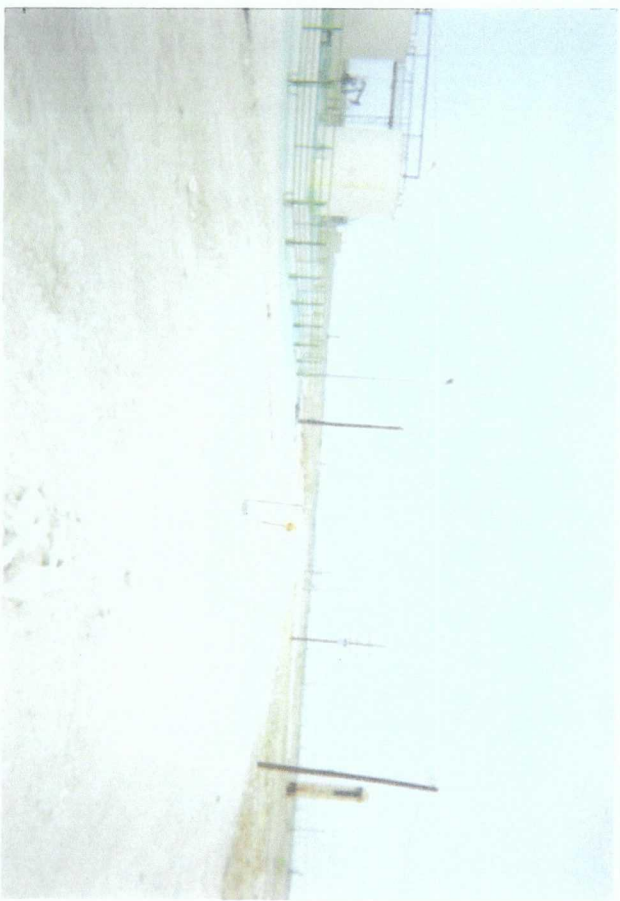
4/22/2008

site complete, facing west

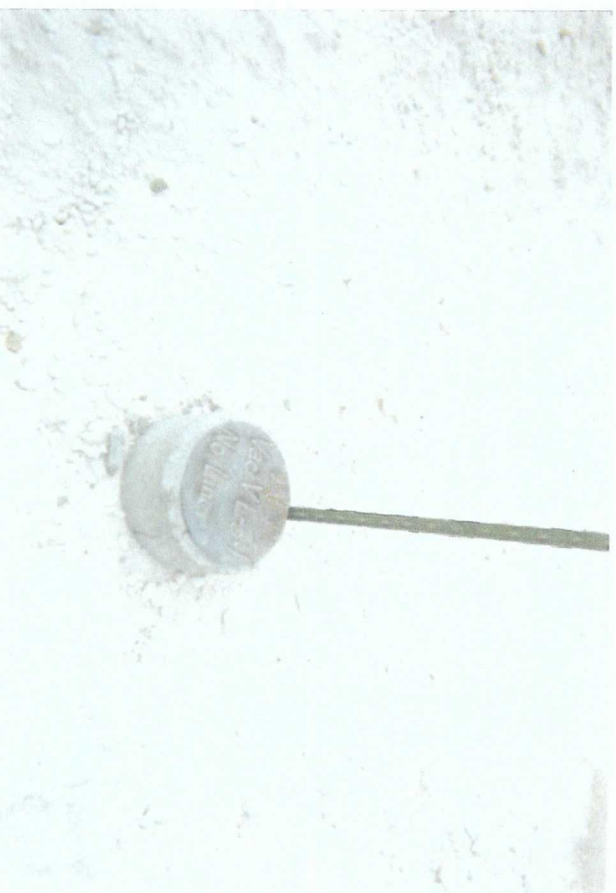
4/22/2008

site marker, facing south

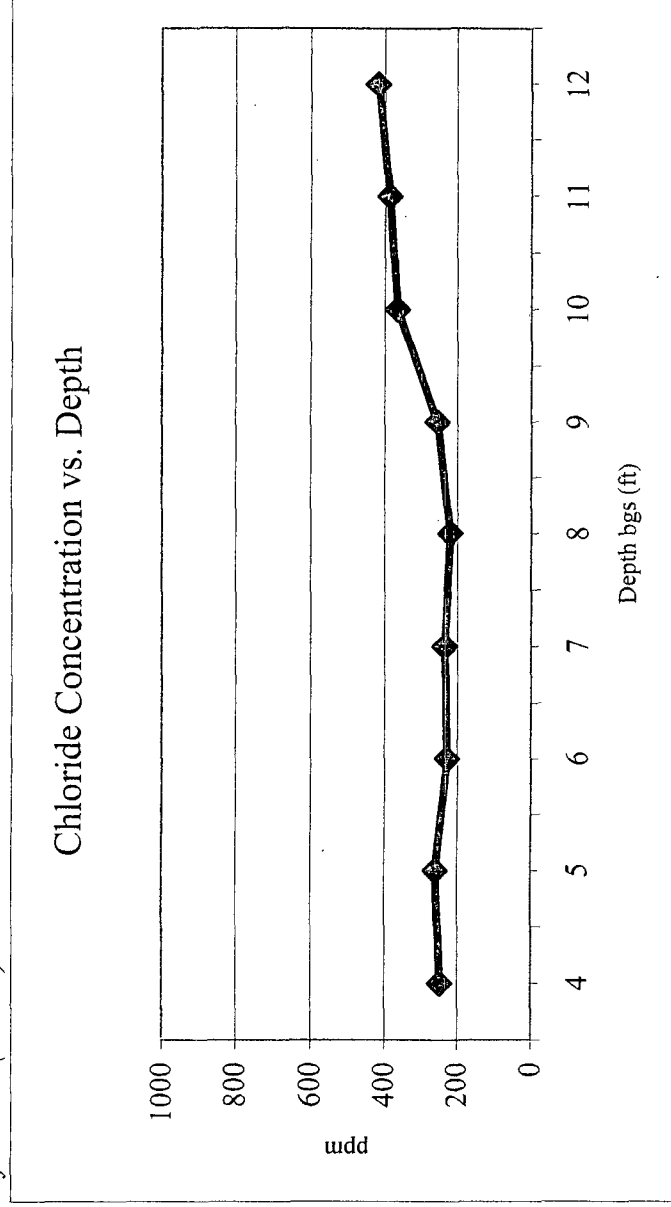
Vacuum vent L-34

Backhoe samples at 5 ft west of the junction (source)

Depth bgs (ft)	[Cl ⁻] ppm
4	248
5	260
6	229
7	235
8	220
9	255
10	365
11	387
12	418

Groundwater = 83 ft

LOCATION	DEPTH	mg/kg
4-wall comp.	n/a	813
bottom comp.	12'	714
backfill comp.	n/a	455
vertical delineation trench at 5 ft west of the junction (source)	4'	248
	5'	260
	6'	229
	7'	235
	8'	220
	9'	255
	10'	365
	11'	387
	12'	418
