**RICE OPERATING COMPANY
JUNCTION BOX FINAL REPORT**

SWD SYSTEM	JUNCTION	UNIT	SECTION	TOWNSHIP	RANGE	COUNTY	BOX DIMENSIONS - FEET		
Blinebry-Drinkard (BD)	Jct. M-31-1	M	31	21S	37E	Lea	Length 6'	Width 4'	Depth 6'
							eliminated

BD Jct. M-31-1

Unit M, Section 31, T21S, R37E

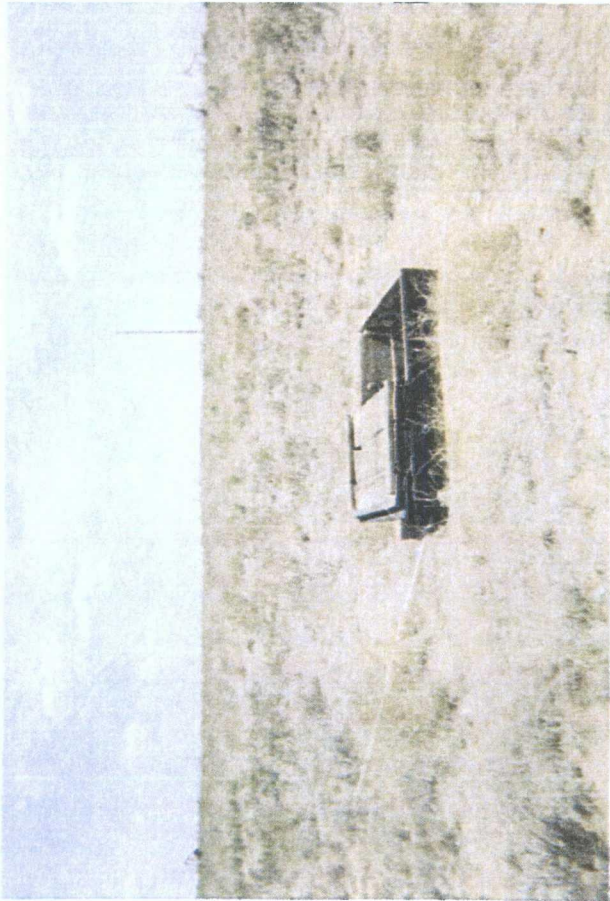
6/24/2008

former junction box

General Description of Remedial Action: This junction was eliminated during the pipeline replacement/upgrade program. After the former junction box was removed, an investigation was conducted using a backhoe to collect soil samples at regular intervals producing a 5x3x12-ft-deep excavation. Field tests were performed on each sample to determine chloride and organic vapor concentrations. Field data suggests the site is low in both chloride and organic vapors with levels similar to that of the background sample.

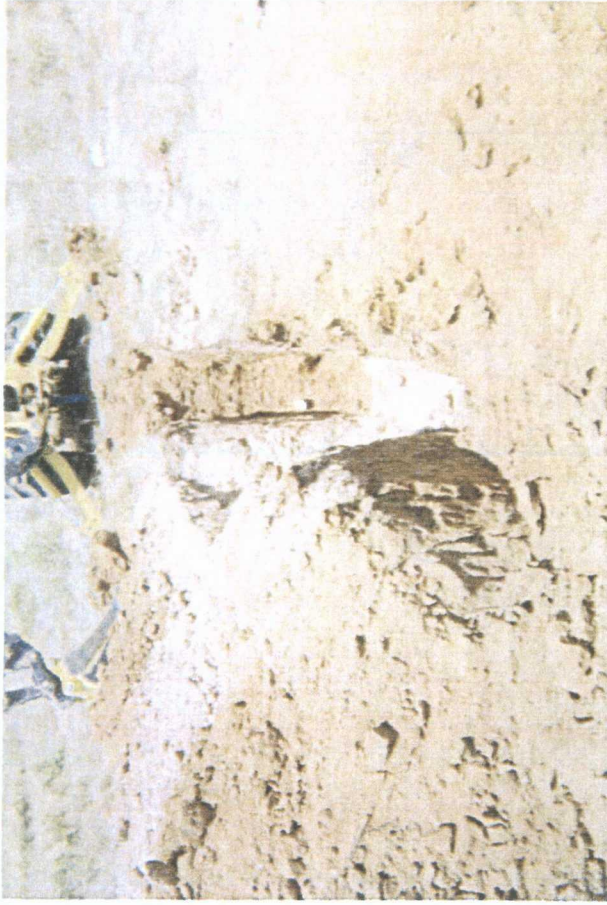
6/25/2008

delineation trench at former junction site

LOCATION	DEPTH	mg/kg
background	6"	90
vertical delineation trench at the junction (source)	7'	285
	8'	161
	9'	315
	10'	293
	11'	149
	12'	187

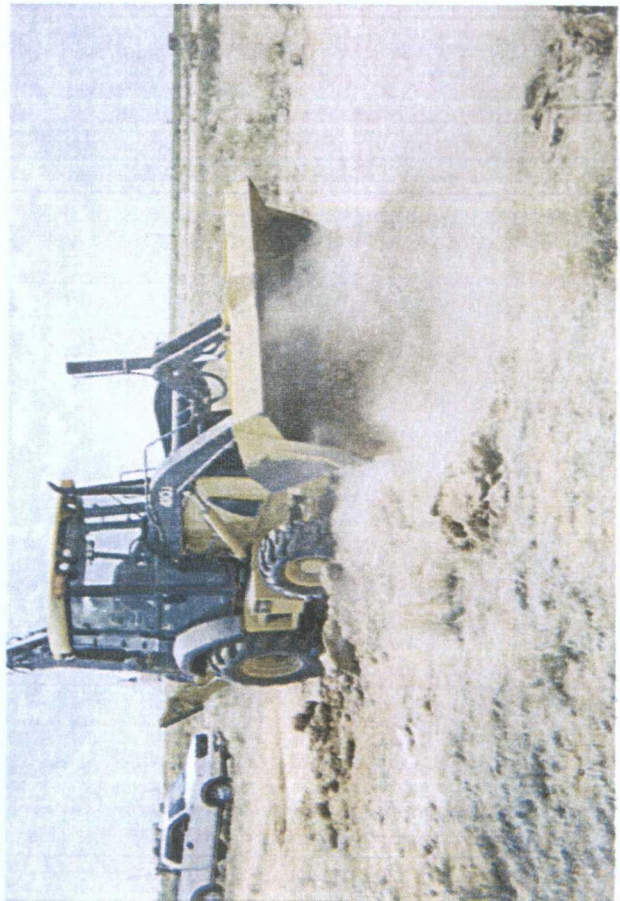
6/25/2008

backfilling excavation

The excavated soil was returned to the excavation, and clean soil was imported and used as a top cap and to contour the site to the surrounding area. On 7/9/2008, the site was seeded with a blend of native vegetation and is expected to return to a productive capacity at a normal rate.

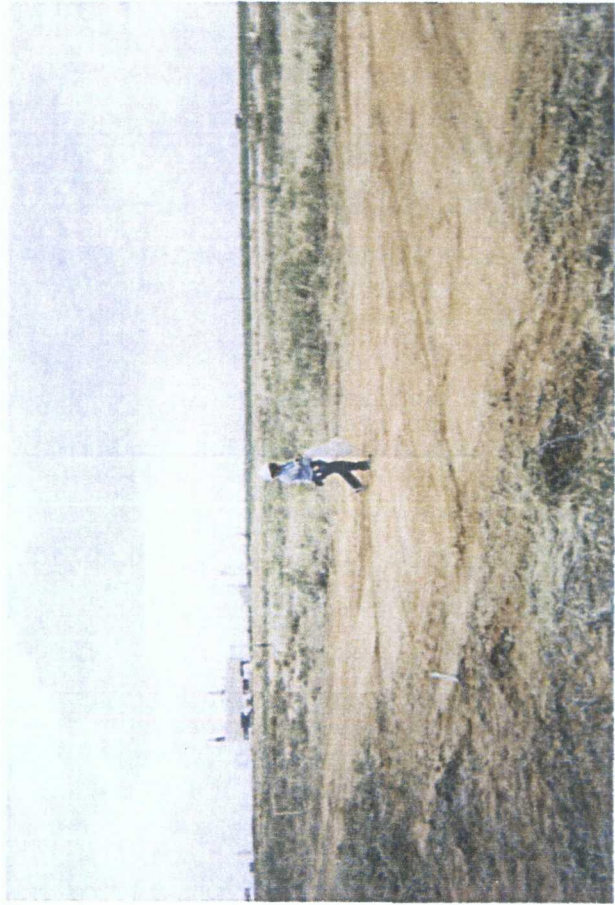
7/9/2008

seeding backfilled site
