BD XTO A L Christmas 'C' Vent EOL

**RICE OPERATING COMPANY  
JUNCTION BOX DISCLOSURE\* REPORT**

Unit E, Section 18, T22S, R37E

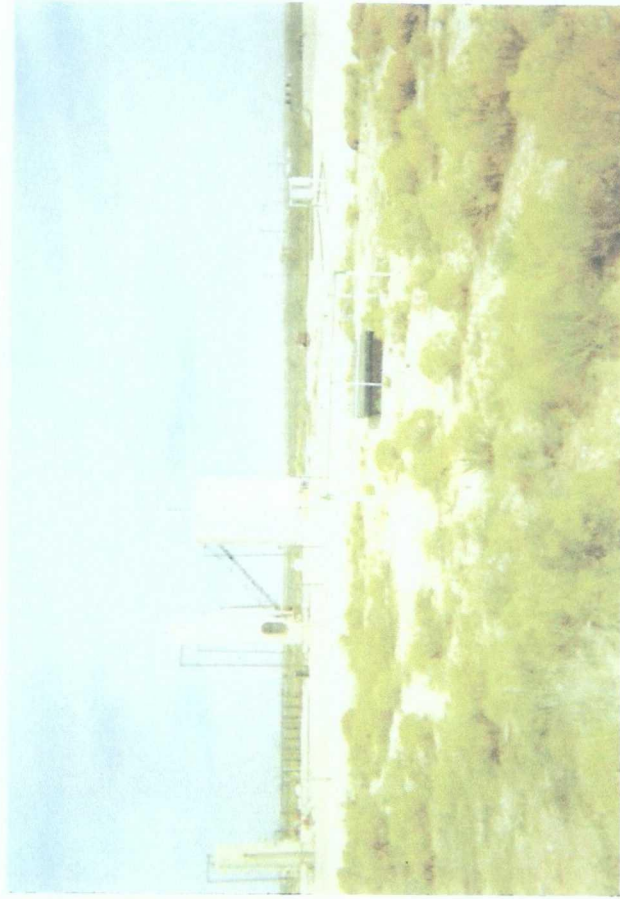
undisturbed junction box, facing north

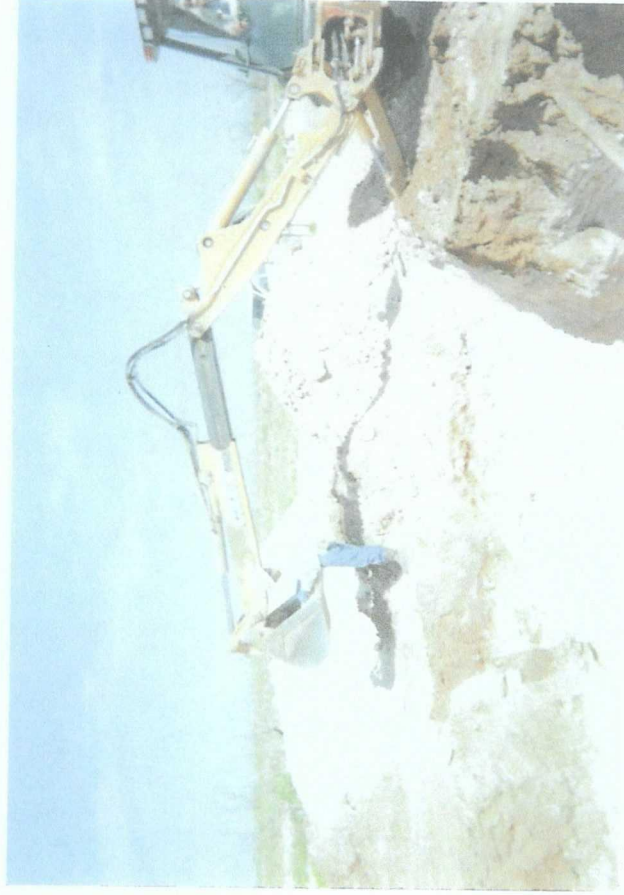
taking samples of excavation

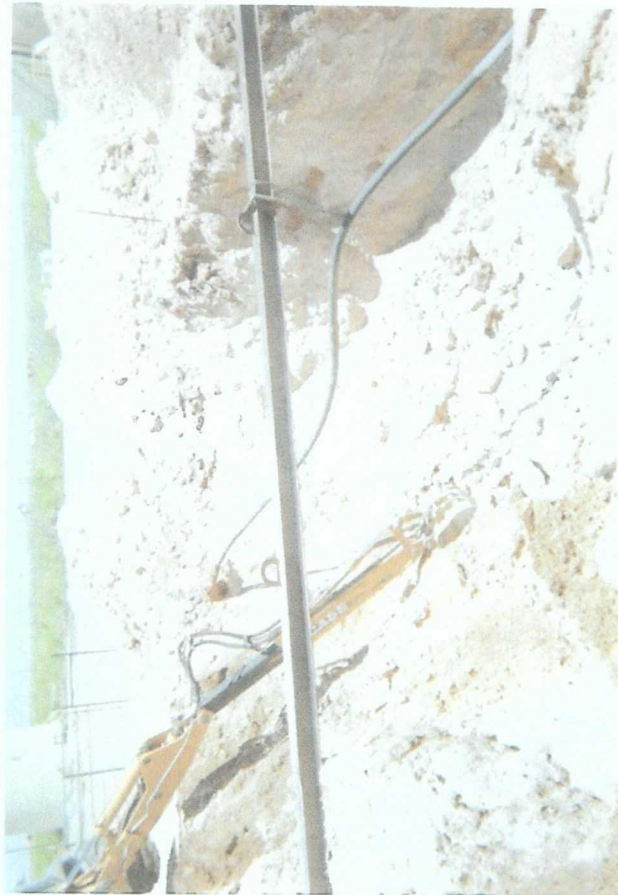
squaring excavation

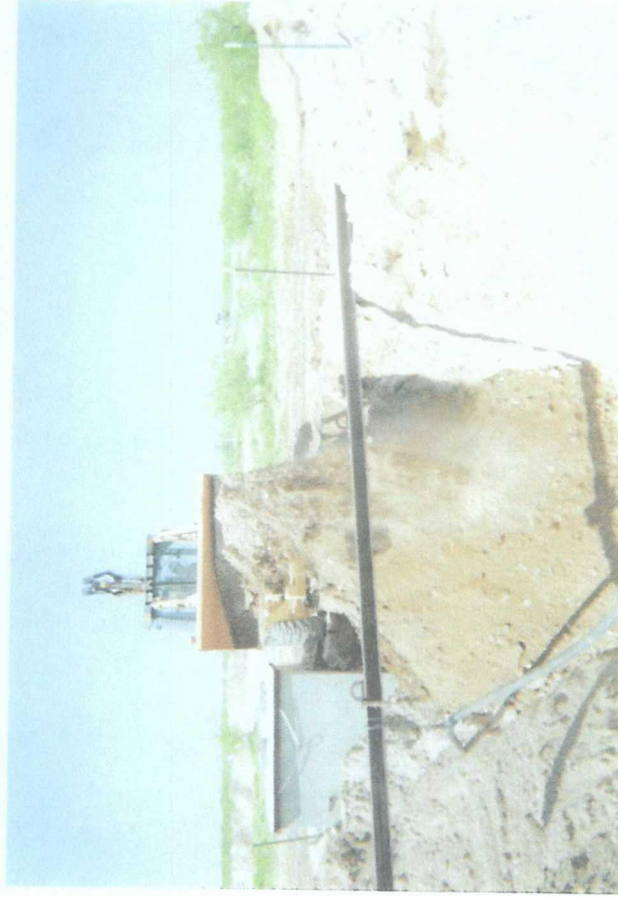
backfilling excavation up to 6 ft BGS

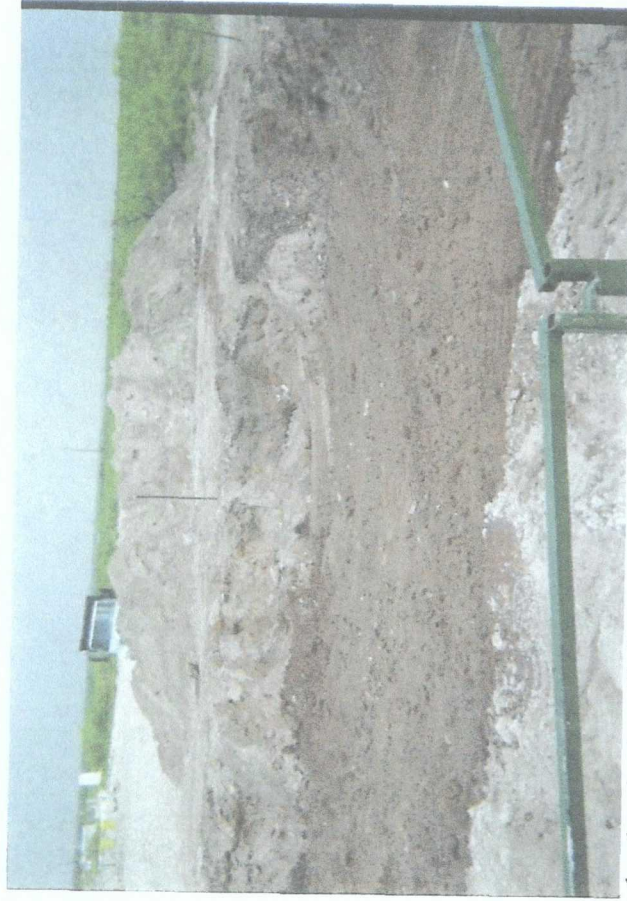
clay barrier installed

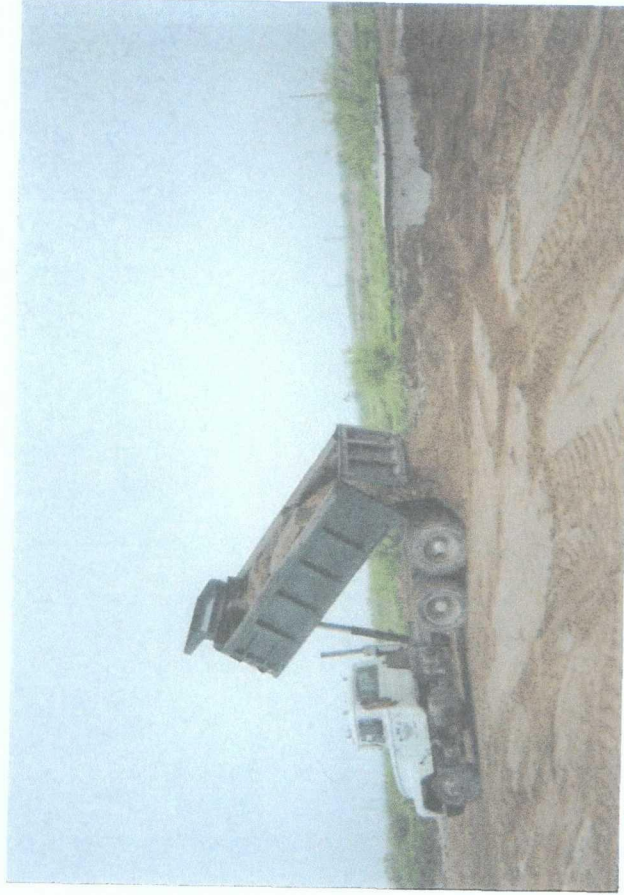
unloading clean, imported top soil

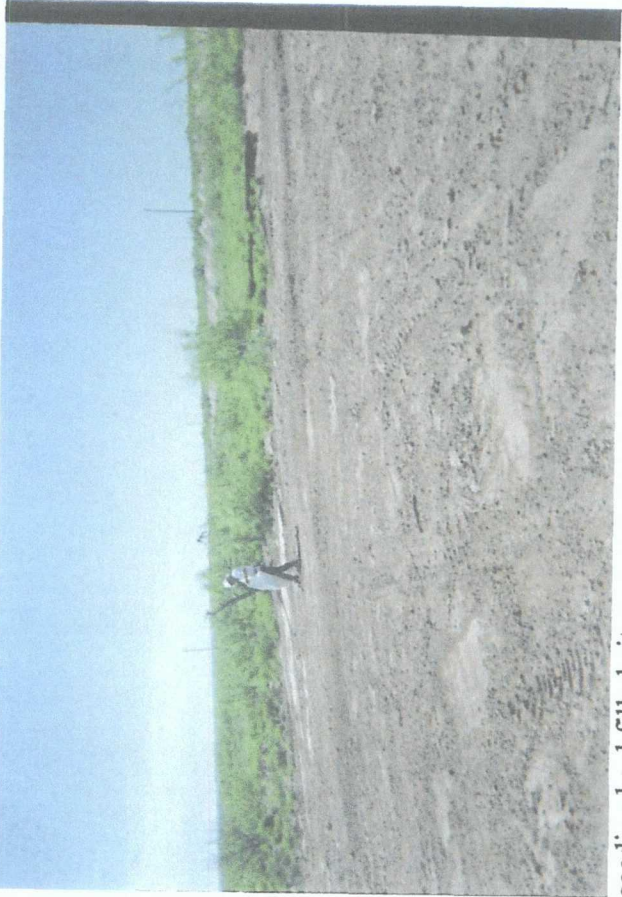
seeding backfilled site

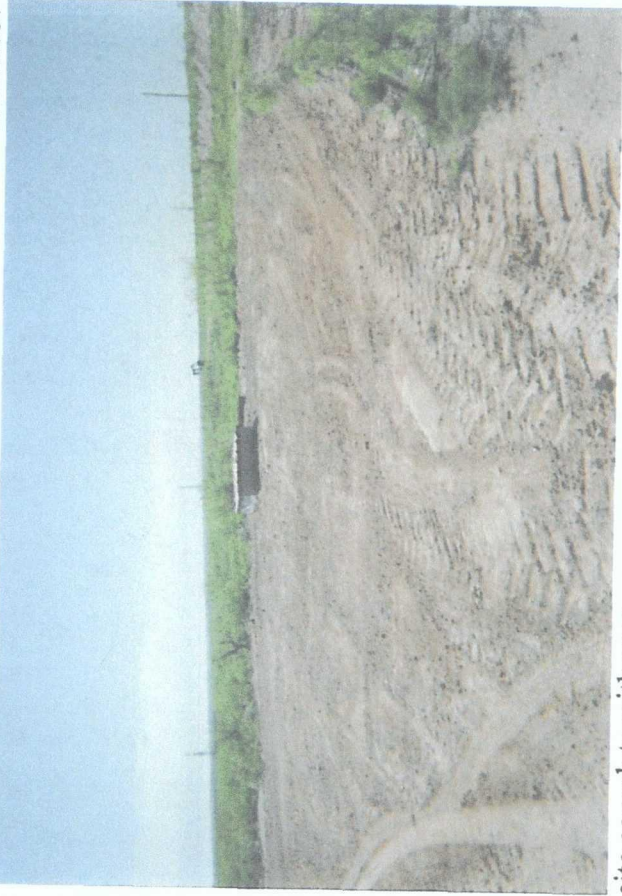
site complete with new,  
watertight junction box in background

General Description of Remedial Action: This junction was addressed as part of the pipeline replacement/upgrade program. A new, watertight junction box was installed 10 ft south of the former. After the former box was removed, an investigation was conducted using a backhoe to collect soil samples at regular intervals producing a 30x30x12-ft-deep hole. Chloride field tests were performed on each sample, which yielded elevated levels of chloride that did not relent with depth. Organic vapors were measured using a PID, which yielded low concentrations. Representative composite samples were sent to a commercial laboratory for analysis. The excavated soil was blended on-site and returned to the excavation up to 6 ft below ground surface. At 6-5 ft BGS, a 1-ft-thick clay barrier was installed. The remaining fill was then returned to the excavation to ground surface. Clean, imported soil was used to top cap the site and to contour to the surrounding area. On 5/21/2007, the site was seeded with a blend of native vegetation and is expected to return to a productive capacity at a normal rate. NMOCD was notified of potential groundwater impact on 8/4/2008.
