Closure

**RICE OPERATING COMPANY  
JUNCTION BOX FINAL REPORT**

# EME Jct. D-4

Unit D, Section 4, T20S, R37E

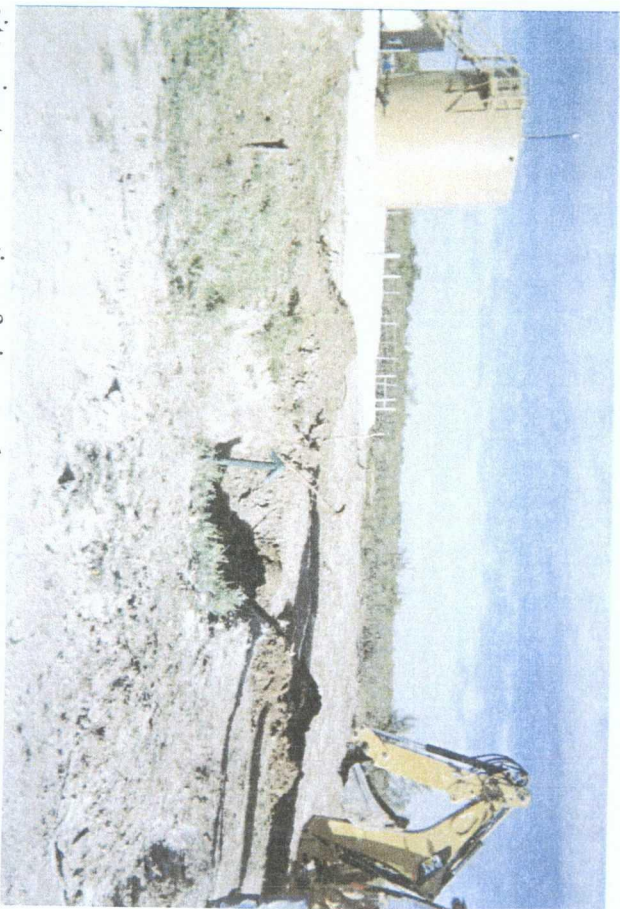
11/01/2007

site prior to excavating, facing north

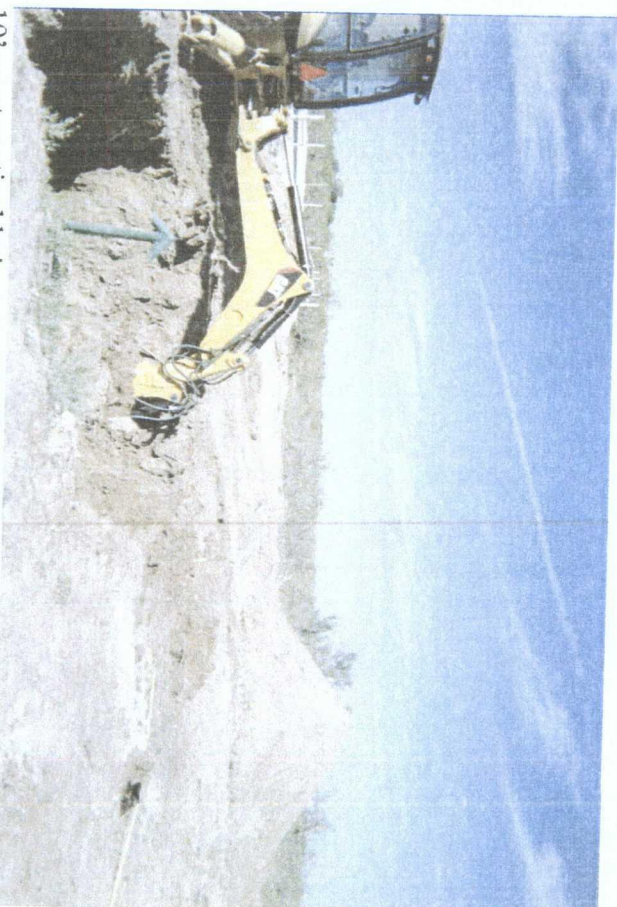
11/01/2007

10' west vertical being excavated

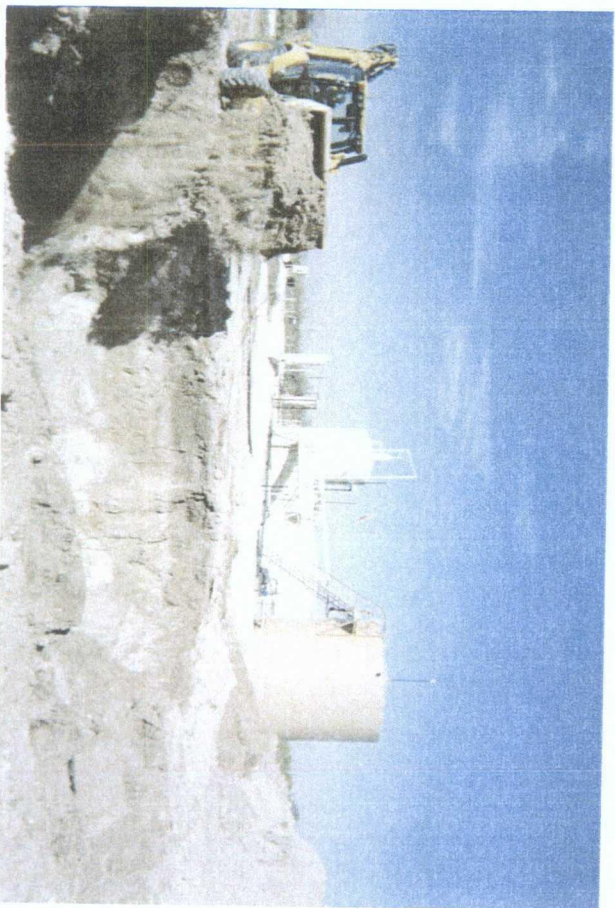
11/12/2007

backfilling excavation site, facing west

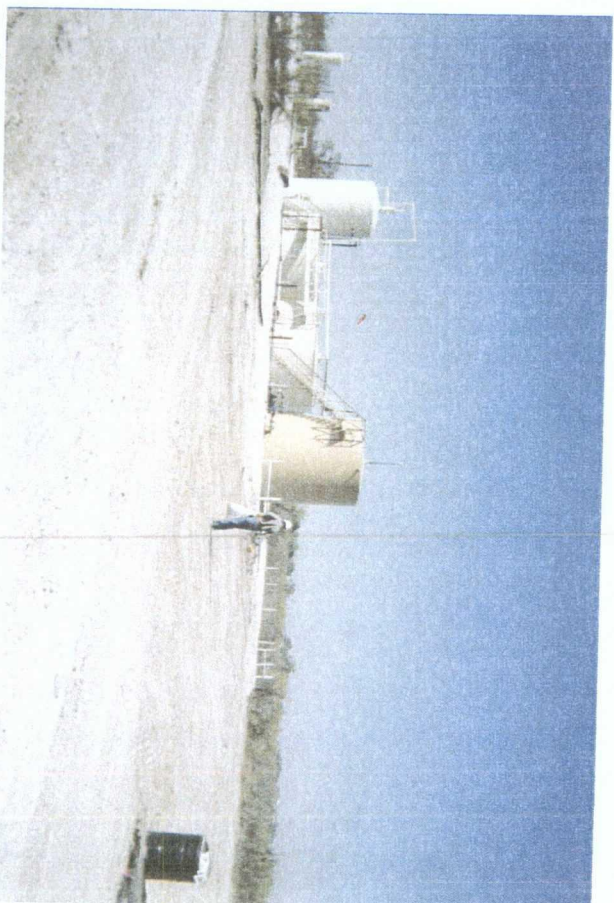
11/13/2007

seeding backfilled site, facing northwest

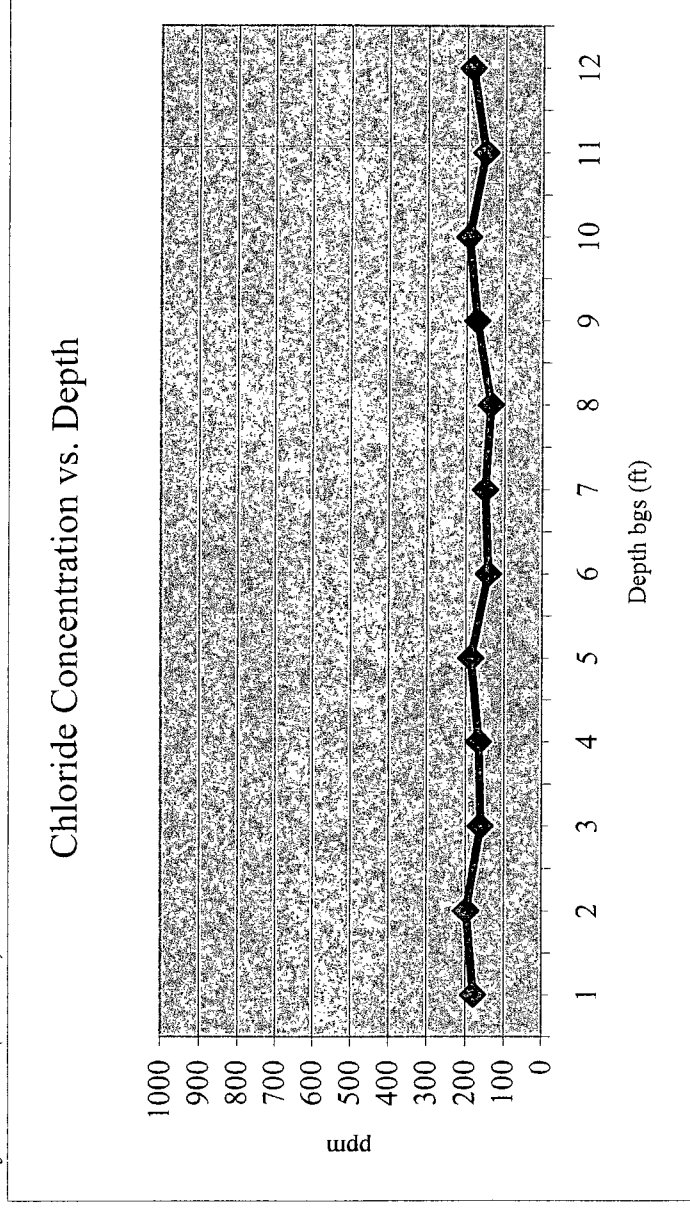
# CHLORIDE CONCENTRATION CURVE

Backhoe samples at 25' north of former junction (source)

Depth bgs (ft)	[Cl <sup>-</sup> ] ppm
1	179
2	198
3	161
4	166
5	187
6	142
7	150
8	136
9	172
10	194
11	151
12	185

Groundwater = 22 ft
