**RICE OPERATING COMPANY
JUNCTION BOX FINAL REPORT**

SWD SYSTEM	JUNCTION	UNIT	SECTION	TOWNSHIP	RANGE	COUNTY	BOX DIMENSIONS - FEET		
Eunice Monument Eumont (EME)	Jct. D-9 boot (2 boxes)	D	9	20S	37E	Lea	Length	Width	Depth
							moved 160 ft southeast

EME Jct. D-9 boot

Unit D, Section 9, T20S, R37E

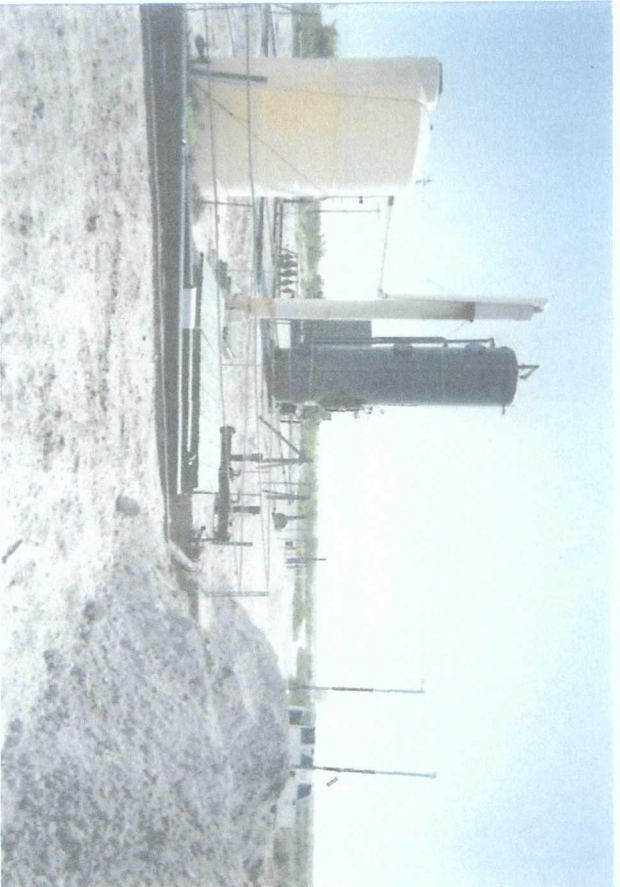
undisturbed junction boxes, facing south

8/9/2007

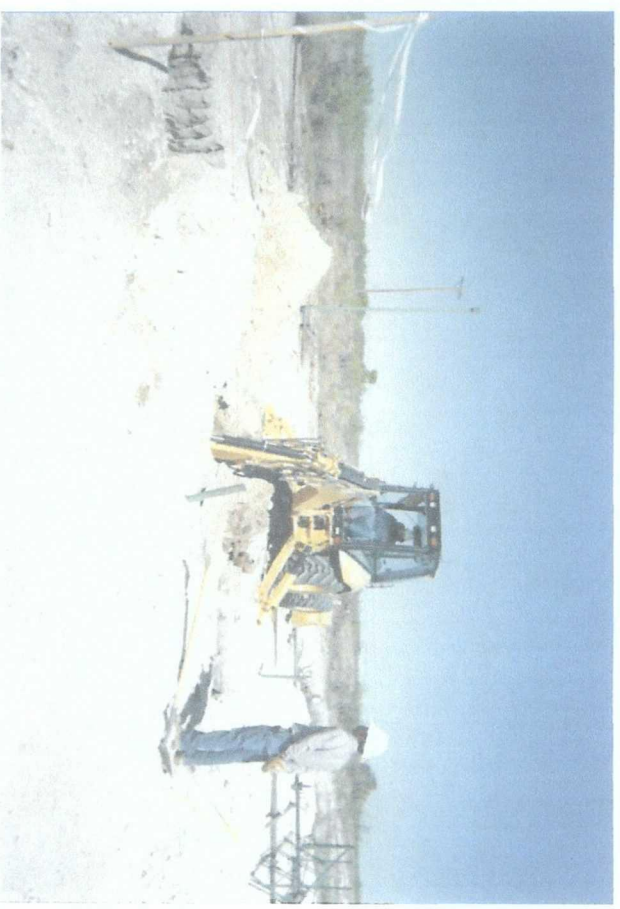
delineation trench, facing north

10/30/2007

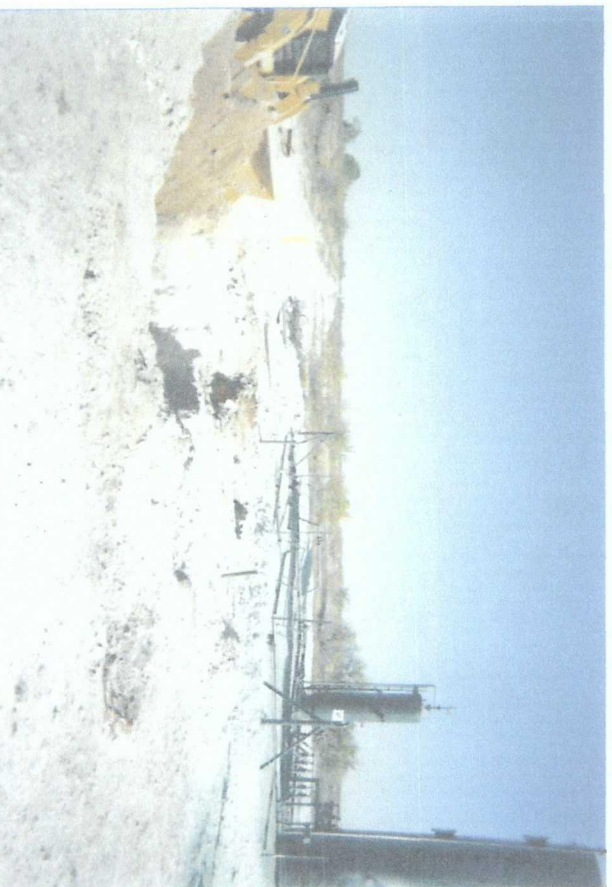
backfilling excavation site

11/09/2007

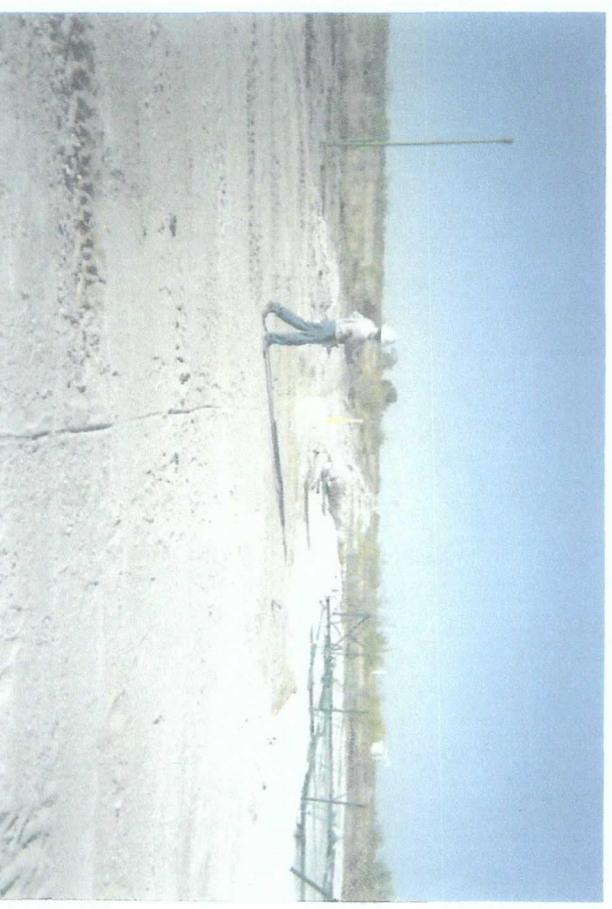
seeding backfilled site, facing north

11/09/2007

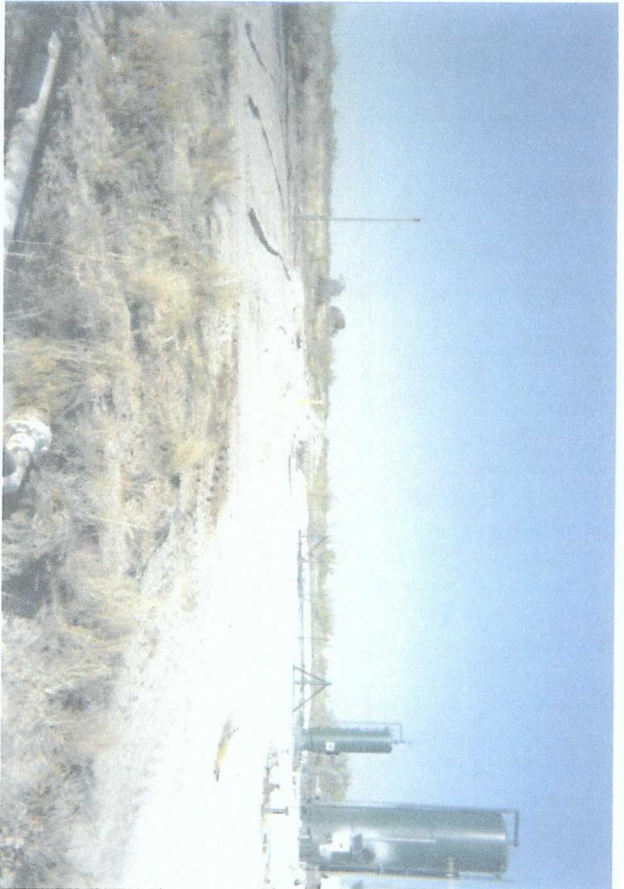
site complete, facing north

11/09/2007

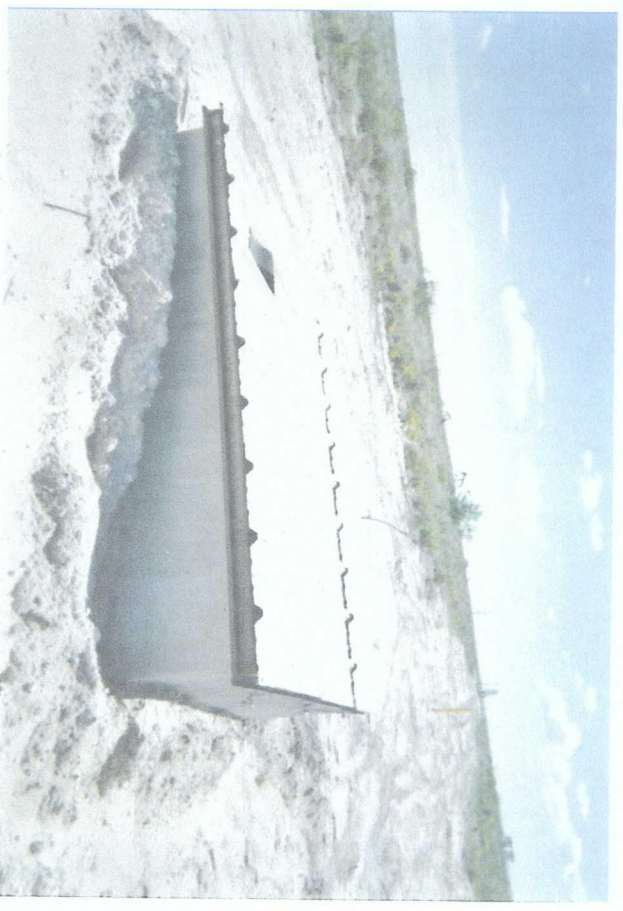
new, watertight junction box

9/24/2007

General Description of Remedial Action: These junction boxes were addressed under the pipeline replacement/upgrade program. A new, watertight junction box was installed 160 ft southeast of the former site. After the lumber was removed, an investigation was conducted using a backhoe to collect soil samples at regular intervals producing a 2.5x6x12-ft-deep hole. Chloride field tests were performed on each sample, which yielded low concentrations of chloride, similar to that of the background. Organic vapors were measured using PID, which also yielded low concentrations. A 12 ft grab sample from the source and a backfill composite sample were sent to a commercial laboratory for analysis confirming low concentrations of chloride and organics. The excavated soil was then blended on-site and returned to the excavation and contoured to the surrounding area. On 11/09/2007, the site was seeded with a blend of native vegetation and is expected to return to a productive capacity at a normal rate.
