RICE OPERATING COMPANY JUNCTION BOX FINAL REPORT

EME Finley McQuarter EOL

Unit 'G', Sec. 11, T21S, R36E

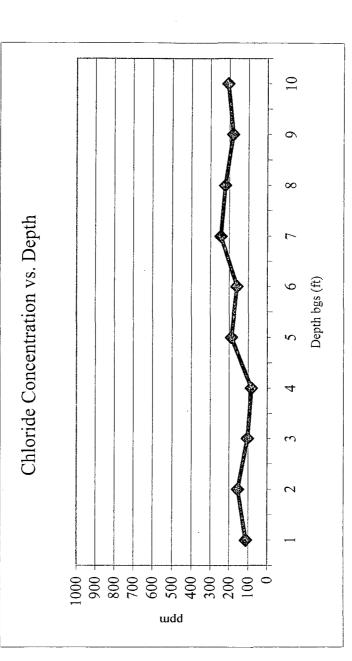
CHLORIDE CONCENTRATION CURVE

Backhoe samples at junction (source)

[C]] ppm 112	154	104	84	189	159	246	222	181	208	191	222
Depth bgs (ft) 1	5	ю	4	5	6	7	8	6	10	11	12

Groundwater = 200 ft
