RICE OPERATING COMPANY JUNCTION BOX FINAL REPORT

EME Jct. 0-7-1

Unit O, Section 7, T19S, R37E

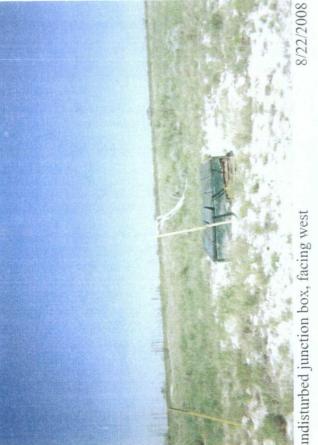
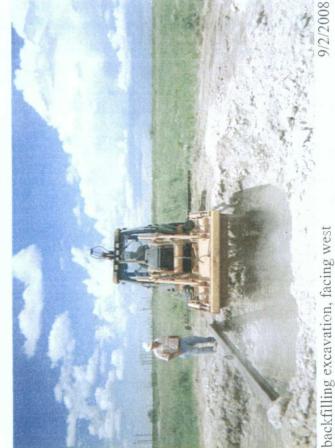
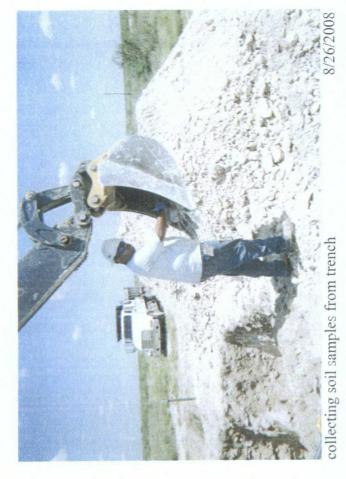
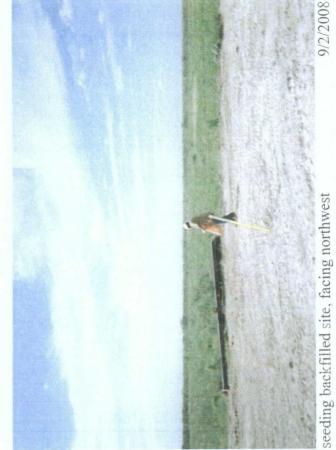
•				•		ackground	6"	172
General Description of I	Remedial	Action:	This junction	n was elimina	ated during th	ie 👘		1'	184
pipeline replacement/upg	rade progra	am. After the	former box w	vas removed	d, an investiga	ation		2'	150
was conducted using a ba	ackhoe to c	collect soil sa	imples at reg	ular intervals	s producing a			3'	207
10x25x12-ft-deep hole. C	hloride field	d tests were	performed or	n each samp	le, which yiel	ded		4'	124
generally low concentration	ons. Organ	ic vapors we	re measured	using a PID	, which also		vertical	5'	234

yielded low concentrations. Representative composite samples were sent to a commercial

laboratory for analysis of chloride and TPH, confirming low concentrations. The excavated

soil was returned to the excavation and contoured to the surrounding area. On 9/2/2008,

the site was seeded with a blend of native vegetation and is expected to return to a

productive capacity at a normal rate.

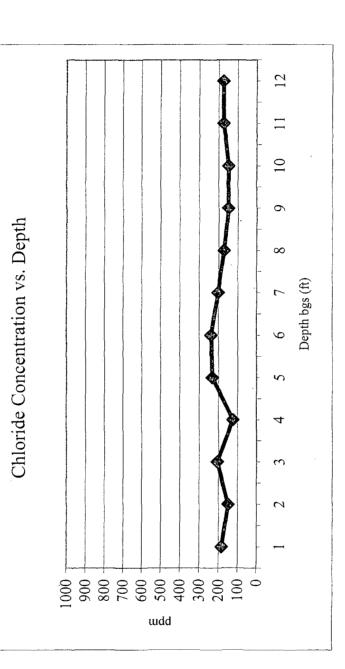
CHLORIDE CONCENTRATION CURVE

Backhoe samples at 15 ft north of the junction (source)

[CI] ppm	184	150	207	124	234	239	204	173	150	149	174	177
Depth bgs (ft)	1	2	3	4	5	6	7	8	6	10	11	12
