EME OXY St 'C' EOL

CLOSURE

**RICE OPERATING COMPANY
JUNCTION BOX FINAL REPORT**

Unit M, Section 16, T21S, R36E

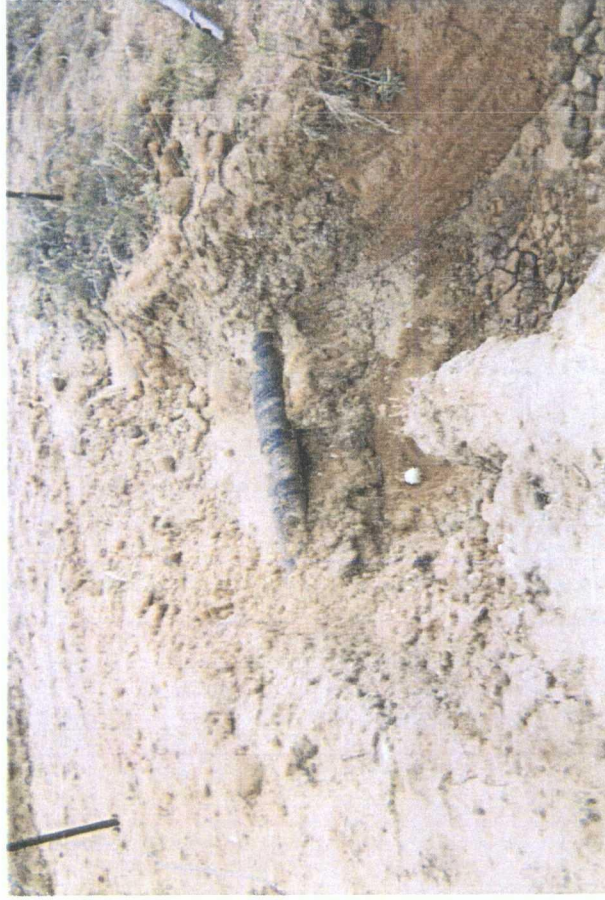
10/21/2008

site prior to excavating, facing east

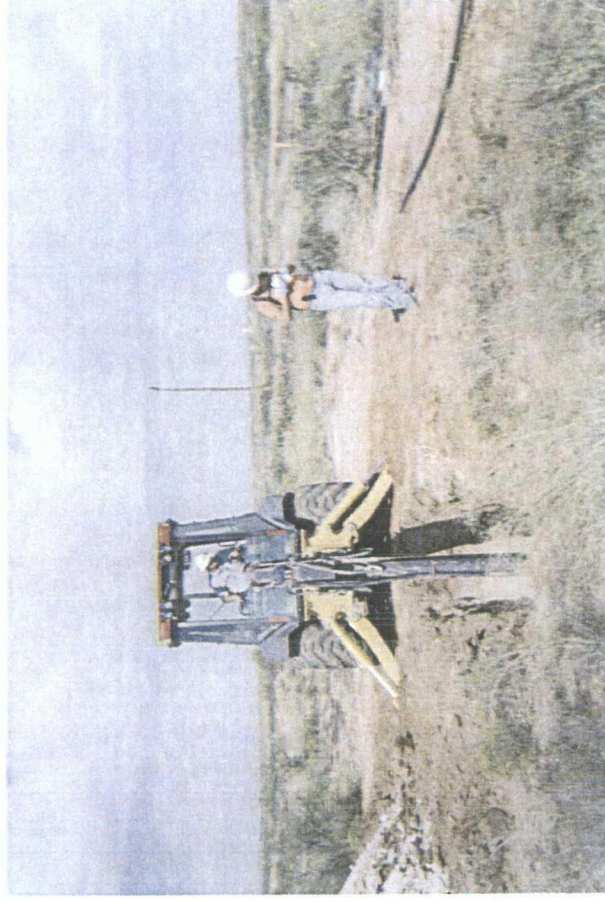
10/21/2008

excavating vertical at the source, facing north

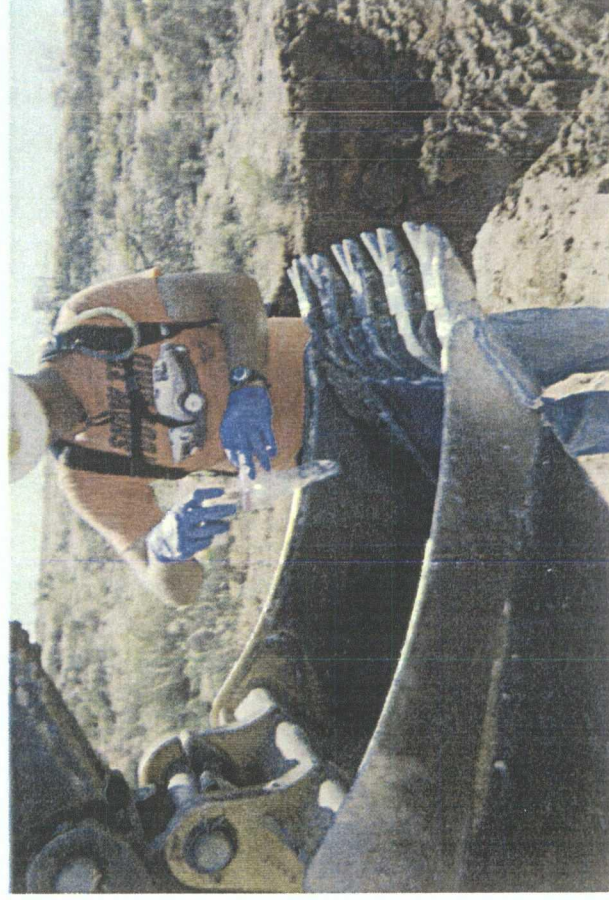
10/21/2008

collecting a soil sample, facing west

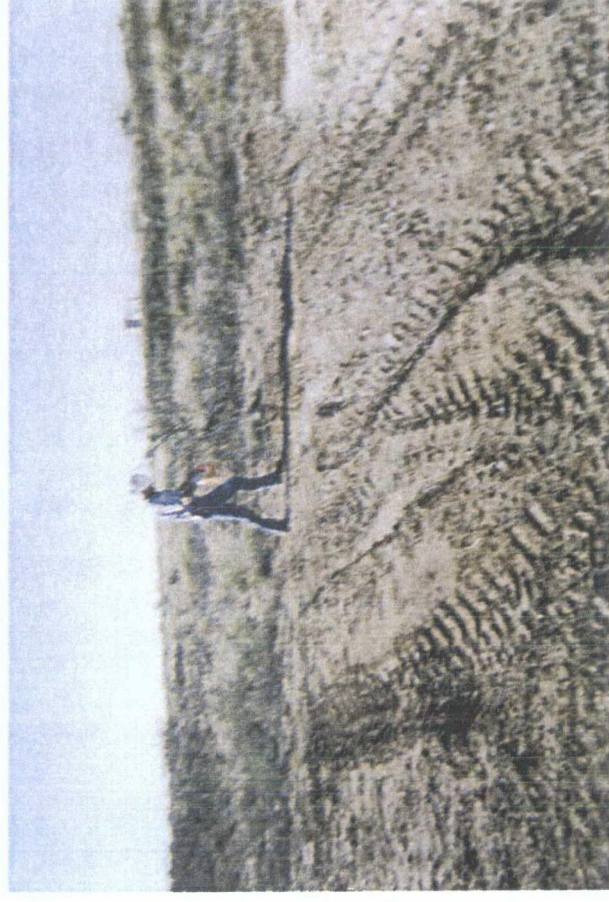
10/31/2008

seeding backfilled site, facing south
