EME Jct F-33 Vent

**RICE OPERATING COMPANY
JUNCTION BOX FINAL REPORT**

EME Jct. F-33 vent

Unit F, Section 33, T20S, R37E

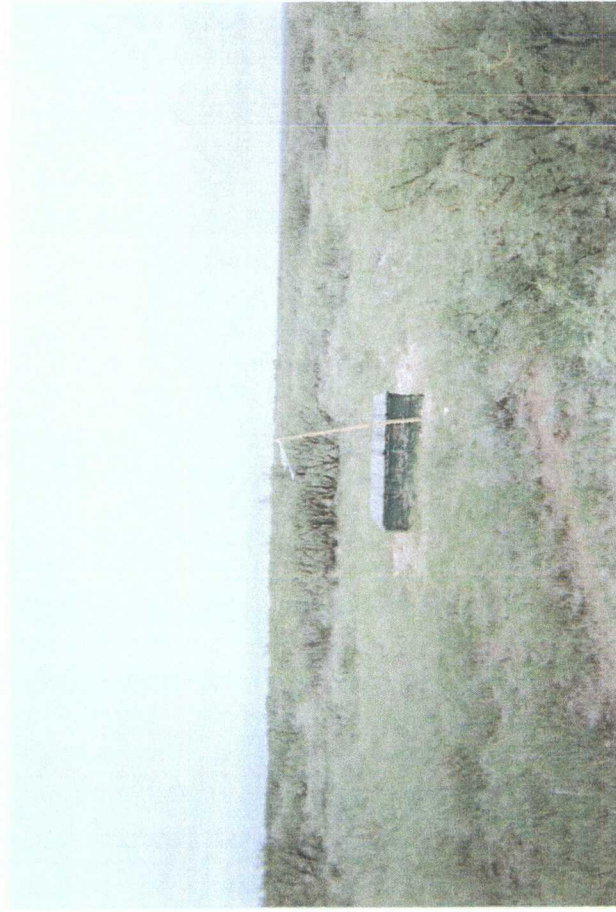
undisturbed junction box, facing west

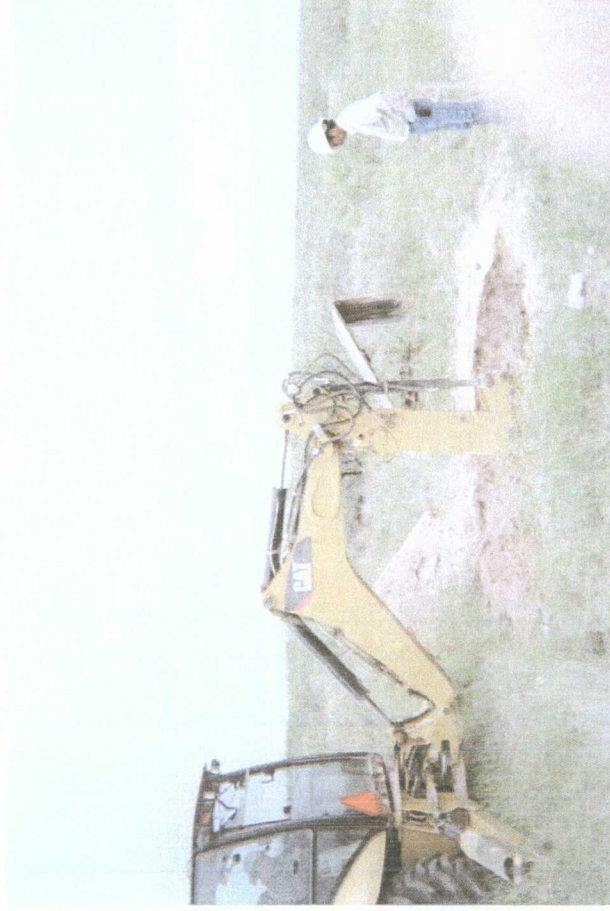
excavating at former junction site, facing west

General Description of Remedial Action: This junction was eliminated during the pipeline replacement/upgrade program. After the former junction box was removed, an investigation was conducted using a backhoe to collect soil samples at regular intervals producing a 5x3x12-ft-deep excavation. Chloride field tests performed on each sample yielded low concentrations, similar to that of the background sample. Organic vapors measured with a PID also yielded low concentrations. The deepest sample, 12 ft BGS, was sent to a commercial laboratory for analysis of chloride and TPH, which confirmed low concentrations. The excavated soil was returned to the excavation to ground surface and contoured to the surrounding area. On 9/3/2008, the site was seeded with a blend of native vegetation and is expected to return to a productive capacity at a normal rate.

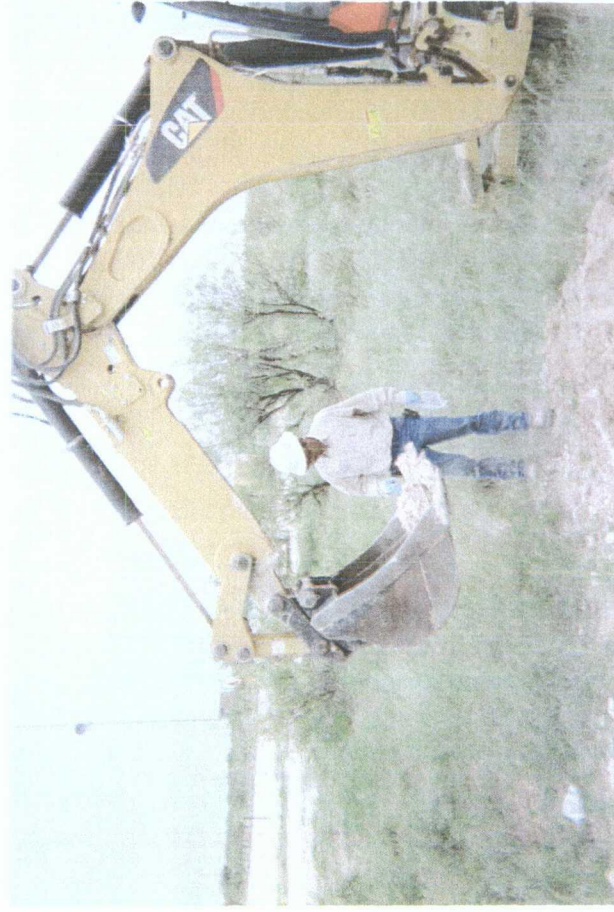
collecting a soil sample, facing east

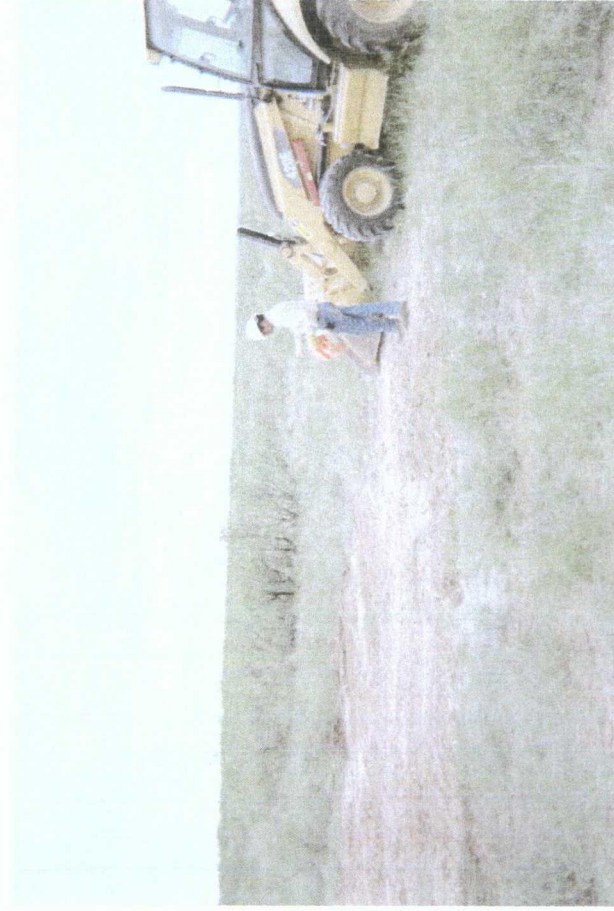
seeding backfilled site, facing west
