EME Jct I-8

**RICE OPERATING COMPANY
JUNCTION BOX FINAL REPORT**

EME Jct. I-8

Unit I, Section 8, T21S, R36E

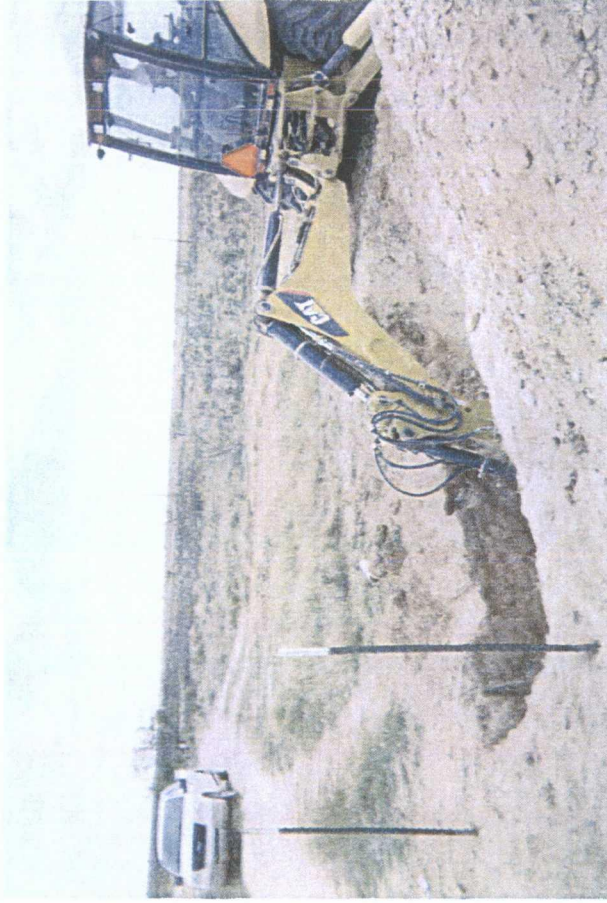
excavating at former junction site, facing east

11/3/2008

General Description of Remedial Action: This junction was eliminated during the pipeline replacement/upgrade program. After the former junction box was removed, an investigation was conducted using a backhoe to collect soil samples at regular intervals producing a 5x3x10-ft-deep excavation. Chloride field tests performed on each sample yielded low concentrations similar to that of the background sample. Organic vapors measured with a PID also yielded low concentrations. The deepest sample, 10 ft BGS, was sent to a commercial laboratory for analysis of chloride and TPH, which confirmed low concentrations. The excavated soil was returned to the excavation to ground surface and contoured to the surrounding area. On 11/7/2008, the site was seeded with a blend of native vegetation and is expected to return to a productive capacity at a normal rate.

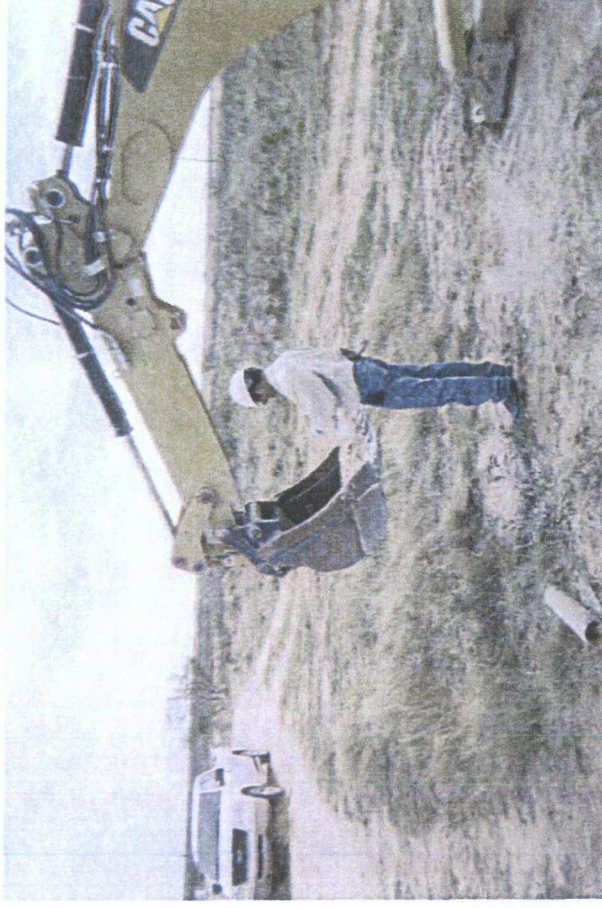
collecting a soil sample, facing east

11/3/2008

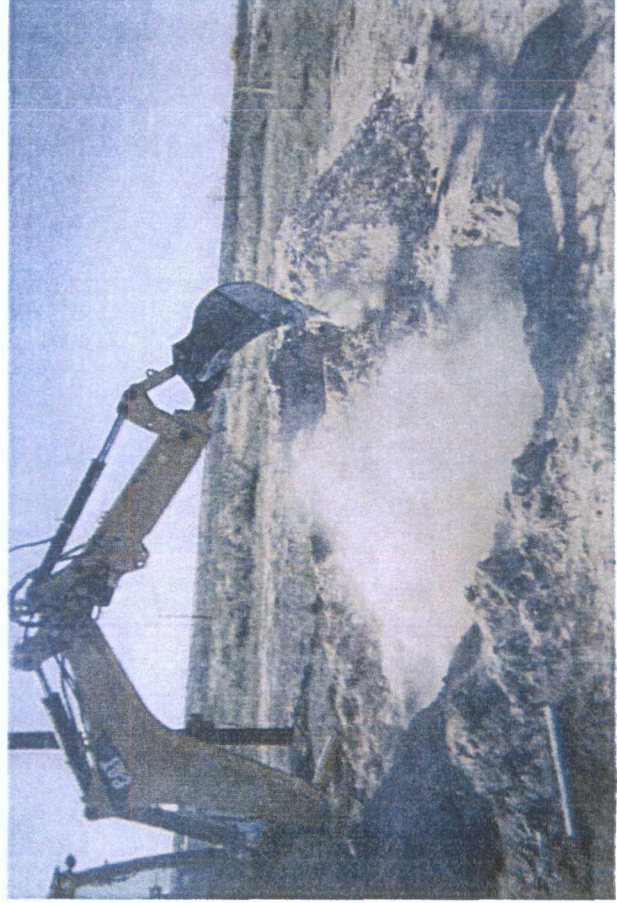
backfilling excavation, facing west

11/3/2008

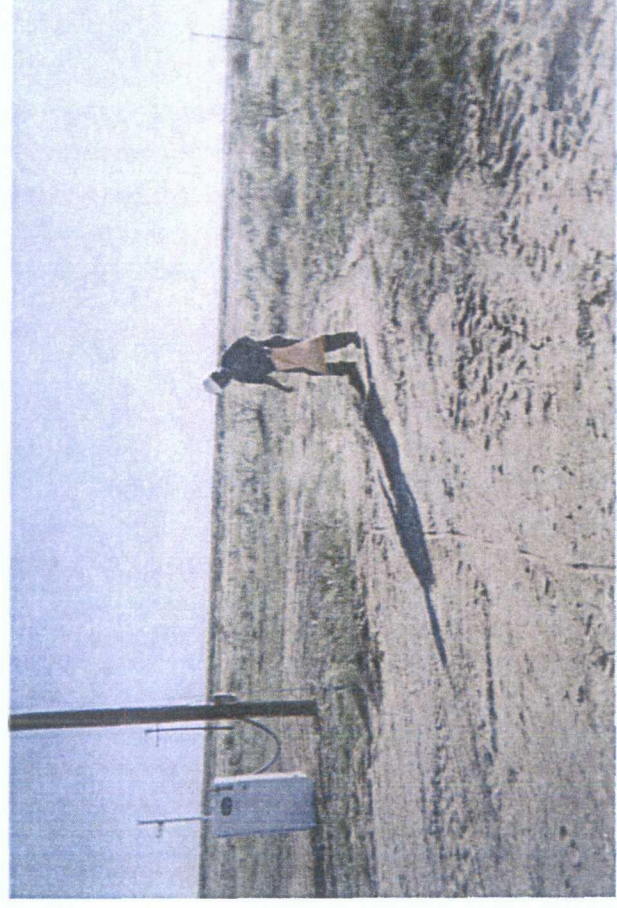
seeding backfilled site, facing south

11/7/2008
