EME Jct C-6

**RICE OPERATING COMPANY
JUNCTION BOX FINAL REPORT**

SWD SYSTEM	JUNCTION	UNIT	SECTION	TOWNSHIP	RANGE	COUNTY	BOX DIMENSIONS - FEET		
Eunice Monument Eumont (EME)	Jct. C-6	C	6	21S	36E	Lea	Length 6'	Width 8'	Depth 5'
							eliminated

General Description of Remedial Action: This junction was eliminated during the pipeline replacement/upgrade program. After the former junction was removed, an investigation was conducted using a backhoe to collect soil samples at regular intervals producing a 30x30x12-ft-deep excavation. Chloride field tests were performed on each sample, which yielded generally low concentrations. Organic vapors measured using a PID yielded some elevated concentrations. Representative composite samples were sent to a commercial laboratory for analysis of chloride, TPH, and BTEX which confirmed low concentrations. The excavated soil was blended on-site, returned to the excavation to ground surface, and contoured to the surrounding area. On 10/1/2008, the site was seeded with a blend of native vegetation and is expected to return to a productive capacity at normal rate.

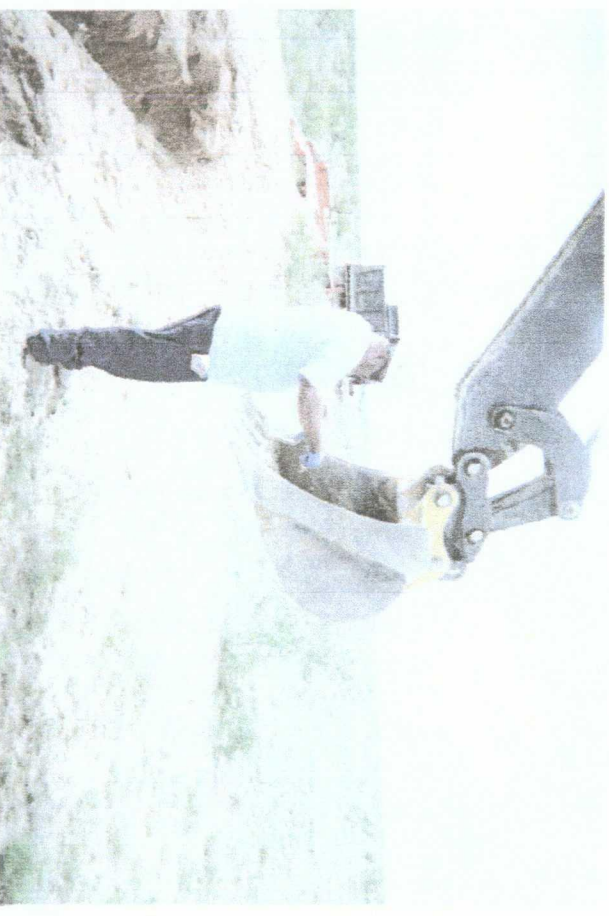
8/29/2008

collecting a soil sample

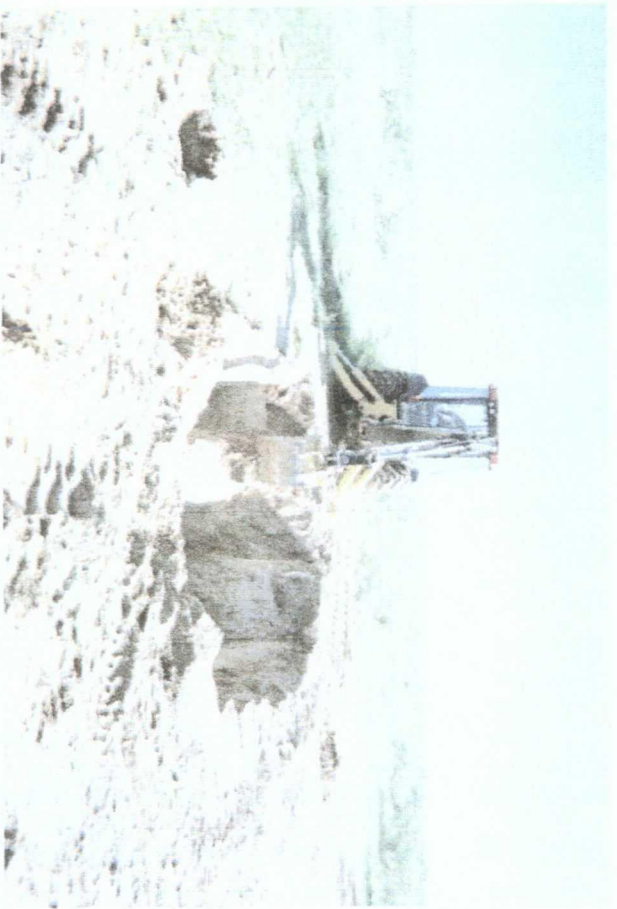
9/2/2008

excavating at former junction site, facing south

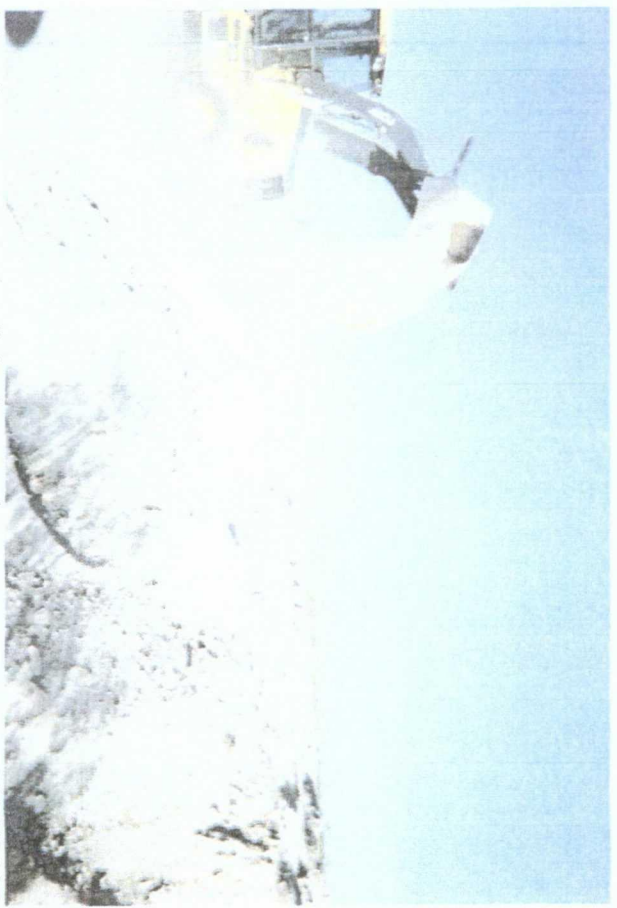
9/17/2008

blending excavated soil, facing north

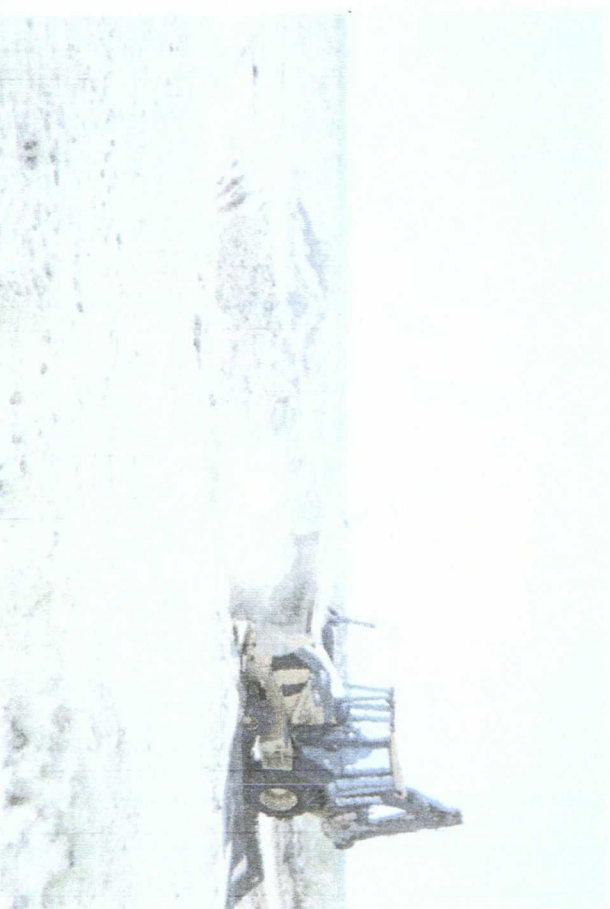
10/1/2008

backfilling excavation, facing east

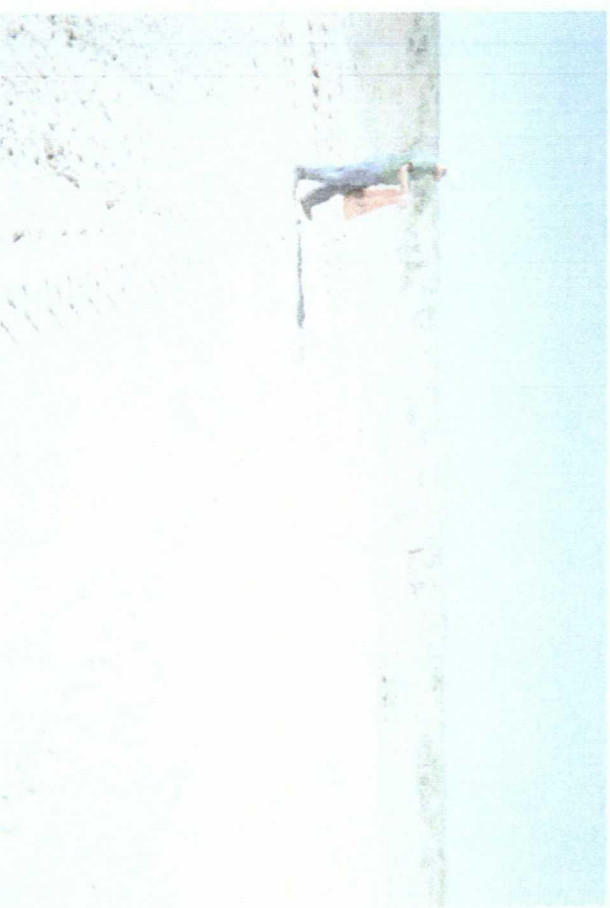
10/1/2008

seeding backfilled site, facing north
