EME Jct J-20

CLOSURE

**RICE OPERATING COMPANY
JUNCTION BOX FINAL REPORT**

Unit J, Section 20, T21S, R36E

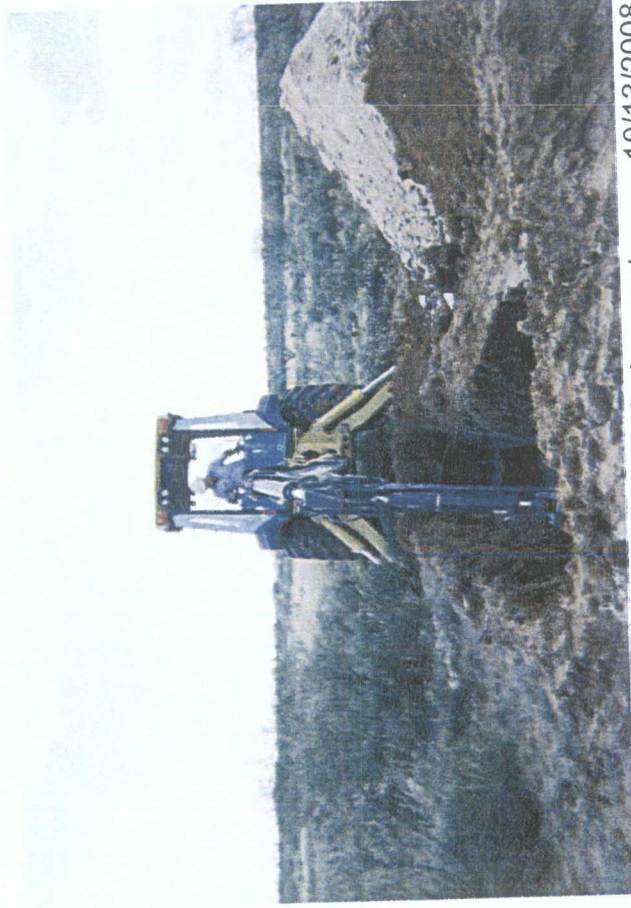
excavating at former junction site, facing west

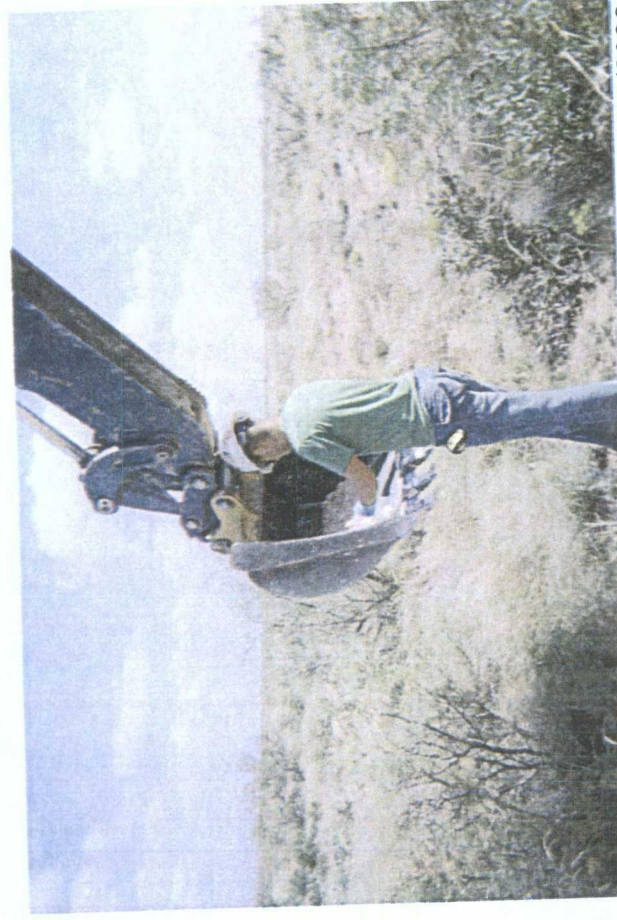
collecting a soil sample, facing west

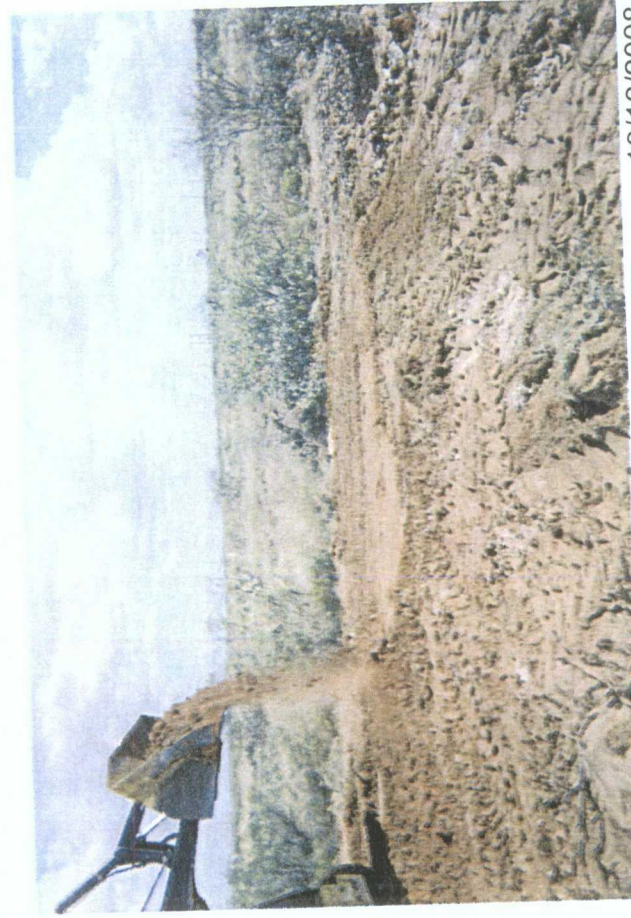
backfilling excavation, facing east

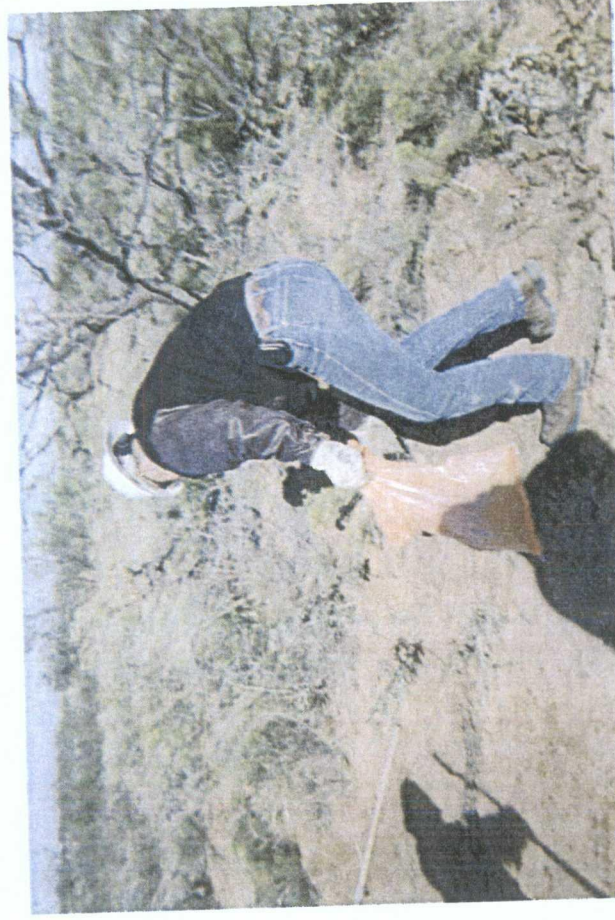
seeding backfilled site, facing north

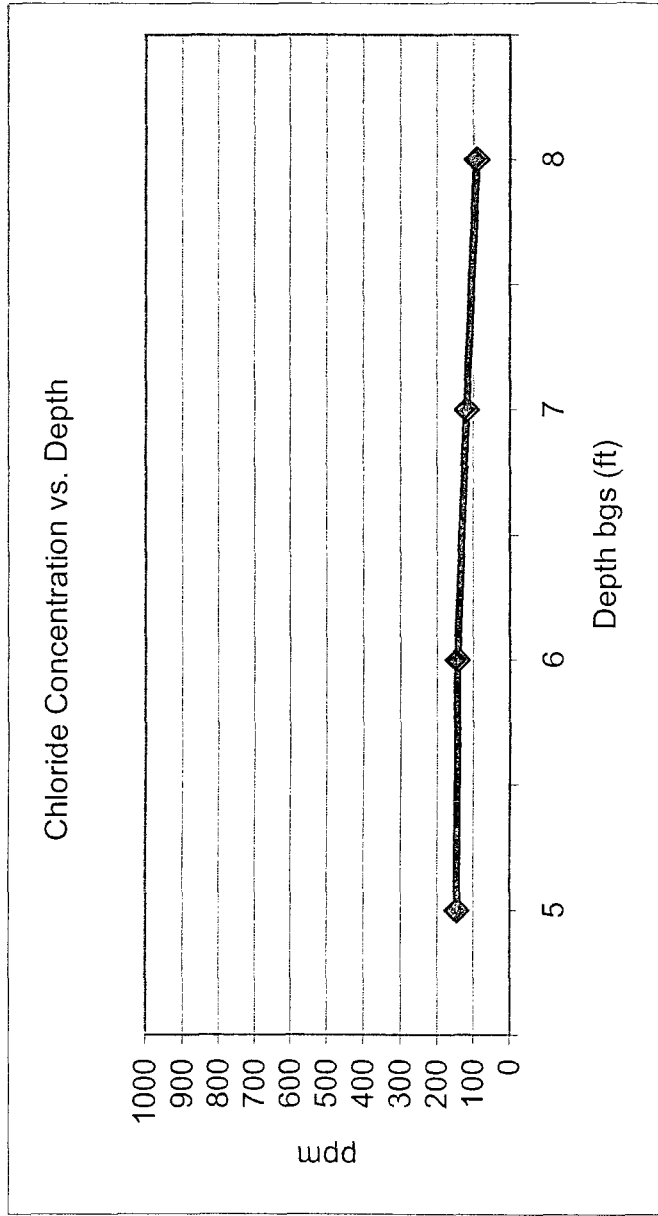
CHLORIDE CONCENTRATION CURVE

Backhoe samples at the junction (source)

Depth bgs (ft)	Cl ppm
5	146
6	144
7	119
8	91

Groundwater = 180 ft
