EME Jct G-7

RICE OPERATING COMPANY JUNCTION BOX FINAL REPORT

EME Jct. G-7

Unit G, Section 7, T21S, R36E

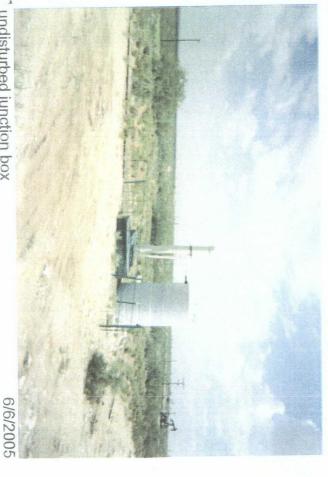
undisturbed junction box

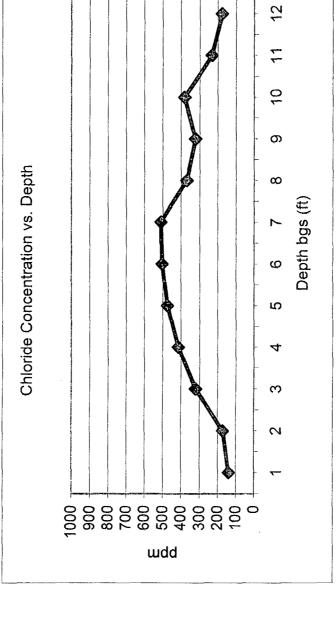
EME JCt. G.7Unit 'G', Sec. 7, T21S, R36E

Backhoe samples at 10 ft west of the junction (source)

[G] ppm 140	171	321	414	473	503	510	369	323	382	233	177
Depth bgs/(ff)	2	3	4	5	9	7	8	6	10	11	12

Groundwater = 234 ft

LOCATION	DEPTH	mg/kg		
4-wall comp.	n/a	501		
bottom comp.	12'	319		
blended backfill	n/a	410		
background	6"	229		
vertical delineation	1'	140		
	2'	171		
	3'	321		
	4'	414		
	5'	473		
trench at 10 ft	6'	503		
west of the	7'	510		
junction (source)	8'	369		
(200.00)	9'	323		
	10'	382		
	11'	233		
	12'	177
