**Investigation and Characterization Report and Termination Request
Rice Operating Company – BD SWD System
BD P-35-1 Jct
UL P Sec 35 T 21S R 37E¹
NMOCD Case Number: 1R426-150**

Investigation and Characterization Report and Termination Request

BD P-35-1 Jct

NMOCD Case Number: 1R426-150

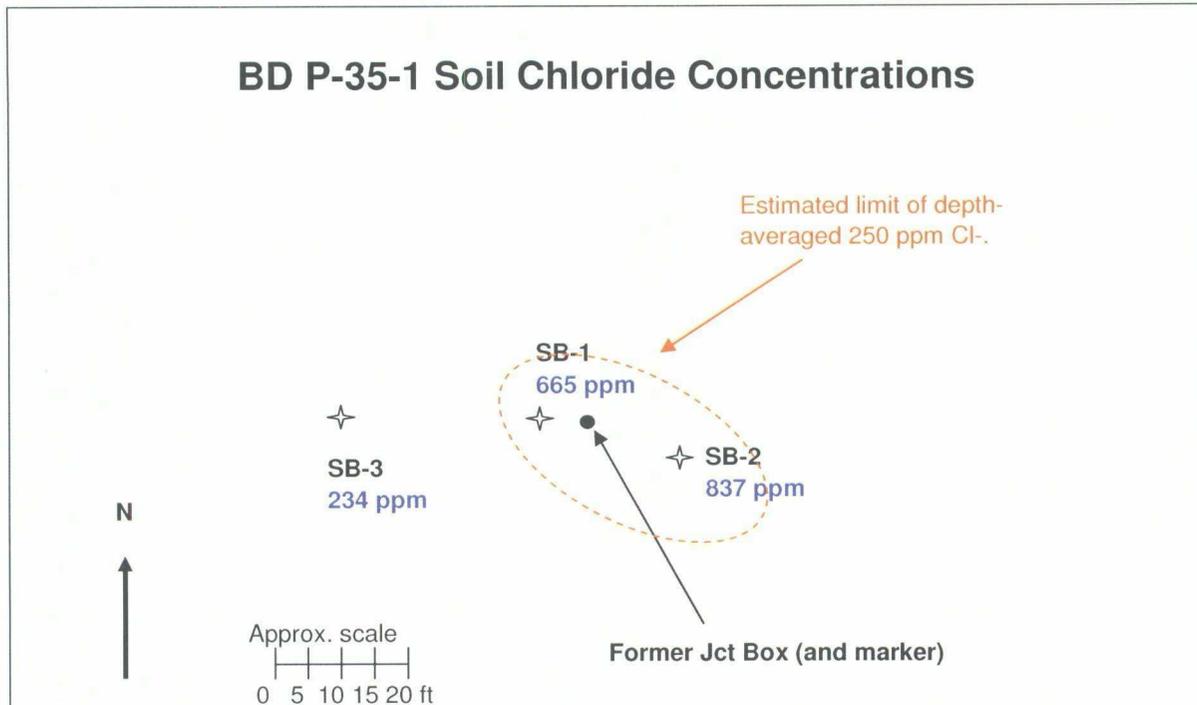
Figure 3a – Approximate soil boring locations and field-measured soil chloride concentrations. The depth-averaged soil chloride concentration within the affected area is 751 ppm. We estimate the natural background soil chloride concentration to be 100 ppm. Therefore, the net depth-averaged soil chloride concentration within the affected area is estimated as 751 ppm – 100 ppm = **651 ppm**.

Three soil borings were advanced at and near the location of the former junction box to depths of 40 to 50 ft bgs (Figures 3a, 3b). Depth-averaged Soil chloride concentrations averaged 751 ppm among two soil borings within the affected area. After subtracting the presumed natural background soil chloride concentration of 100 ppm, the net depth averaged soil chloride concentration from the junction box is estimated to be 651 ppm. Soil petroleum hydrocarbons were found to be below detection by both PID field reading and by laboratory analysis (Appendix B2).

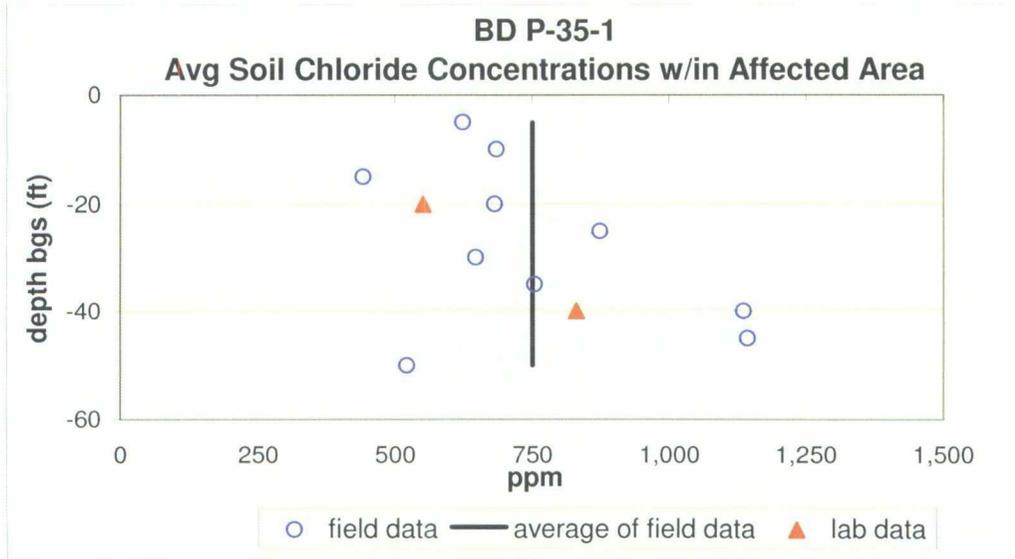
Figure 3b – Average soil chloride and petroleum hydrocarbon concentrations from two soil borings taken within the area affected of the former junction box.

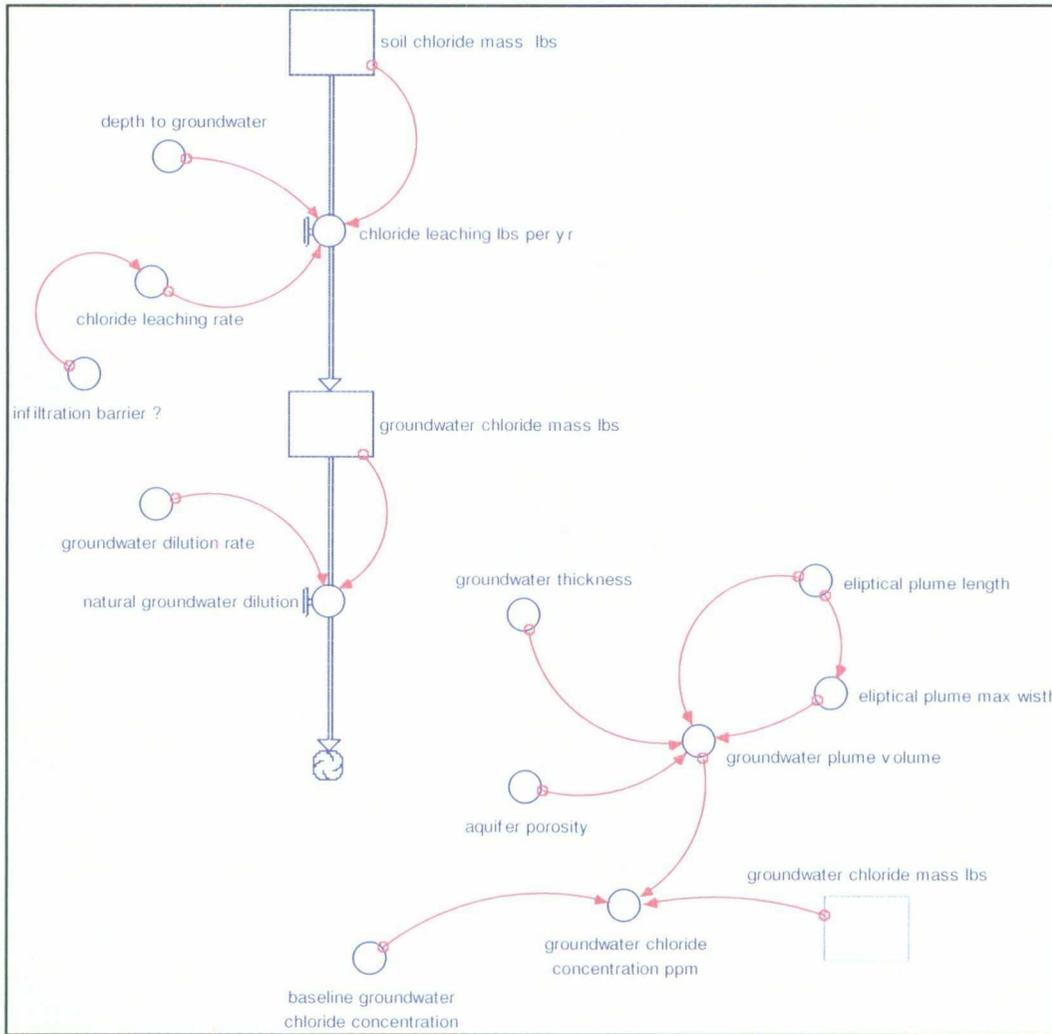
Figure 5- Schematic diagram of soil chloride – groundwater dilution model.

The total mass of residual soil chlorides at this location was estimated to be 2,760 lbs (Figure 4). In order to determine if these residual soil chlorides represent a potential hazard to down gradient groundwater quality, a simple soil chloride transport and groundwater dilution model (Figures 5 & 6) was developed to estimate the potential effect of this residual soil chloride leaching into groundwater over time given the following assumptions:

1. The center of mass of residual chlorides moves downward at a rate of 2.0 ft/yr.
2. It is assumed that these chlorides mix uniformly within an elliptical groundwater plume of dimensions 250 ft maximum length by 100 ft maximum width through a depth of 15 ft of the water table aquifer.
3. Natural dilution of the plume occurs at a rate of 10% per year.

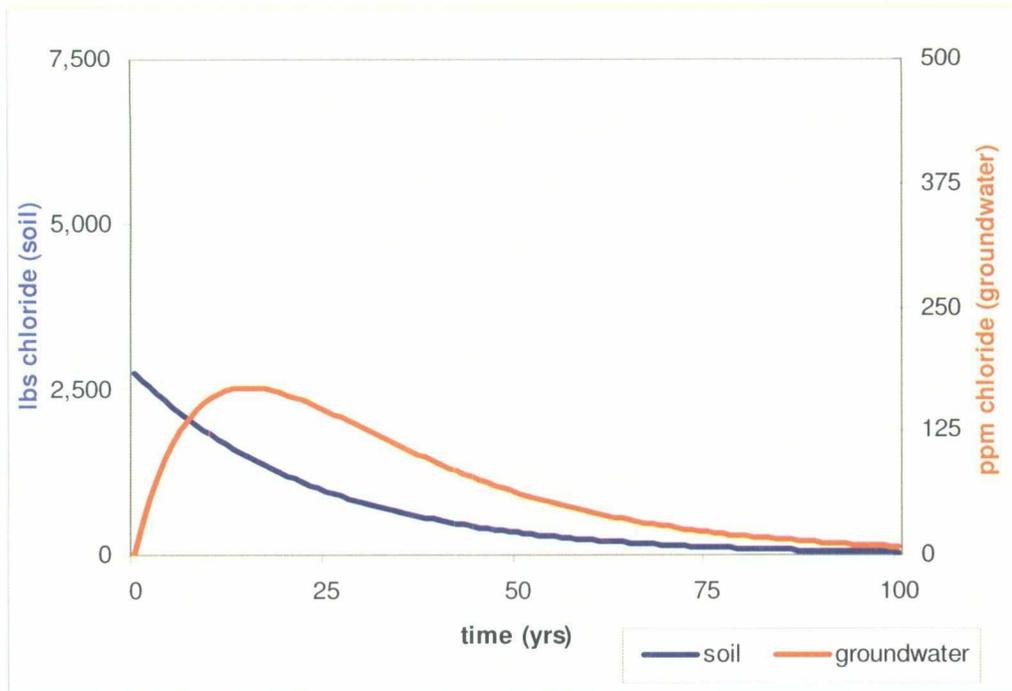
Figure 7 – Estimated change in baseline groundwater chloride concentrations (right axes) over time. The maximum projected elevation in baseline groundwater chloride concentration is 168 ppm.

The model predicted that maximum anticipated elevation of groundwater chlorides caused by the movement of residual soil chlorides is 168 ppm (Figure 7), indicating that residual soil chlorides should not represent a significant hazard to groundwater quality. An initial sample from an at-source monitor well (MW-1) exhibited a chloride concentration of 352 ppm (Appendix C4). However, it is to be expected that chloride concentrations at/near the center of the former junction box would be higher than the model-predicted average value over the volume of the reference plume.

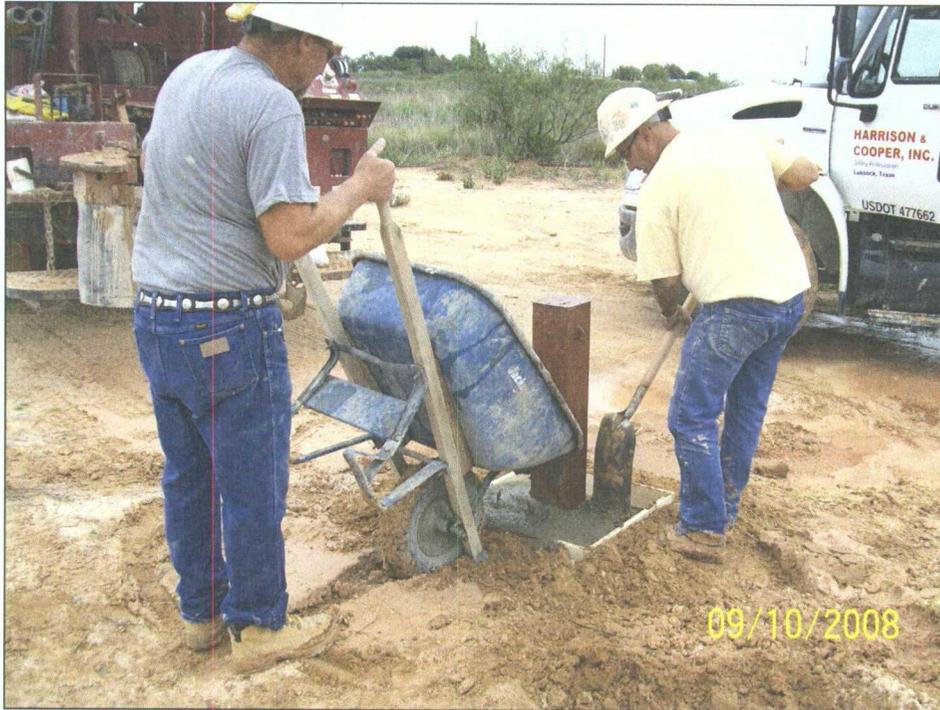
Appendix D – Harrison and Cooper completing MW-1.
