RE: Submittal of **ICP Reports and Termination Requests** for
NMOCD Case Nos. 1R426-117 (BD Oxy Owen A), **1R426-150** (BD P-35-1),
1R427-181 (EME Phillips B EOL) and **1R427-06** (EME O-19 Jct)

**Investigation and Characterization Report and Termination Request
Rice Operating Company – BD SWD System
BD P-35-1 Jct
UL P Sec 35 T 21S R 37E¹
NMOCD Case Number: 1R426-150**

NMOCD Case Number: 1R426-150

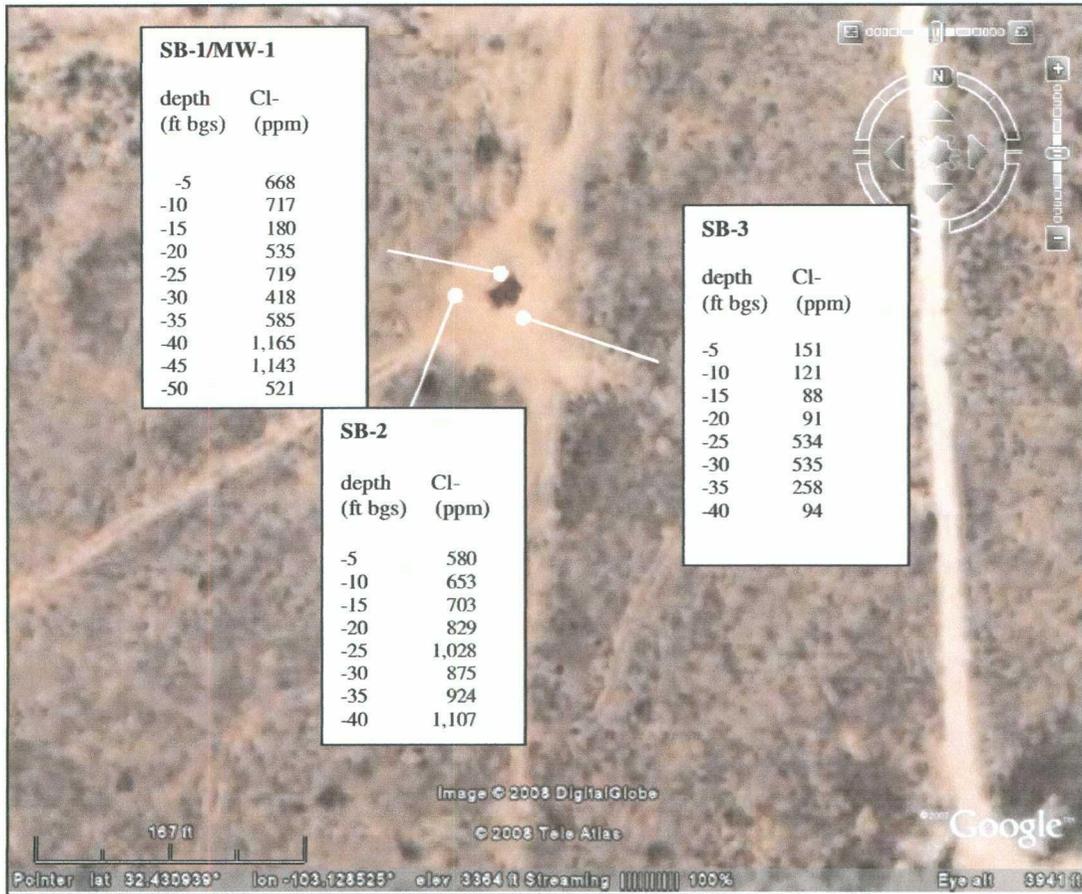
Figure 3a – Approximate soil boring locations and field-measured soil chloride concentrations.

Three soil borings were advanced at and near the location of the former junction box to depths of 40 to 50 ft bgs (Figures 3a, 3b). Soil chloride concentrations averaged 618 ppm among the three soil borings and throughout the depth of drilling. Soil petroleum hydrocarbons were found to be below detection by both PID field reading and by laboratory analysis (Appendix B2).

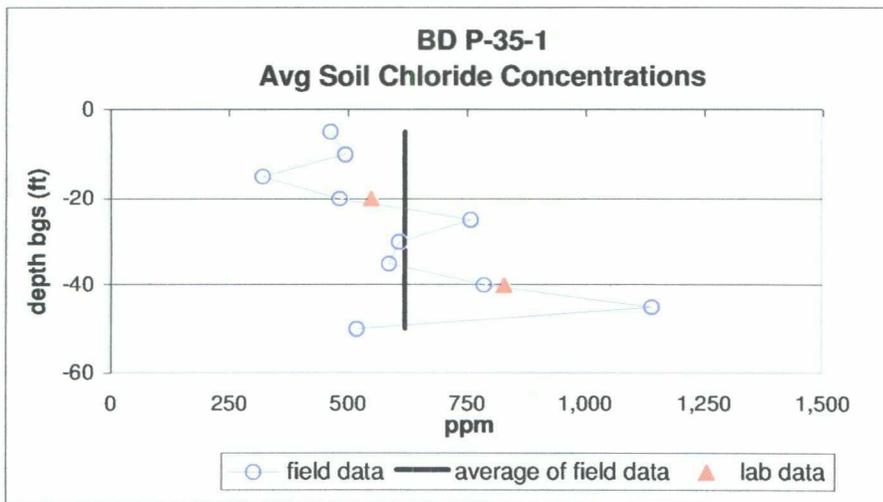
-5	466		0.0			
-10	497		0.0			
-15	324		0.0	< 25.0	< 25.0	organics from SB-1 only
-20	485	551	0.0			
-25	761		0.0			
-30	610		0.0			
-35	589		0.0			
-40	789	831	0.0	< 25.0	< 25.0	organics from SB-1 only
-45	1,143		0.0			
-50	521		0.0			
avg	618		0

Figure 3b – Average soil chloride and petroleum hydrocarbon concentrations from three soil borings taken at/near the former junction box location.

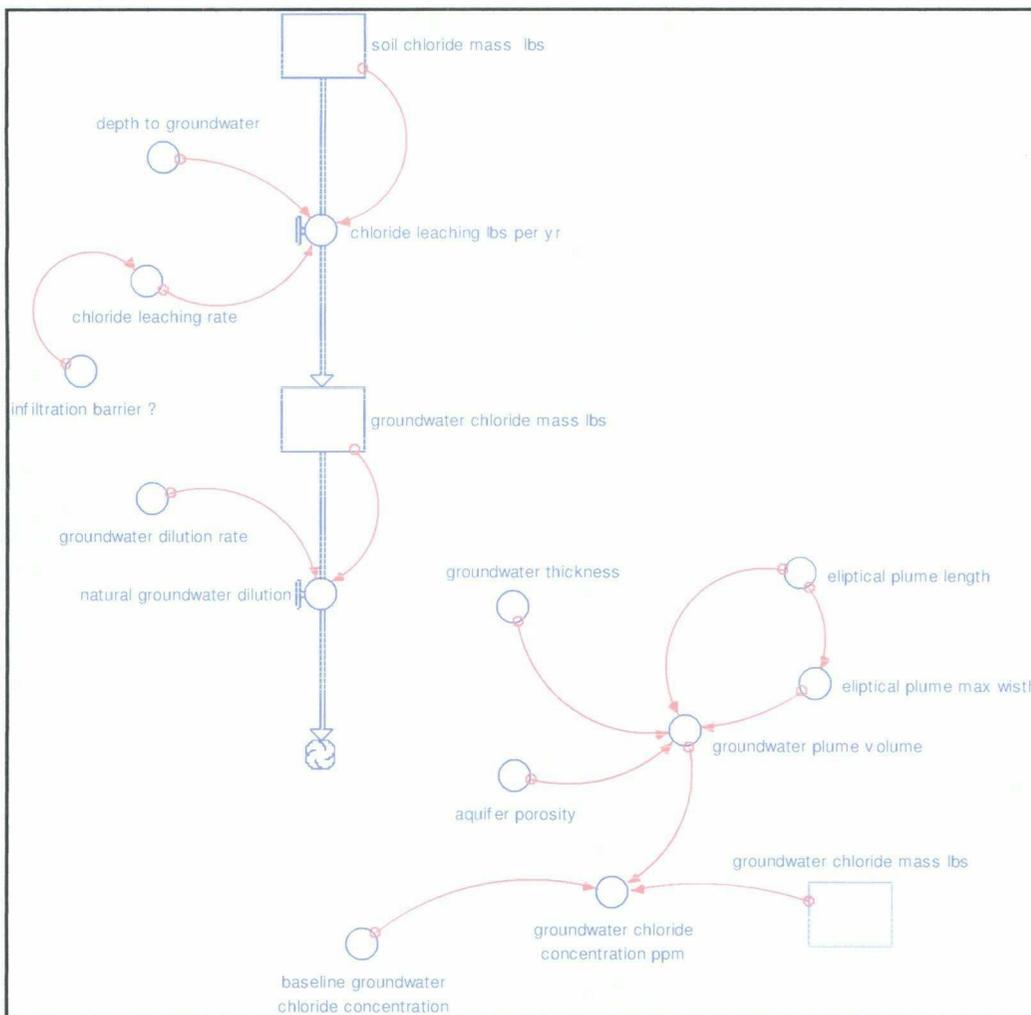
Figure 5- Schematic diagram of soil chloride – groundwater dilution model.

The total mass of residual soil chlorides at this location was estimated to be 5,933 lbs (Figure 4). In order to determine if these residual soil chlorides represent a potential hazard to down gradient groundwater quality, a simple soil chloride transport and groundwater dilution model (Figures 5 & 6) was developed to estimate the potential effect of this residual soil chloride leaching into groundwater over time given the following assumptions:

1. The center of mass of residual chlorides moves downward at a rate of 2.0 ft/yr.
2. It is assumed that these chlorides mix uniformly within an elliptical groundwater plume of dimensions 250 ft maximum length by 100 ft maximum width through a depth of 15 ft of the water table aquifer.
3. Natural dilution of the plume occurs at a rate of 10% per year.

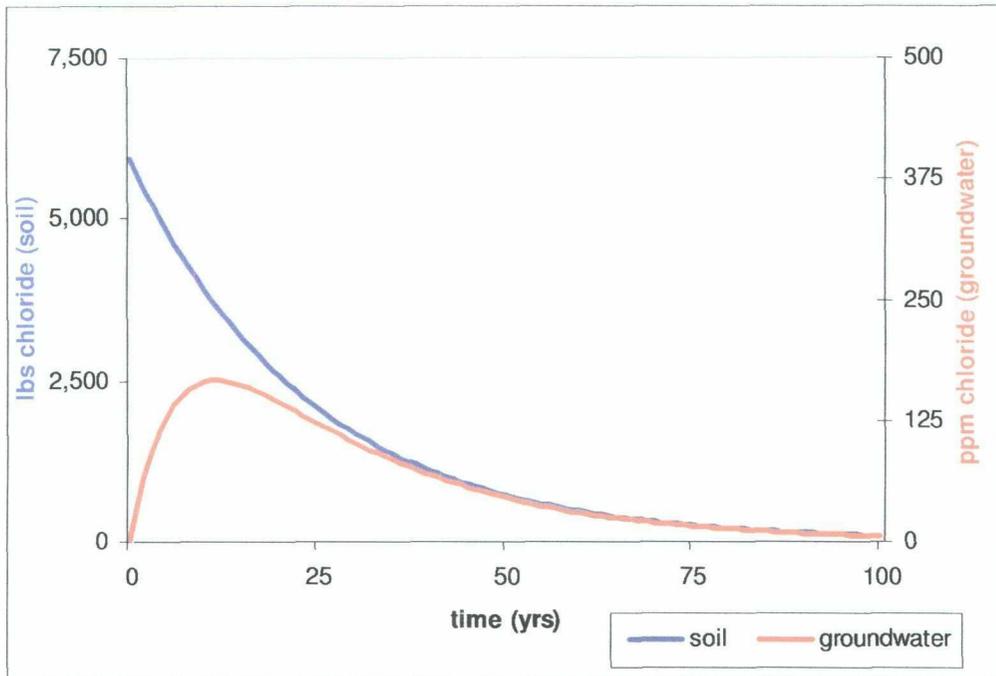
Figure 7 – Estimated change in baseline groundwater chloride concentrations (right axes) over time.

The model predicted that maximum anticipated elevation of groundwater chlorides caused by the movement of residual soil chlorides is less than 175 ppm (Figure 7), indicating that residual soil chlorides should not represent a significant hazard to groundwater quality. An initial sample from an at-source monitor well (MW-1) exhibited a chloride concentration of 352 ppm (Appendix C4). However, it is to be expected that chloride concentrations at/near the center of the release would be higher than the model-predicted average value over the volume of the reference plume.

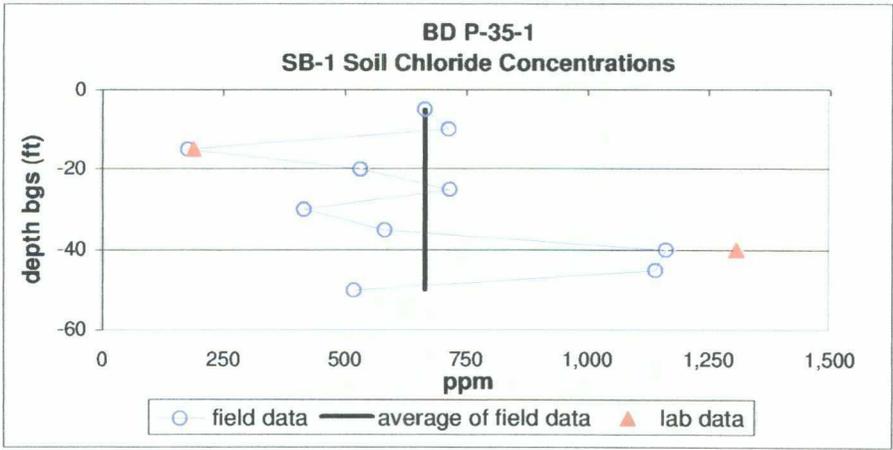
Soil Boring Log							
Rice Operating Company		BD SWD System		BD P-35-1			
Identification:		SB-1					
Location:	Approx. 9 ft W of Rice			Date:	9/10/2008		
Driller:	Harrison & Cooper, Inc. (Ken Cooper supervising)						
Drill method:	Air rotary	L. Peter Galusky, Jr., Texerra					
Total depth:	50						
Screened interval:	40 - 50 ft bg:		Pipe diameter:	4 inch dia			
<u>Depth</u>							
<u>(ft</u>	<u>Field</u>	<u>Lab</u>	<u>Field</u>	<u>Lab</u>	<u>Lab</u>	<u>Well</u>	
<u>below</u>	<u>Chloride</u>	<u>Chloride</u>	<u>PID test</u>	<u>GRO</u>	<u>DRO</u>	<u>Schematic</u>	
<u>ground</u>	<u>Test</u>	<u>Test (ppm)</u>	<u>(ppm)</u>	<u>test</u>	<u>test</u>	<u>Description</u>	
<u>surface)</u>	<u>(ppm)</u>			<u>(ppm)</u>	<u>(ppm)</u>		
-5	668		0.0			oil stained sandy loam	solid pipe
-10	717		0.0			"	"
-15	180	192	0.0	< 25.0	< 25.0	"	"
						oil stained reddish brown coarse sandy loam	"
-20	535		0.0			light olive loamy sand, common small gravels	"

-25	719					"	"
-30	418					variegated olive brown and grayish white fine gravelly sandy loam	"
-35	585					"	"
-40	1,165	1,310		< 25.0	< 25.0	"	"
-45	1,143					tan fine gravelly sand	screen
-50	521					reddish brown gravelly sand, moist	"
avg	665		0

Appendix B1 – SB-1 soil boring log.

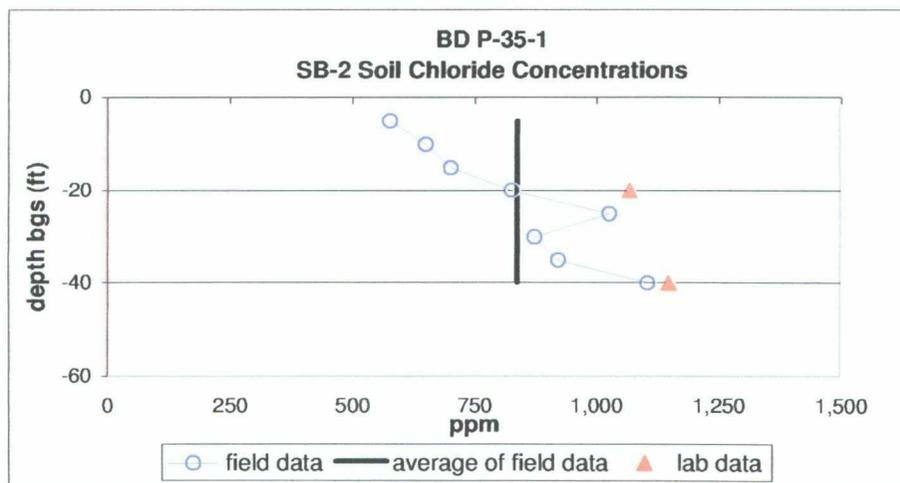
Identification: SB-2
 Location: Approx. 15 ft SSE of Rice marker
 Date: 9/10/2008
 Driller: Harrison & Cooper, Inc. (Ken Cooper supervising)
 Drill method: Air rotary
 Logged by: L. Peter Galusky, Jr., Texerra
 Total depth: 40 ft below ground surface
 Screened interval: n/a (no well installed)
 Pipe diameter: "

<u>Depth (ft)</u> <u>below</u> <u>ground</u> <u>surface)</u>	<u>Field</u> <u>Chloride</u> <u>Test (ppm)</u>	<u>Lab</u> <u>Chloride</u> <u>Test (ppm)</u>	<u>Field PID</u> <u>test (ppm)</u>	<u>Lab GRO</u> <u>test (ppm)</u>	<u>Lab DRO</u> <u>test (ppm)</u>	<u>Cutting Description</u>
-5	580					pale yellowish brown loamy sand
-10	653					pale olive brown loamy sand
-15	703					fine gravelly, pale olive brown loamy sand
-20	829	1,070				yellowish brown gravelly loamy sand
-25	1,028					"
-30	875					variegated white & reddish brown gravelly loamy sand
-35	924					"
-40	1,107	1,150				"
avg	837

Appendix B2 – SB-2 soil boring log.

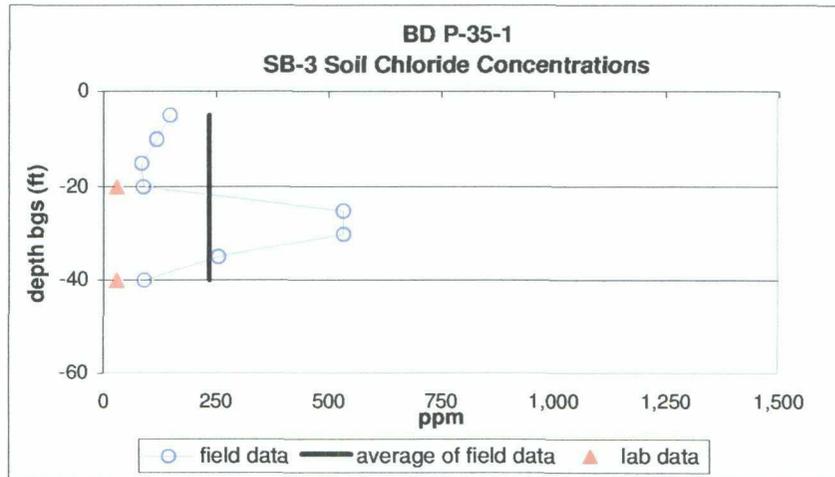
Identification: SB-3
 Location: Approx. 31 ft W of Rice marker
 Date: 9/10/2008
 Driller: Harrison & Cooper, Inc. (Ken Cooper supervising)
 Drill method: Air rotary
 Logged by: L. Peter Galusky, Jr., Texerra
 Total depth: 40 ft below ground surface
 Screened interval: n/a (no well installed)
 Pipe diameter: "

-5	151					reddish brown loamy sand
-10	121					pale brown loamy sand
-15	88					light reddish brown, fine gravelly loamy sand
-20	91	32				gravelly reddish brown loamy sand
-25	534					pale brown, gravelly loamy sand
-30	535					"
-35	258					"
-40	94	32				"
avg	234

Appendix B3 – SB-3 soil boring log.

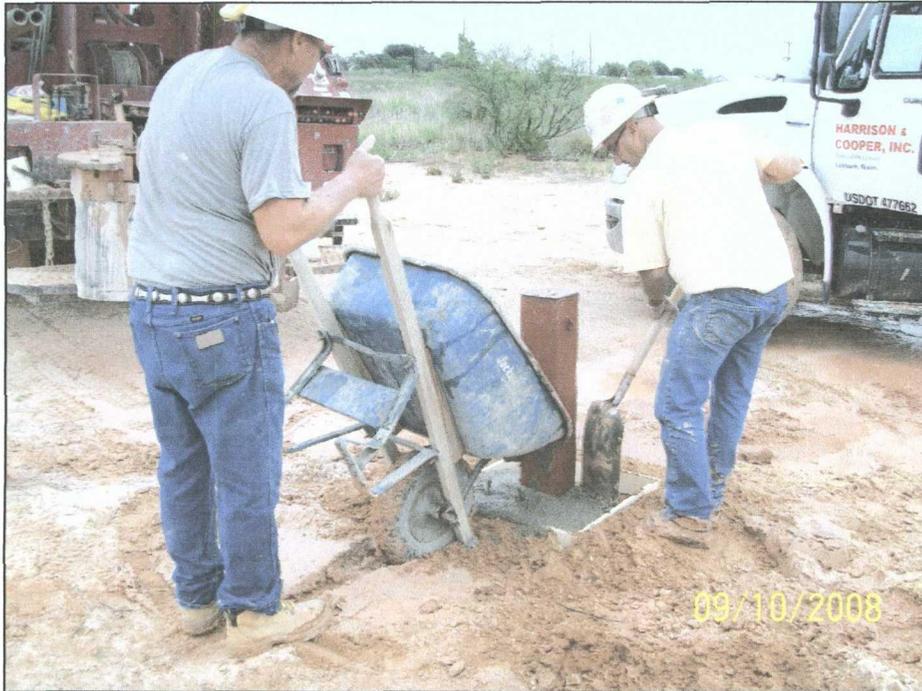
Appendix D – Harrison and Cooper completing MW-1.

This level of chloride concentration, while somewhat above NMOCD's desired standard of 250 ppm, does not appear to warrant remedial actions (or the development of a Corrective Action Plan). Further, given that the monitor well is located within a high oil-field traffic location it may well be advisable to plug and abandon this well altogether, so as to avoid any potential for truck run-over and subsequent direct contamination of the aquifer through the well pipe.
