Environmental Bureau  
Oil Conservation DivisionRICE OPERATING COMPANY  
JUNCTION BOX FINAL REPORT

## Vacuum Jct. C-7

Unit C, Section 7, T18S, R35E

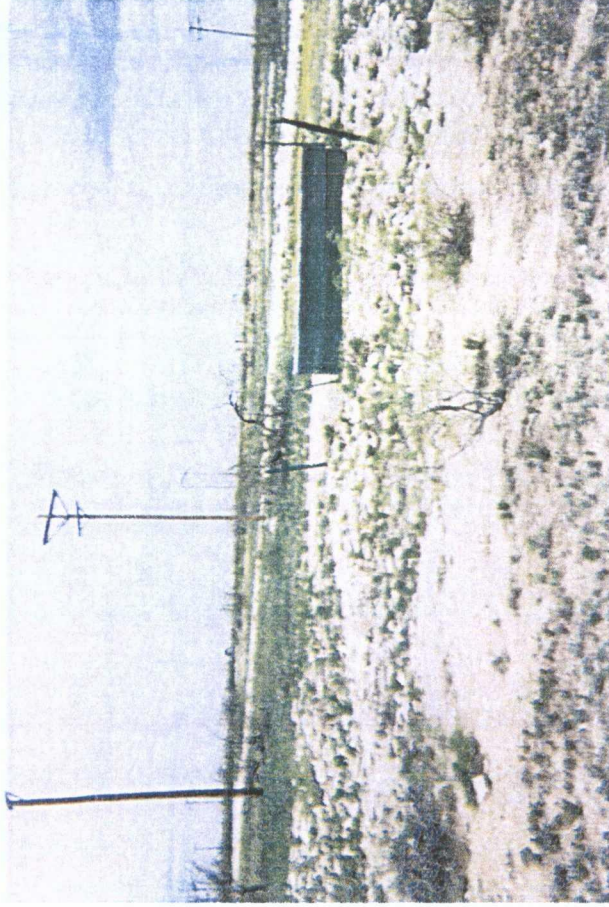
4/18/2002

former junction box site

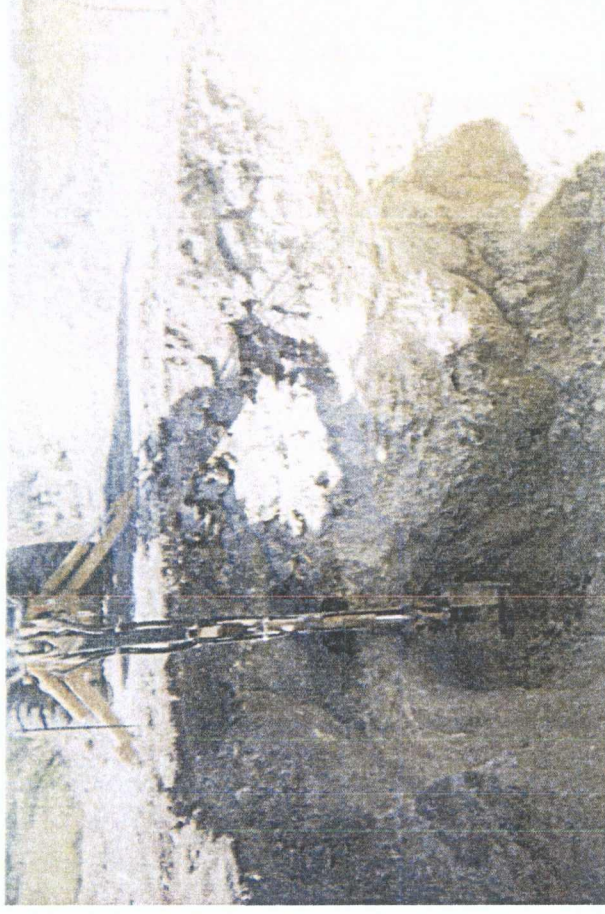
10/4/2006

excavating the former junction box site

an investigation was conducted using a backhoe to excavate the site to dimensions of

20x20x12-ft deep. Representative composite samples were collected and sent to a

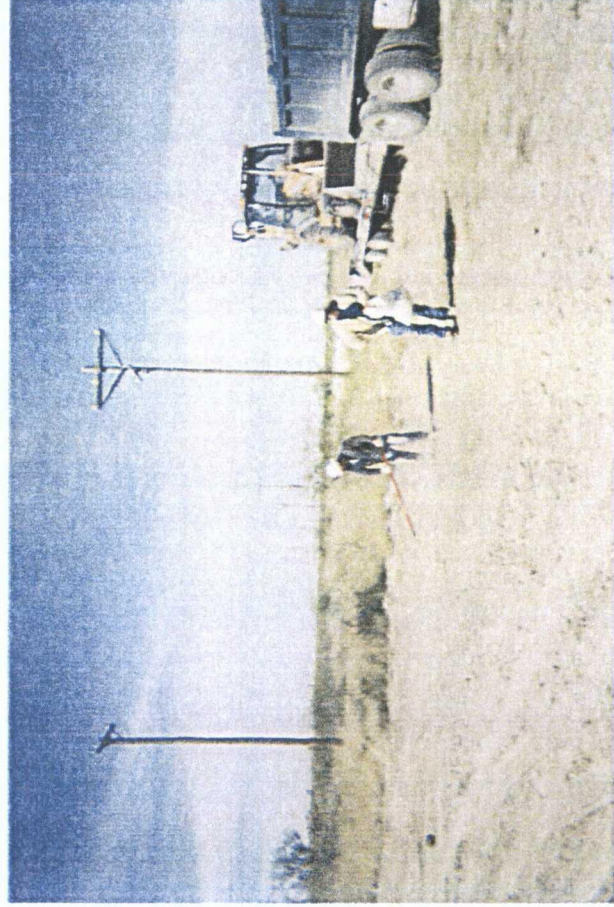
11/6/2006

seeding backfilled site

to the excavation to ground surface and contoured to the surrounding area. On 3/20/2006,

the site was seeded with a blend of native vegetation and is expected to return to a

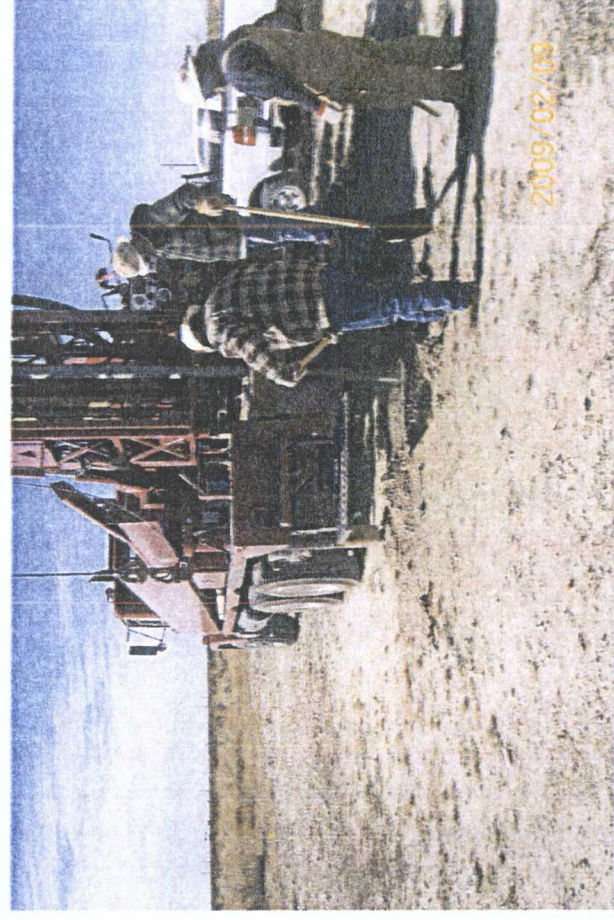
soil boring the former junction box site

productive capacity at a normal rate. To further investigate depth of TPH presence, a soil

boring was initiated on 2/9/2009 at the former junction box location. The boring was advanced to a depth of 30 ft BGS while soil samples

were collected every 5 ft and field tested for chlorides and organic vapors. The 30 ft sample was analyzed by a commercial laboratory for

chloride and TPH which confirmed low concentrations of each. The entire borehole was plugged with bentonite to the ground surface.

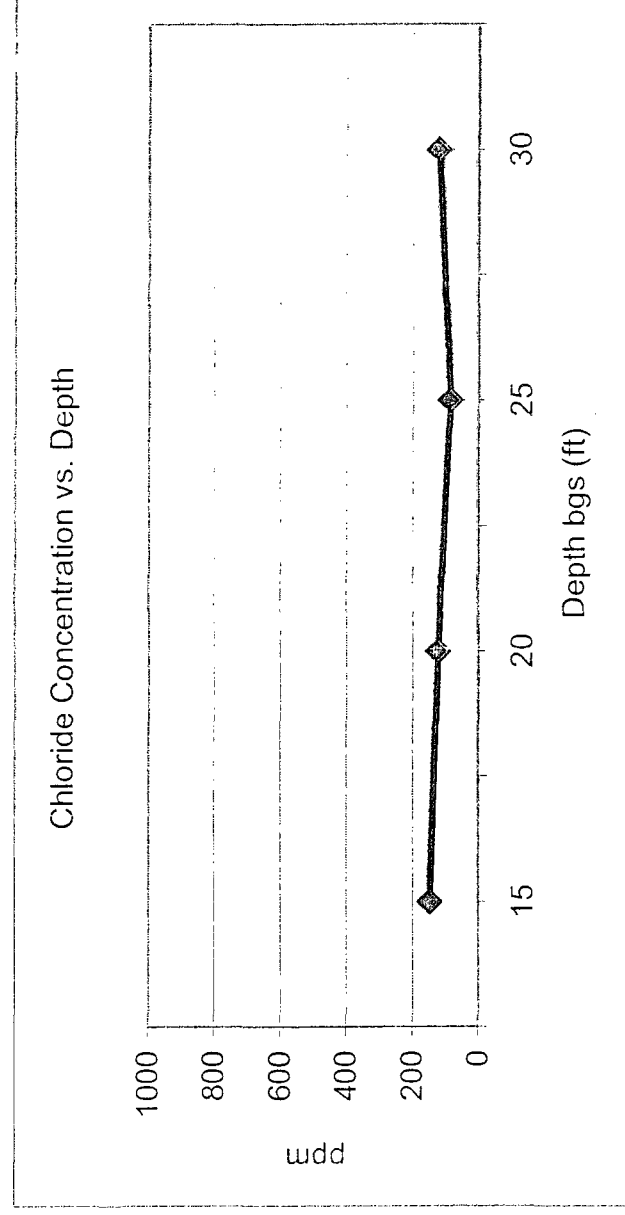
SOIL BORING samples at the junction (source)

Depth bgs (ft)	[Cl] ppm
15	148
20	122
25	84
30	117

Groundwater = 100 ft
