**Vac Jct C-31 (2 boxes)
2009**

RICE OPERATING COMPANY
JUNCTION BOX DISCLOSURE* REPORT

Vacuum Jct C-31

Unit C, Section 31, T17S, R35E

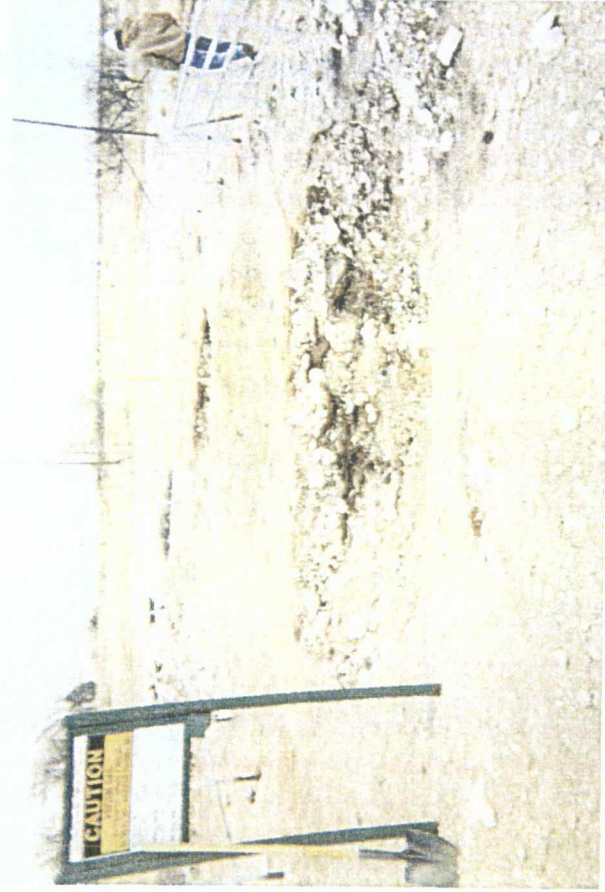
2/16/2009

Site prior to excavation (east)

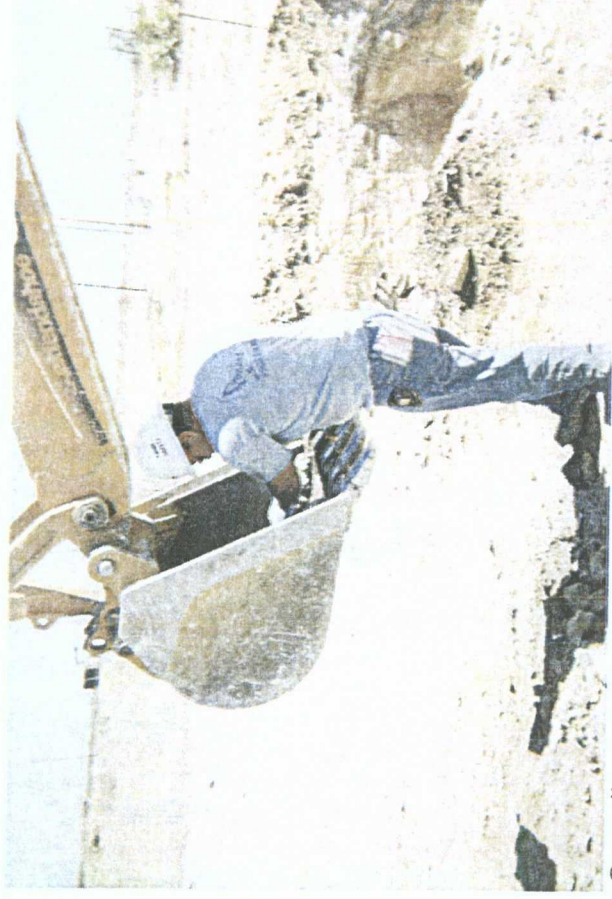
2/16/2009

Sampling source (south west)

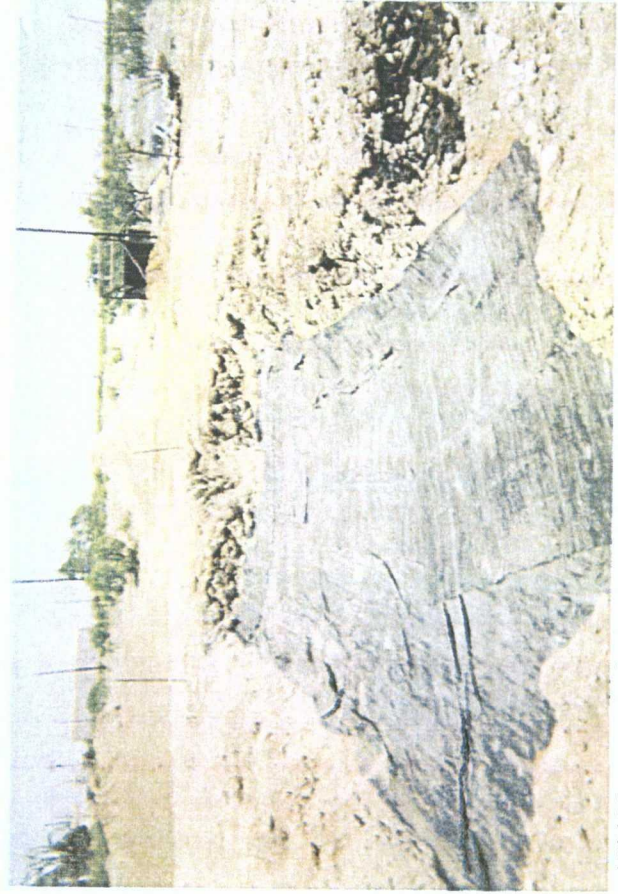
5/28/2009

45X20 geosynthetic liner installed

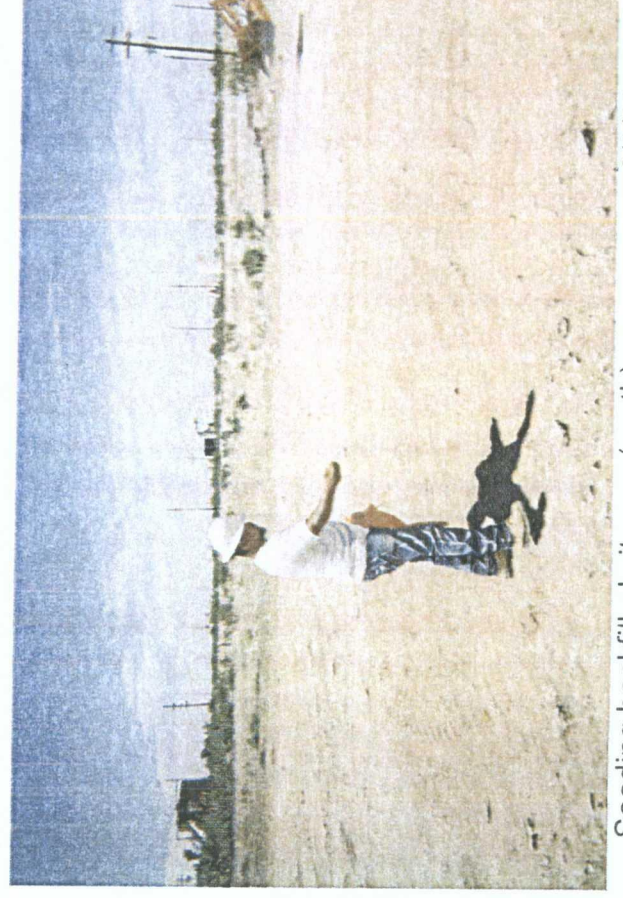
6/8/2009

Seeding backfilled site (north)

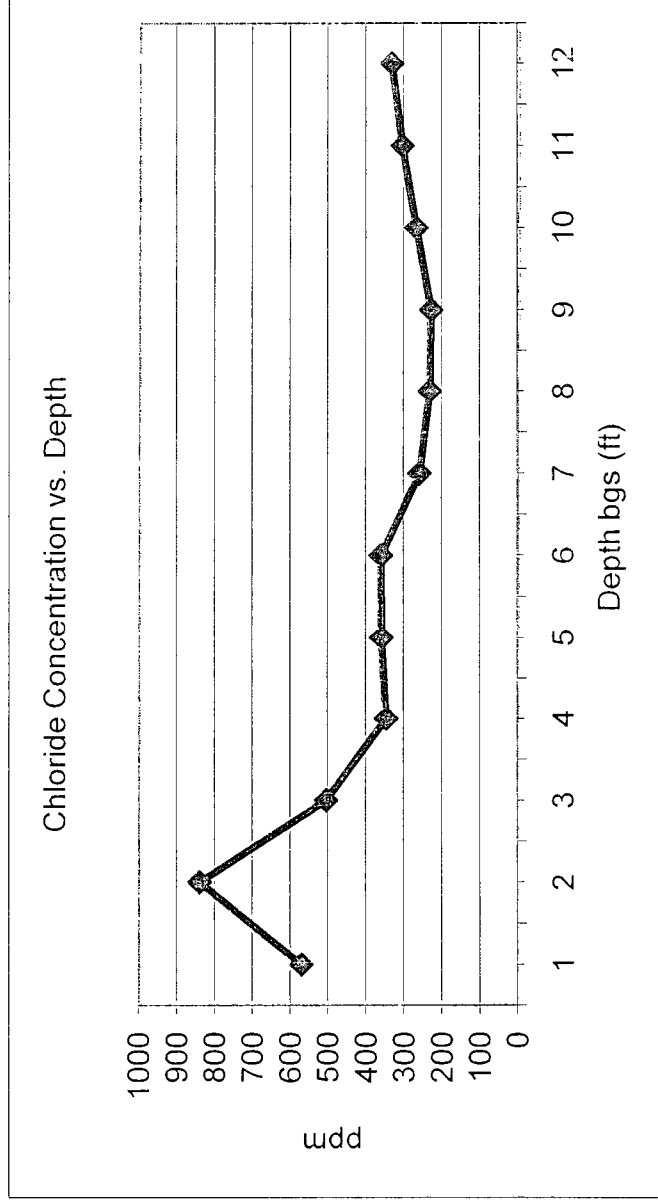
CHLORIDE CONCENTRATION CURVE

Backhoe samples at 5 ft west of the junction (source)

Depth bgs (ft)	[C] ppm
1	570
2	840
3	504
4	346
5	359
6	360
7	258
8	231
9	227
10	266
11	303
12	331

Groundwater = 117 ft

LOCATION	DEPTH	mg/kg
vertical delineation trench at 5 ft west of the junction (source)	1'	570
	2'	840
	3'	504
	4'	346
	5'	359
	6'	360
	7'	258
	8'	231
	9'	227
	10'	266
	11'	303
	12'	331
