**EME Jct K-15
2009**

**RICE OPERATING COMPANY
JUNCTION BOX FINAL REPORT**

EME Jct. K-15

Unit K, Section 15, T21S, R36E

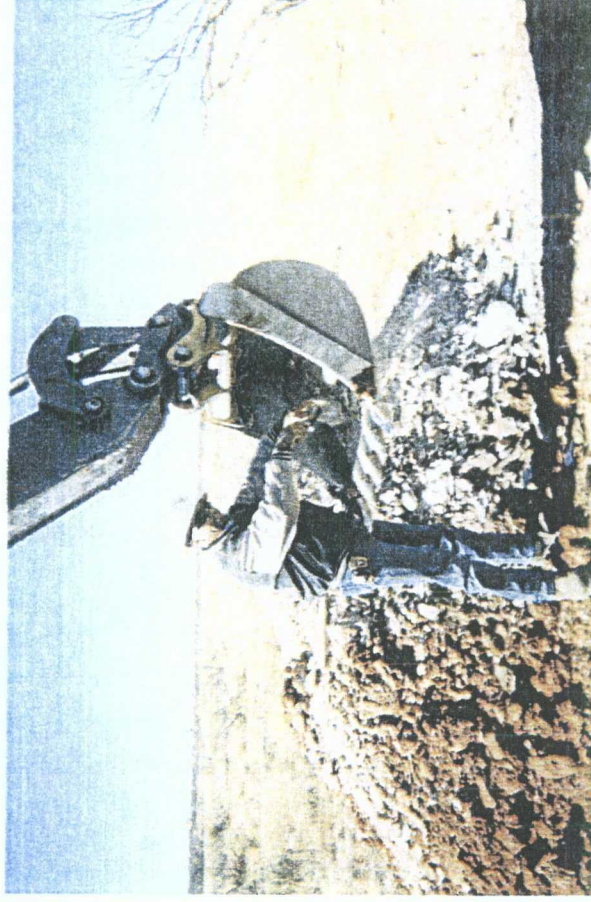
1/13/2009

collecting a soil sample, facing south

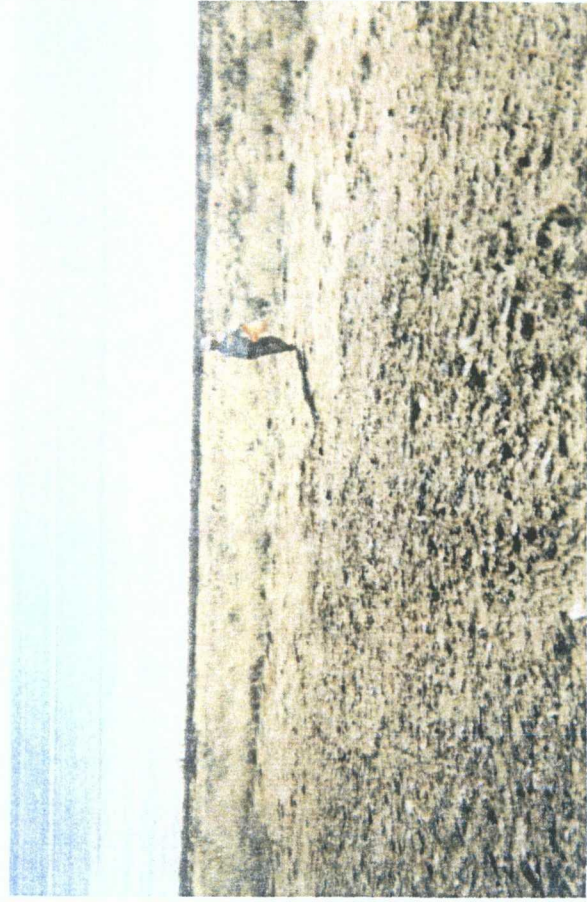
2/25/2009

seeding backfilled site, facing south
