CLOSURE

Environmental Bureau
Oil Conservation DivisionRICE OPERATING COMPANY
JUNCTION BOX FINAL REPORT

EME Jct. P-8-2

Unit P, Section 8, T20S, R37E

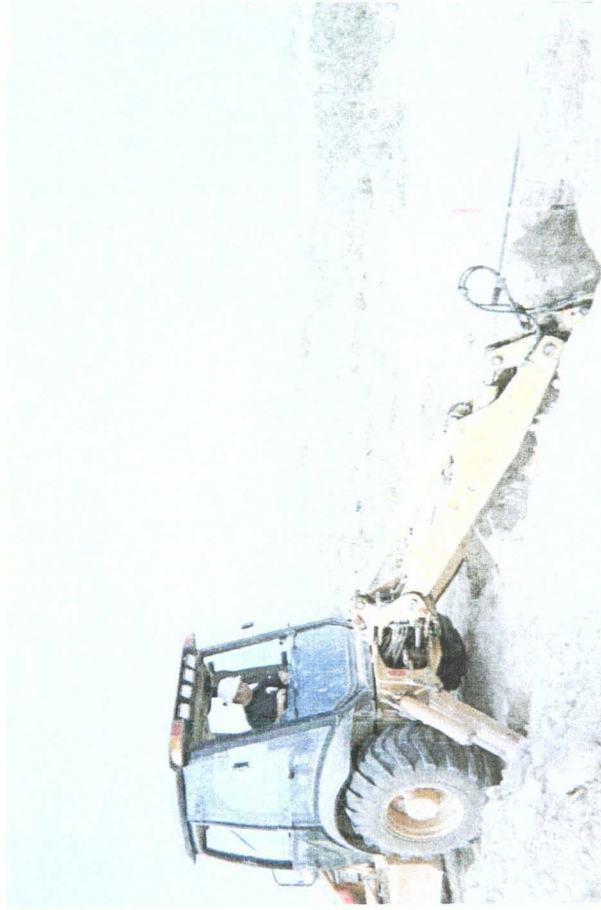
9/11/2009

excavating the former junction box, facing north

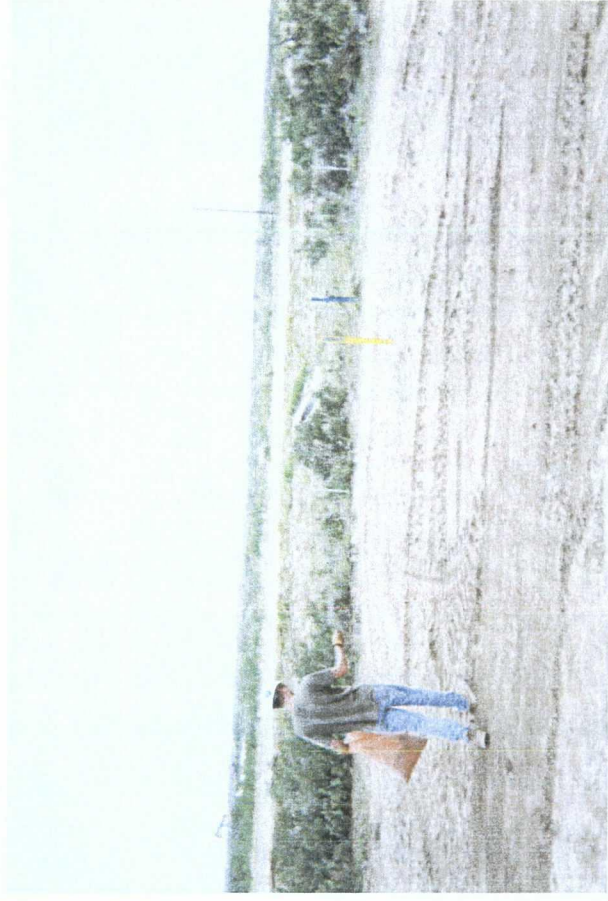
9/18/2009

seeding backfilled site, facing east

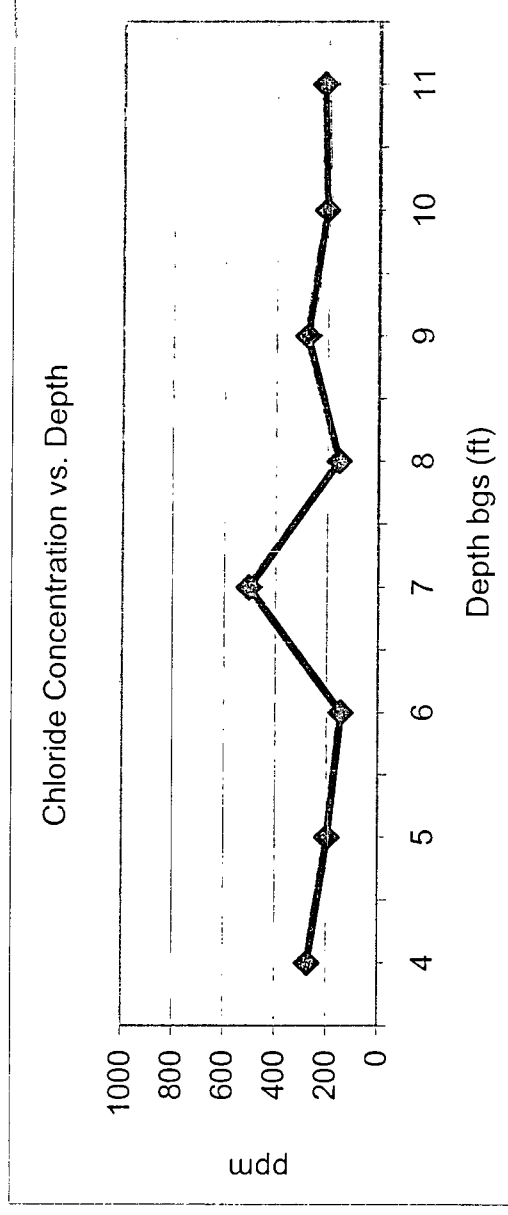
CHLORIDE CONCENTRATION CURVE

Backhoe samples at the junction (source)

Depth bgs (ft)	[Cl] ppm
4	274
5	197
6	145
7	502
8	152
9	276
10	203
11	212

Groundwater = 35 ft
