Environmental Bureau
Oil Conservation DivisionRICE OPERATING COMPANY
JUNCTION BOX FINAL REPORT

SWD SYSTEM	JUNCTION	UNIT	SECTION	TOWNSHIP	RANGE	COUNTY	BOX DIMENSIONS - FEET		
Eunice Monument Eumont (EME)	Amoco St 'J' EOL	E	22	21S	36E	Lea	Length	Width	Depth
							eliminated

EME Amoco St 'J' EOL

Unit E, Section 22, T21S, R36E

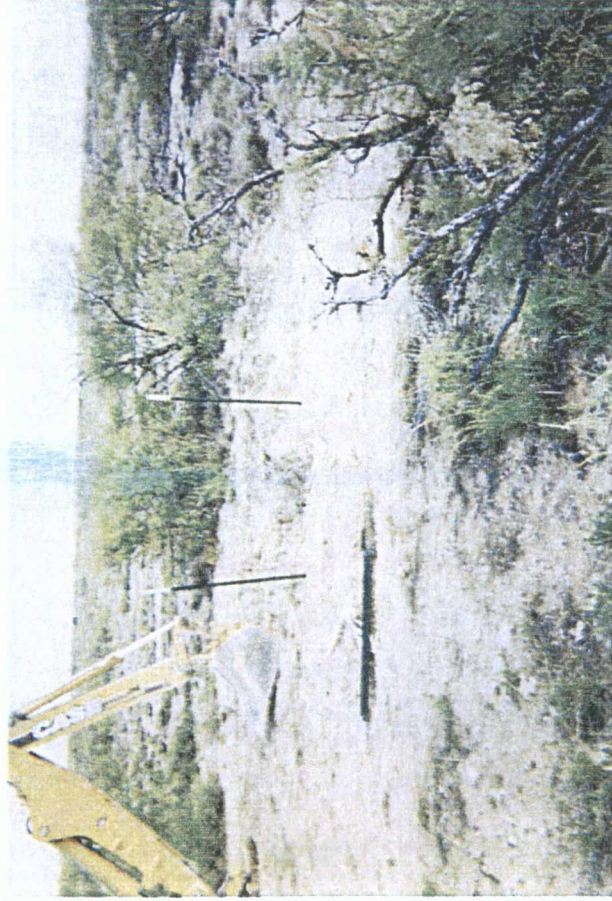
10/21/2008

former junction box site, facing north

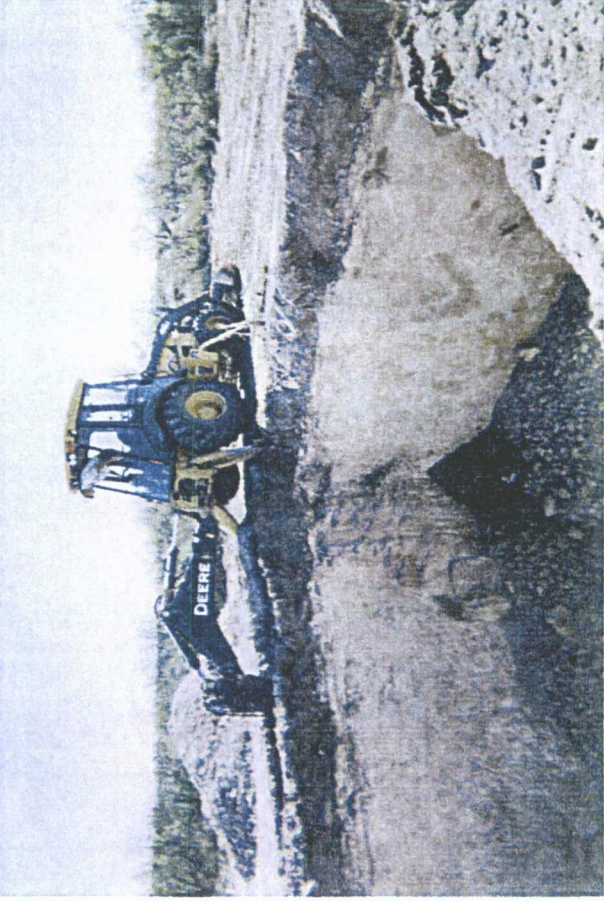
11/13/2008

excavating former junction box site
to 30x30x12-ft-deep, facing east

General Description of Remedial Action: This junction box was eliminated during pipeline replacement/upgrade program. After the former junction box was removed, an investigation was conducted using a backhoe to collect soil samples at regular intervals producing a 30x30x12-ft-deep excavation. Chloride field tests performed on each sample yielded low concentrations similar to that of the background sample. Organic vapors were measured using a PID, which also yielded low concentrations. Representative composite samples were sent to a commercial laboratory for analysis of chloride and TPH, which confirmed low concentrations. The excavated soil was blended on site and returned to the excavation to ground surface and contoured to the surrounding area. On 11/21/2008, the site was seeded with a blend of native vegetation and is expected to return to a productive capacity at a normal rate.
