EME Arco 'B' EOL

**RICE OPERATING COMPANY  
JUNCTION BOX FINAL REPORT**

## EME Arco 'B' EOL

Unit I, Section 8, T21S, R36E

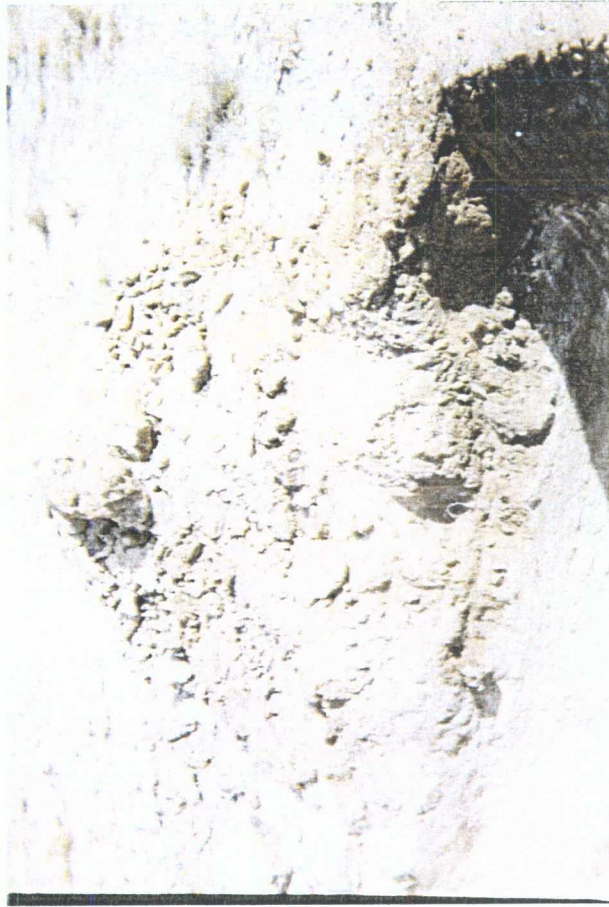
former junction box location

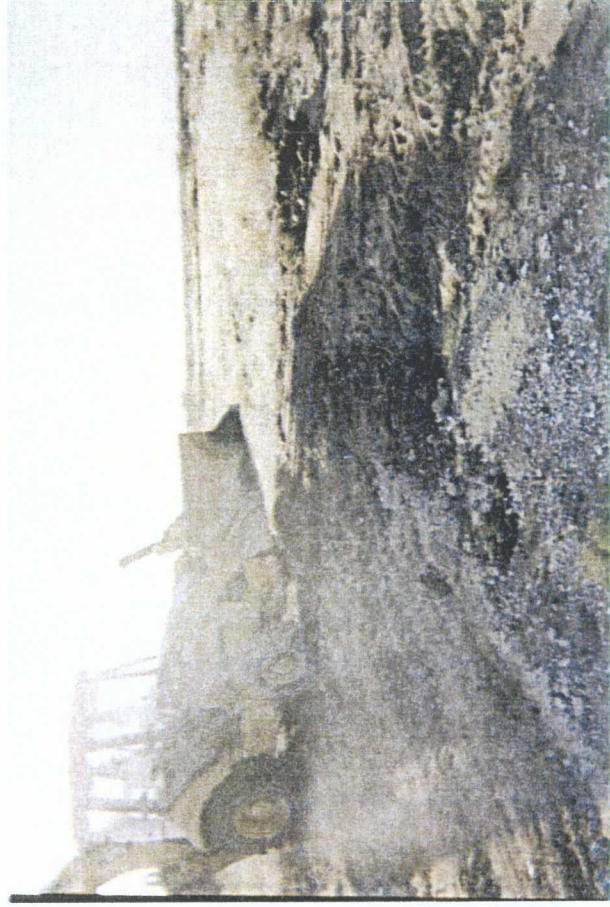
backfilling excavation
