**RICE OPERATING COMPANY
JUNCTION BOX DISCLOSURE* REPORT**

BOX LOCATION							BOX DIMENSIONS - FEET		
SWD SYSTEM	JUNCTION	UNIT	SECTION	TOWNSHIP	RANGE	COUNTY	Length	Width	Depth
Eunice Monument Eumont (EME)	Jct. I-30	I	30	19S	37E	Lea	eliminated

EME Jct. I-30

Unit I, Section 30, T19S, R37E

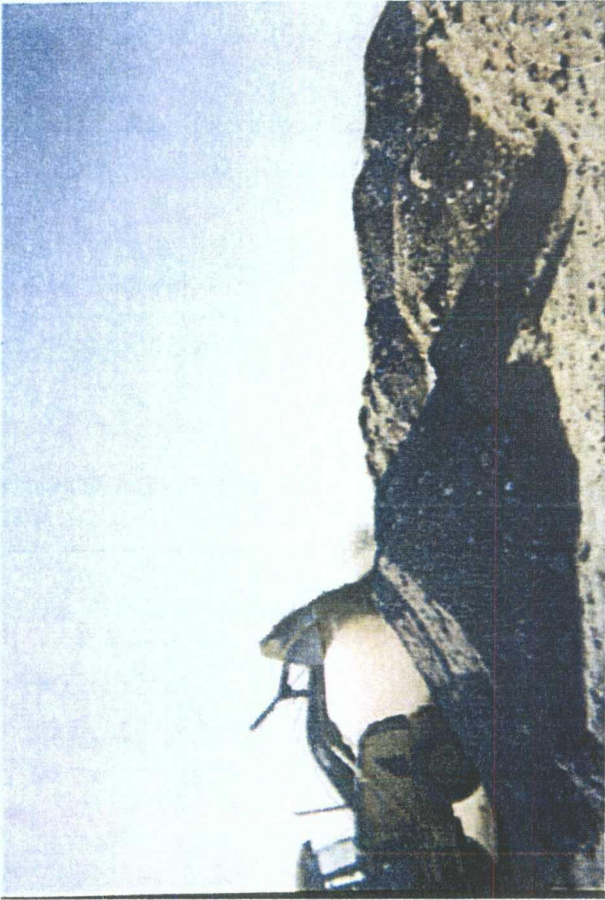
1/12/2009

blending excavated soil
with imported soil, facing south

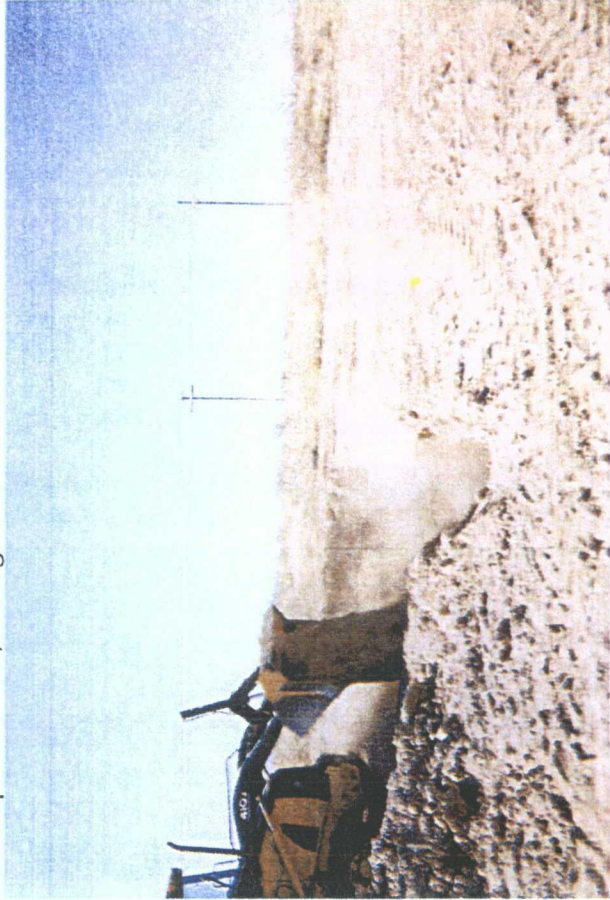
2/5/2009

backfilling the excavation, facing west

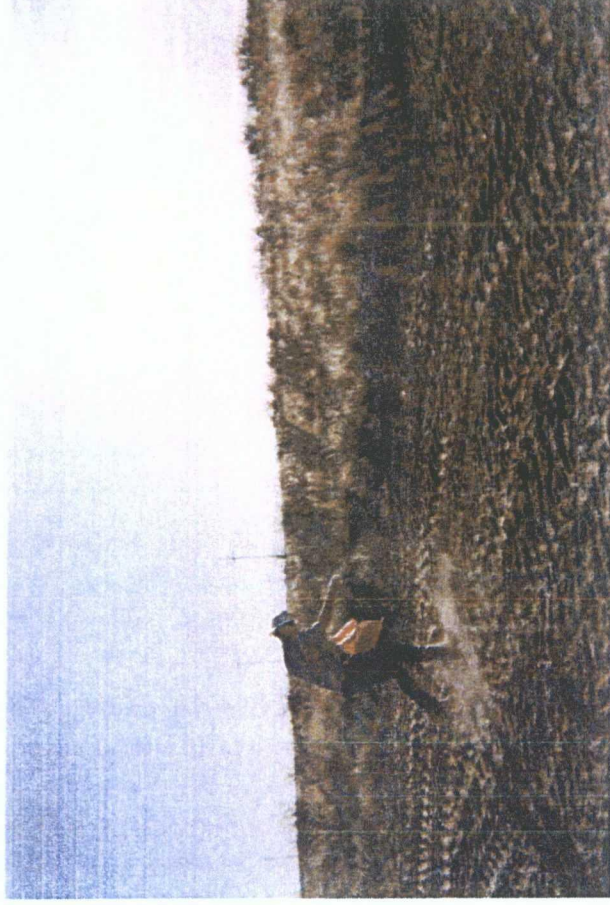
2/5/2009

seeding backfilled site, facing south
