BD Jct E-14  
2009

**RICE OPERATING COMPANY  
JUNCTION BOX FINAL REPORT**

# BD E-14 EOL

Unit E, Section 14, T21S, R37E

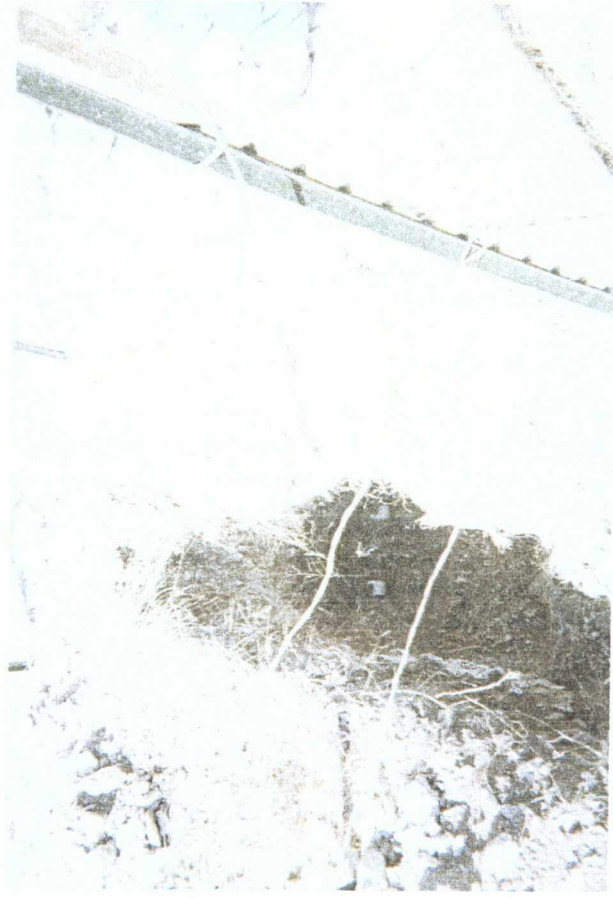
former junction box site, facing west

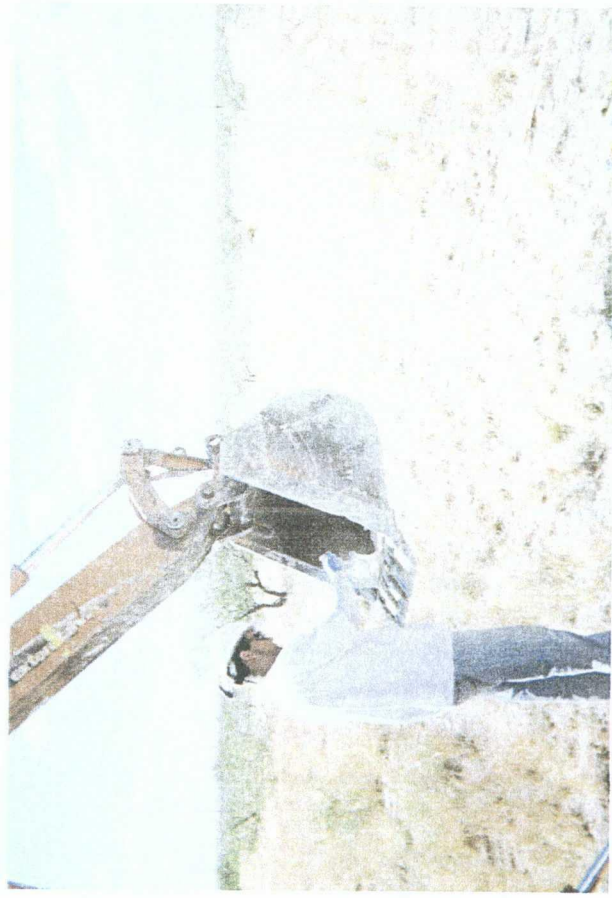
collecting a soil sample, facing west

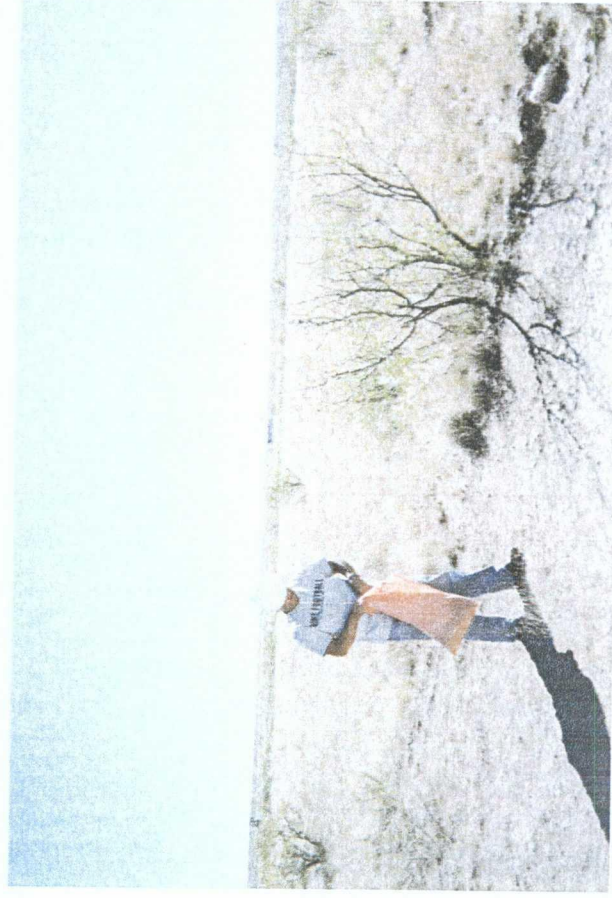
seeding the backfilled site, facing south

**General Description of Remedial Action:** This junction was eliminated during the pipeline replacement/upgrade program. After the former junction box was removed, the site was investigated using a backhoe to collect soil samples at regular intervals producing a 2x5x8-ft deep excavation. Chloride field tests performed on each sample yielded low concentrations similar to that of the background sample. Organic vapors were measured using a PID which also yielded low concentrations. Laboratory analysis of the 8 ft BGS sample confirmed low concentration of chloride and TPH. The excavated soil was returned to the excavation to ground surface and contoured to the surrounding area. On 11/6/2009, the site was seeded with a blend of native vegetation and is expected to return to a productive capacity at a normal rate.

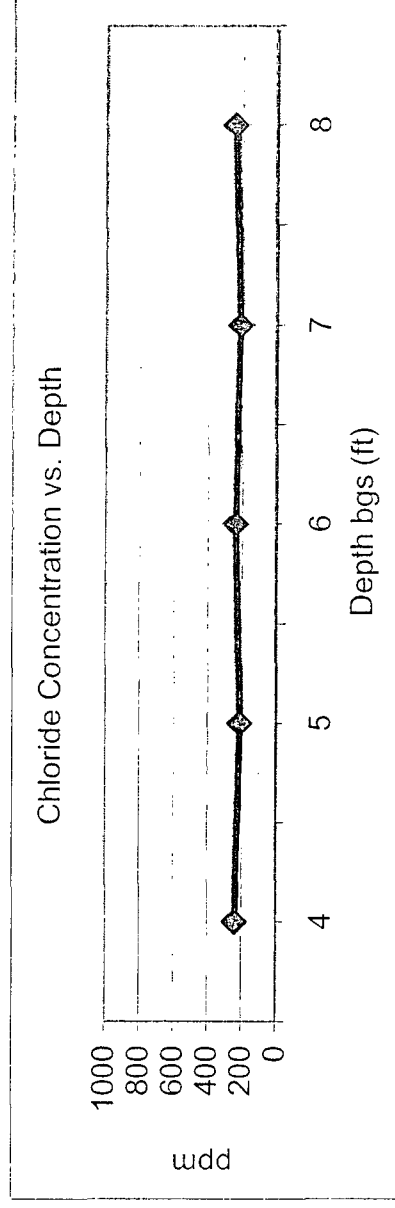
CHLORIDE CONCENTRATION CURVE

Backhoe samples at the junction (source)

Depth bgs (ft)	[Cl <sup>-</sup> ] ppm
4	241
5	211
6	238
7	211
8	241

Groundwater = 41 ft
