RICE OPERATING COMPANY
JUNCTION BOX FINAL REPORTAPP - 6 2010
Environmental Bureau
Oil Conservation Division

BD C-23 EOL

Unit C, Section 23, T21S, R37E

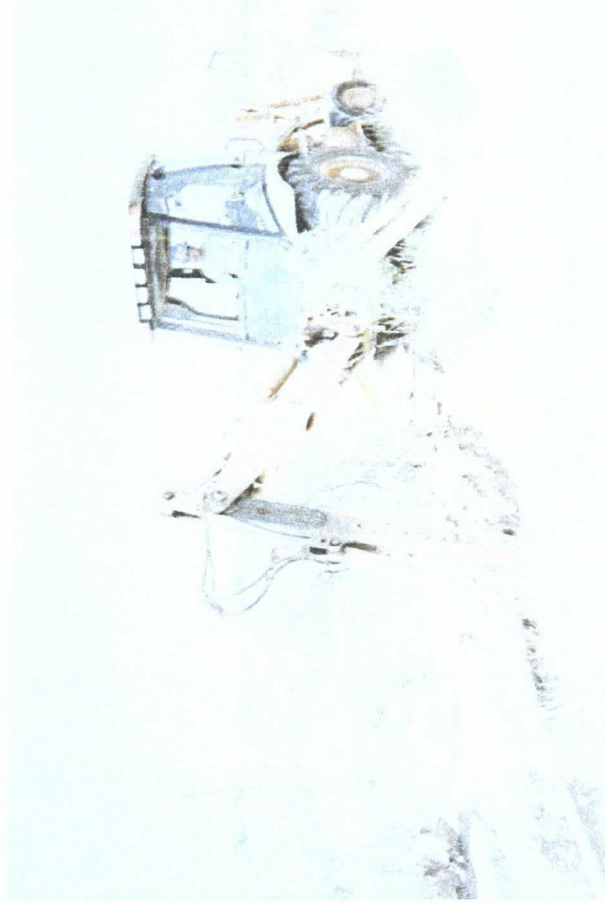
8/31/2009

excavating the former junction box site, facing west
