Environmental Bureau  
Oil Conservation DivisionRICE OPERATING COMPANY  
JUNCTION BOX FINAL REPORT

## BD O-23 EOL

Unit O, Section 23, T21S, R37E

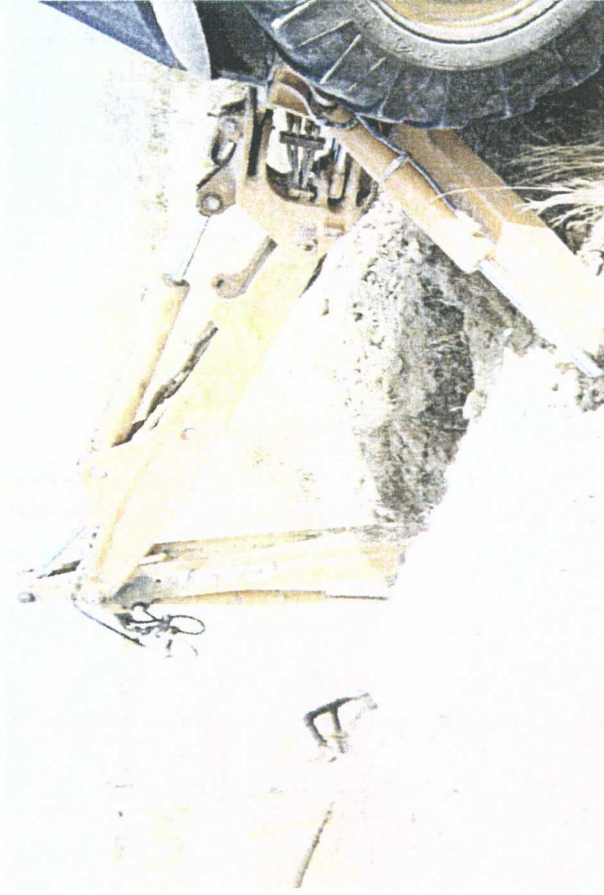
excavating the former junction box site, facing east 10/18/2009

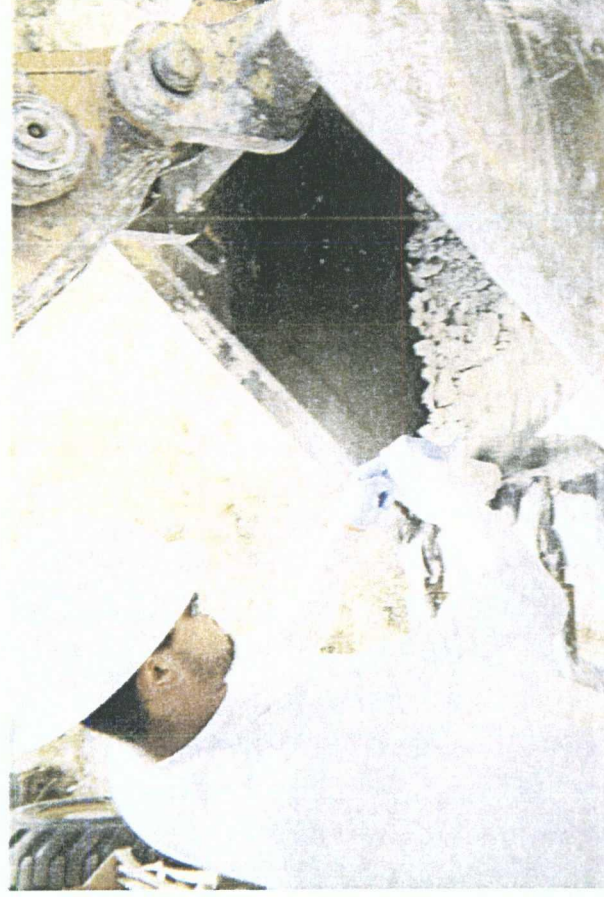
collecting a soil sample, facing source 10/18/2009

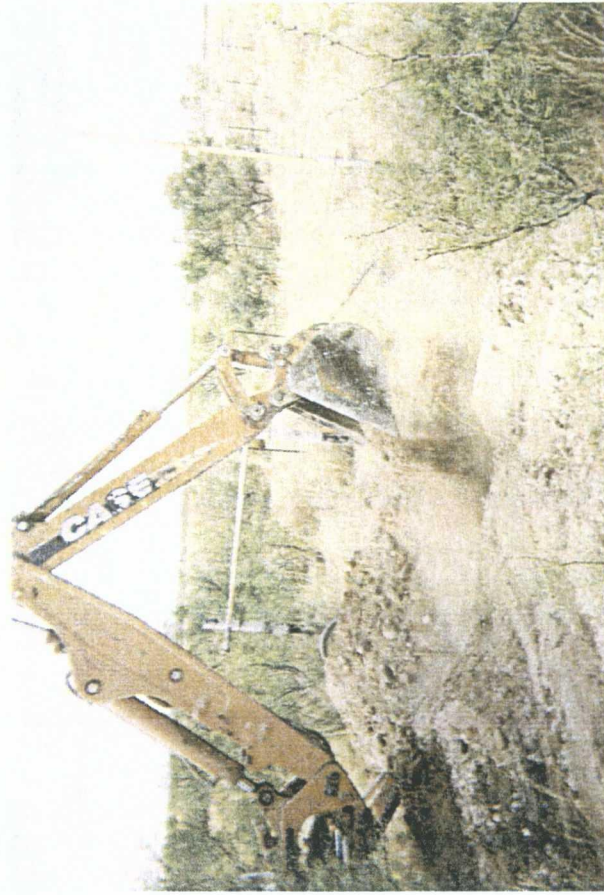
backfilling the excavation, facing west 10/18/2009

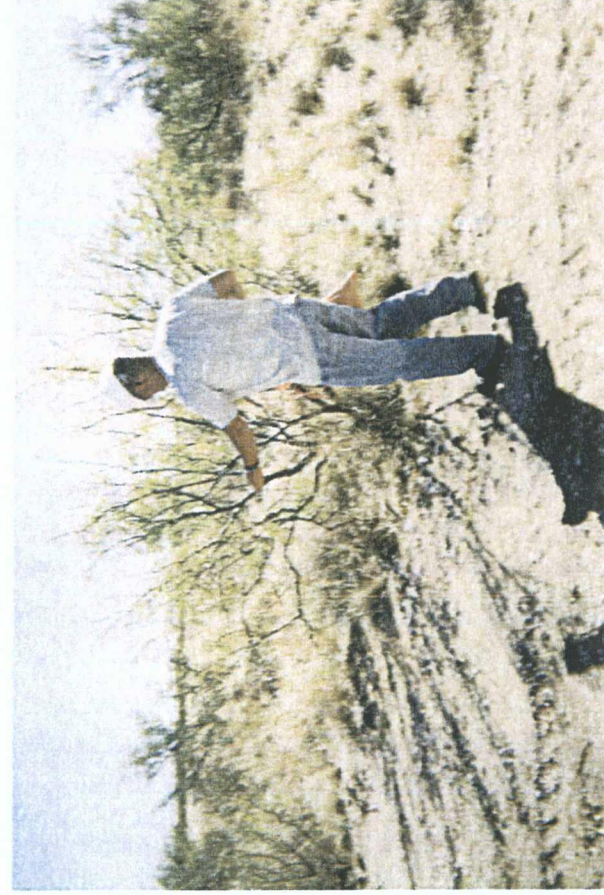
seeding the backfilled site, facing south 11/6/2009

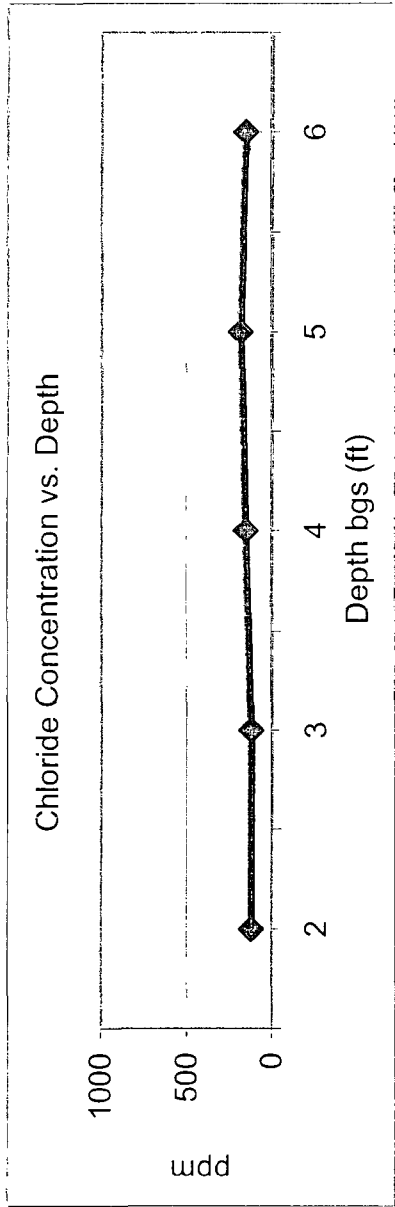
CHLORIDE CONCENTRATION CURVE

Backhoe samples at the junction (source)

Depth bgs (ft)	[Cl <sup>-</sup> ] ppm
2	120
3	120
4	150
5	180
6	149

Groundwater = 43 ft
