BD Jct N-7-1  
2009

**RICE OPERATING COMPANY  
JUNCTION BOX FINAL REPORT**

## BD Jct. N-7-1

Unit N, Section 7, T22S, R37E

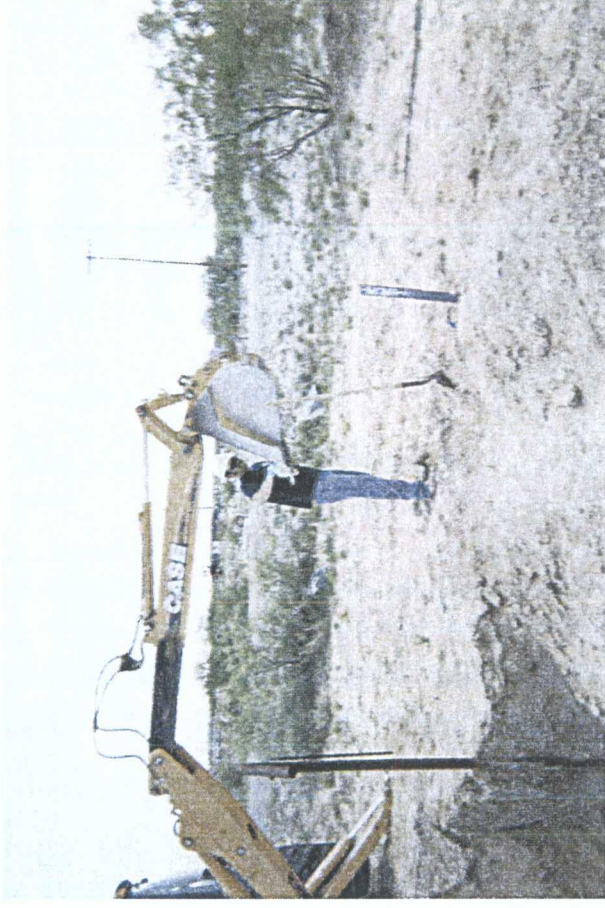
6/3/2009

collecting a soil sample, facing south

an investigation was conducted using a backhoe to collect soil samples at regular intervals

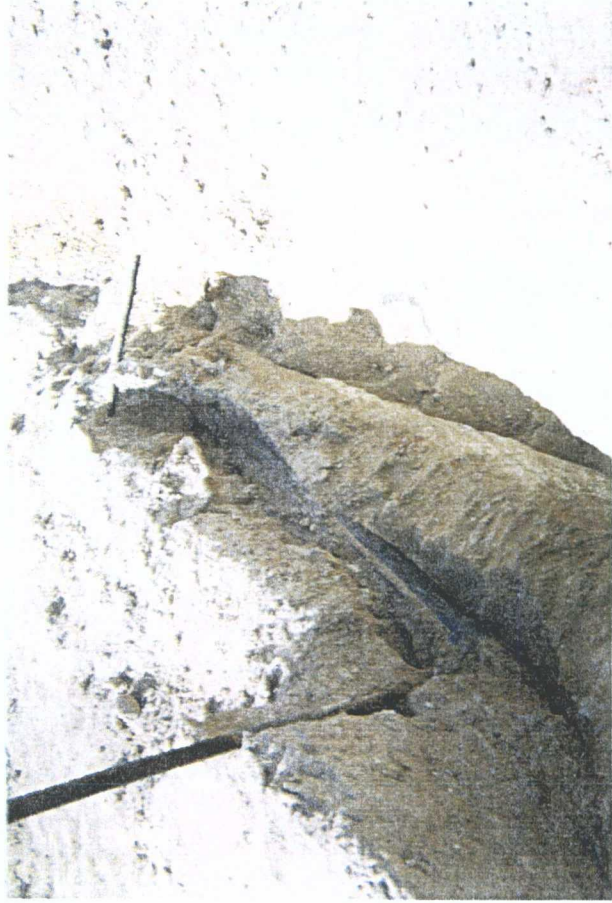
6/3/2009

excavation at the source, facing north

creating a 5x3x10-ft deep excavation. Field analysis yielded chloride concentrations similar

to that of the background. Organic vapors were measured using a PID which also yielded

low concentrations. The deepest sample, 10 ft BGS, was sent to a commercial laboratory for analysis of chloride and TPH, which confirmed
