**RICE OPERATING COMPANY
JUNCTION BOX FINAL REPORT**

SWD SYSTEM	JUNCTION	UNIT	SECTION	TOWNSHIP	RANGE	COUNTY	BOX DIMENSIONS (feet)		
Blinebry-Drinkard (BD)	I-25-1 EOL	I	25	21S	36E	Lea	Length	Width	Depth
							Eliminated

BD I-25-1 EOL

Unit I, Section 25, T21S, R36E

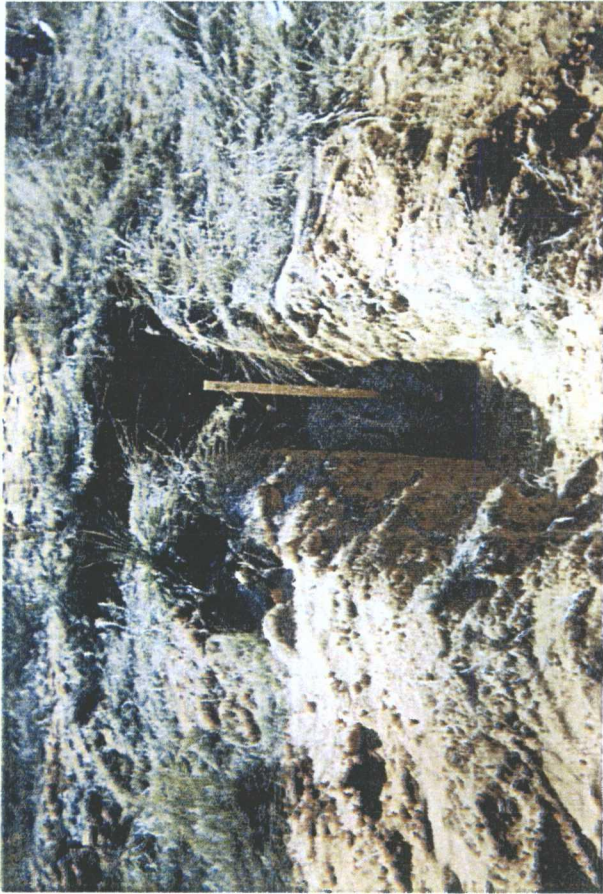
11/20/2009

South of source

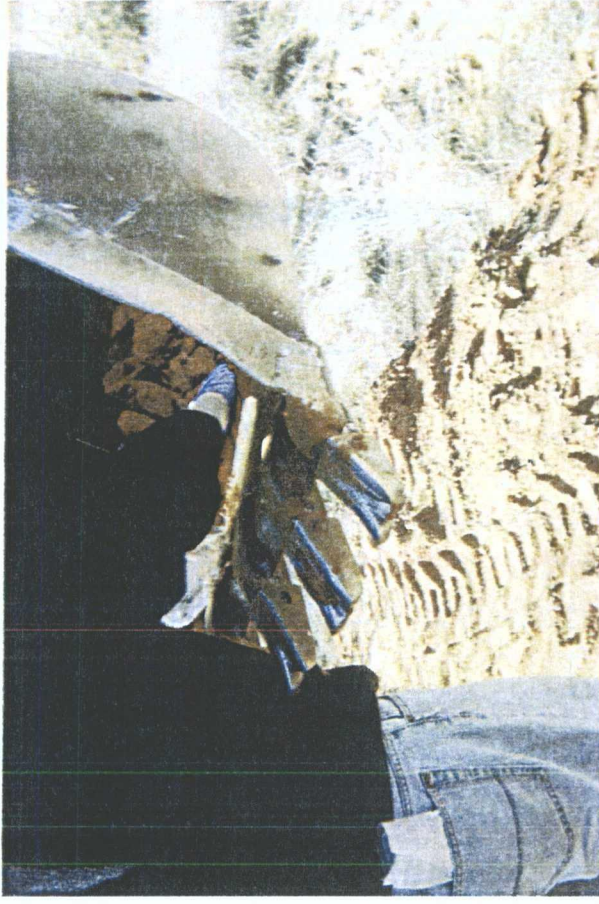
11/20/2009

Sampling source (south)

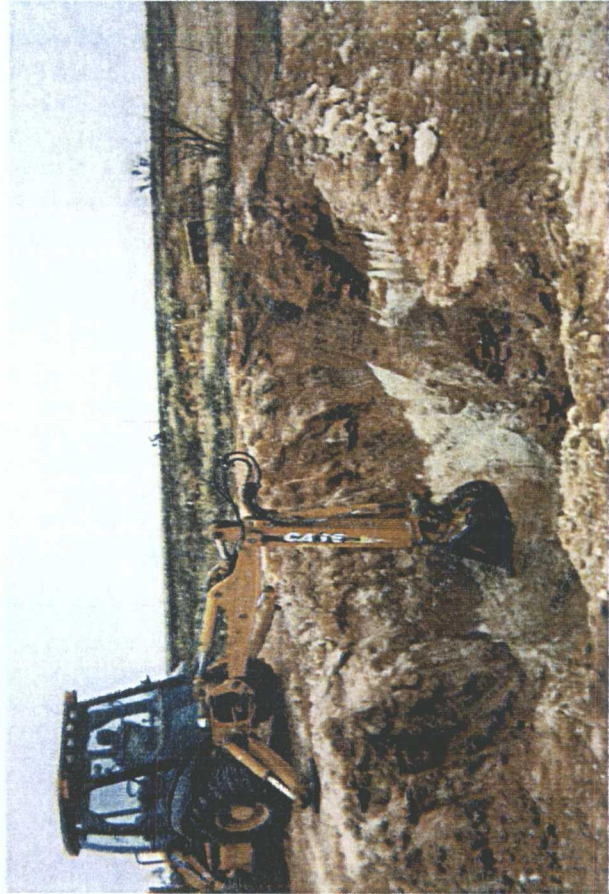
11/22/2009

Cleaning out excavation

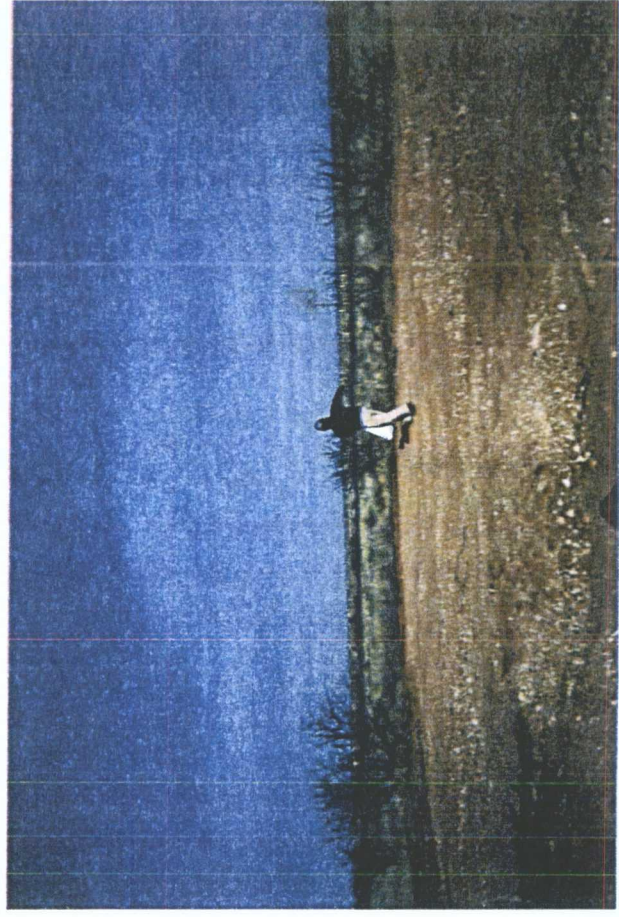
12/30/2009

Seeding backfilled site

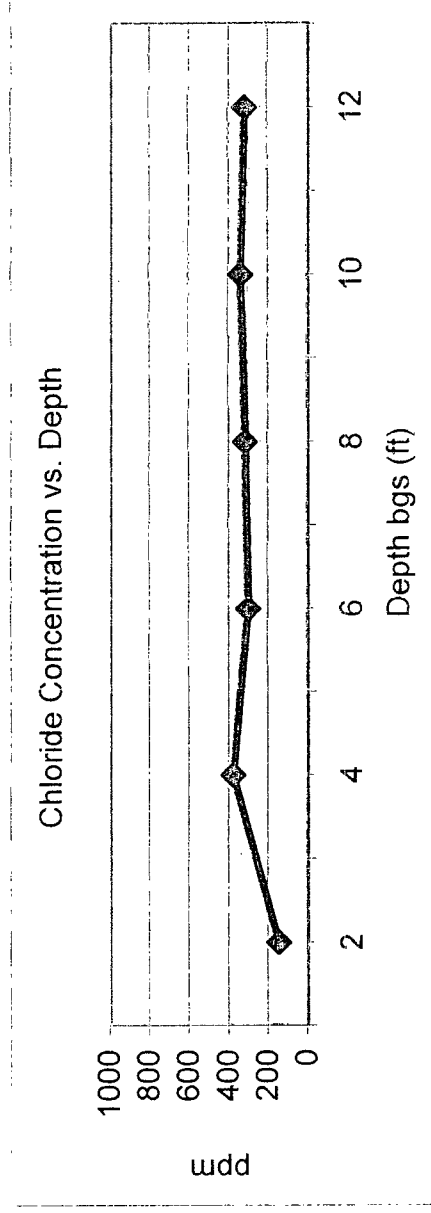
CHLORIDE CONCENTRATION CURVE

Backhoe samples at 5' south of source

Depth bgs (ft)	[Cl ⁻] ppm
2	143
4	373
6	297
8	311
10	335
12	314

Groundwater = 148 ft
